Fatigue assessment of the collapsed XXth Century cable-stayed Polcevera Bridge in Genoa

25th International Conference on Fracture and Structural Integrity

# Fatigue assessment of the collapsed XX<sup>th</sup> Century cable-stayed Polcevera Bridge in Genoa

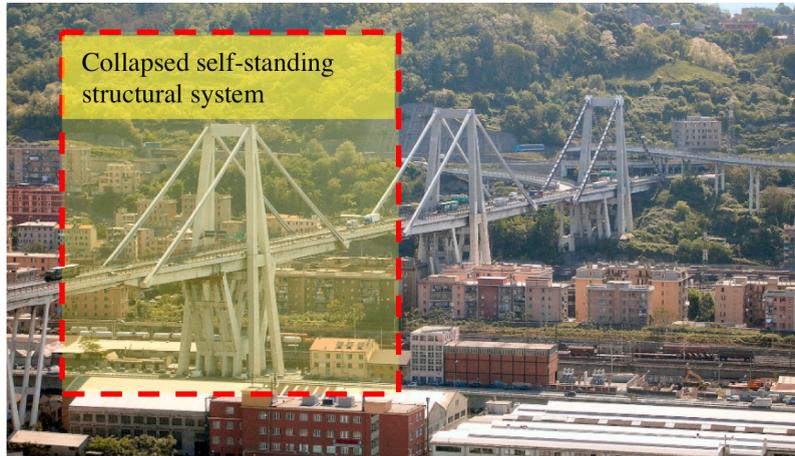
The Polcevera viaduct was a complex structure, which was composed by several minor spans and three main spans, besides all the connecting ramps. The collapsed part of the viaduct was linked with the adjacent parts of the bridge by means of two statically determinate Gerber beams of 36 m span each, which have been involved in the collapse (Fig. 1).

Fig. 1. Three self-standing structural systems of Polcevera Bridge.

Therefore, in order to simplify the analysis and better understand the failure mechanism, our attention has been focused exclusively on the self-standing structural system, which collapsed independently of the remaining parts of the viaduct. Furthermore, the balanced system designed by Morandi was a quite complicated structure itself and it is worth, at the first step, to limit the analysis to the bridge deck.

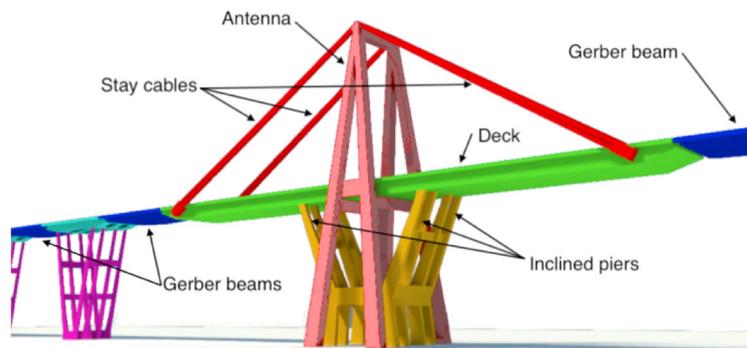
The deck of the self-sustained system was a multi-cell box girder 4.5 m deep and 171.9 m wide, which was supported at four points by inclined piers and two couples of stay cables (yellow and red elements in Fig. 2, respectively) hanged at the top of the A-shaped antenna. Four transverse beams, orthogonal to the girder, had the purpose to link the deck to the piers and to the stay cables.

Fig. 2. Structural components of the self-sustained system.

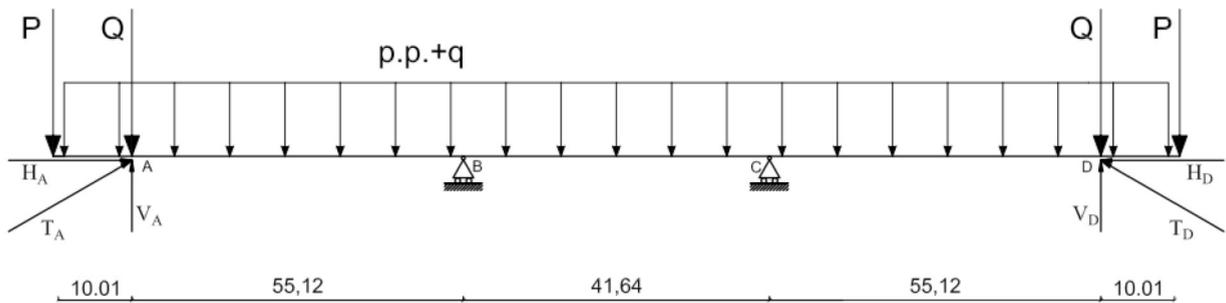
According to Morandi's design concept (Morandi, 1967), the principal stay cables were supposed to support the permanent loads. The tension in the strands was set such as the vertical displacement of the deck at the connection point with the stay cables would vanish. As a consequence, the static scheme shown in Fig. 3 allows for an easy determination of the axial force in the two couples of stay cables due to the permanent loads, whose values are reported in Tab. 1. The tensile forces in the stay cables are obtained by projection of the vertical reaction forces in A and D on the cable direction. The statically indeterminate reactions in A and D are identical due to structural symmetry and can be derived imposing compatibility equations.

Fig. 3. Static scheme used for the evaluation of stresses in the stay cables due to the permanent loads.

Notice that the construction process was highly complex also because of the use of temporary strands, which were removed once the main stays were in place. It is worth noting that, the structural scheme represented in Fig. 3 provides the value of the axial force in the stay cables with a good approximation.

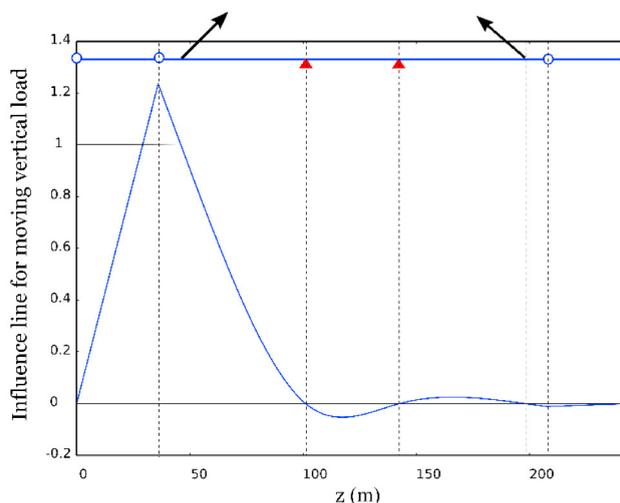
Fig. 4. Influence line of vertical reaction  $V_A$  for moving vertical load.

If we consider the couple of stay cables that support the deck at point A, in order to assess the stress range in each cable, it is necessary to calculate the influence line of the vertical reaction due to vertical moving unit load. Thanks to the reciprocity theorem, this is equivalent to trace the deflection line corresponding to the imposed unit deflection at the point A. The stress in the stay cable can be subsequently obtained by projection according to Eq. (1).

Fig. 4 shows the obtained line of influence. Taking into consideration the safety distance between lorries and according to the standard prescription, it appears that each heavy vehicle will correspond to one main load cycle (EN 1991-2, 2003). The amplitude of the cycle can be calculated multiplying the weight of the lorry by the difference between the highest peak and the lowest valley values of the influence line.

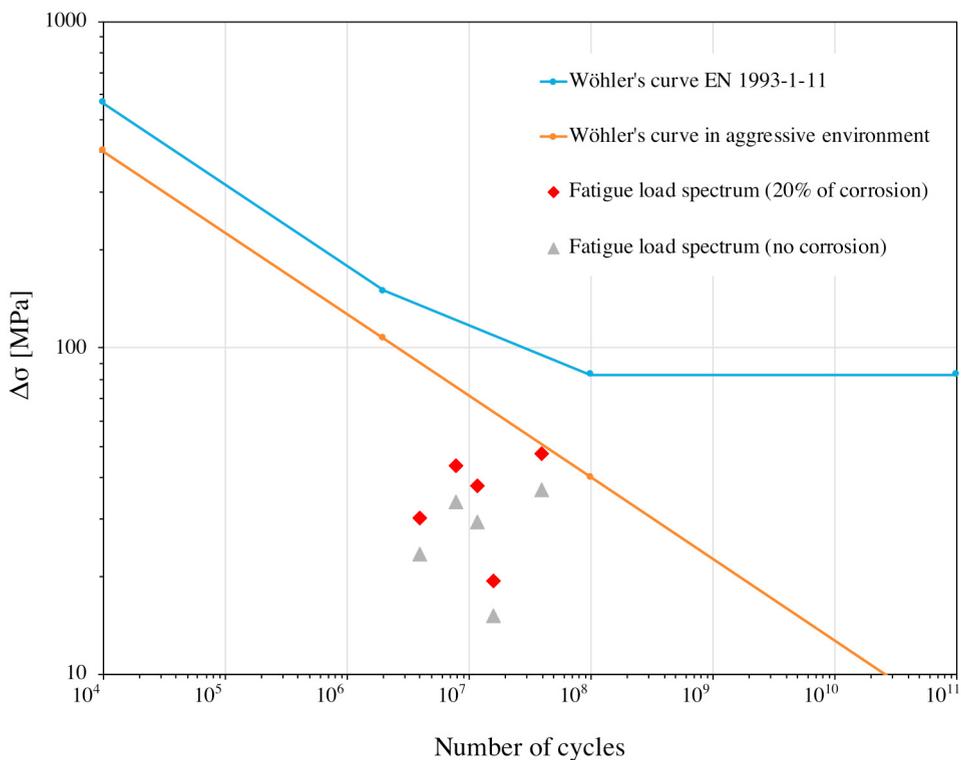
Fig. 5. Application of Palmgren-Miner's rule according to different corrosion scenarios.

Different scenarios can be considered, as shown in Fig. 5. If no corrosion is considered, Wöhler's curve is provided by EN 1993-1-11 (2006) and the failure due to the damage accumulation for the given fatigue load spectrum can be excluded. If the aggressive environment is considered, Wöhler's curve changes, because the curve is translated downwards and because the horizontal asymptote is missing (Lotsberg, 2016). Analogous modification of Wöhler's curve would be obtained if the influence of structural size were additionally considered (Carpinteri & Montagnoli, 2018).

In this context, it is possible to look for the level of absolute corrosion necessary for the damage accumulation to approach unity. Since Eq.(3) can not be inverted directly, the calculation must be performed iteratively. The critical level of corrosion is estimated to be approximately equal to 20%. It is worth noting that the level of corrosion detected during inspections, carried out in 2015, was estimated comprised between 10% and 20% (Relazione Commissione Ispettiva Mit, 2018). In addition, recent analyses carried out on the bridge's stay cable ruins (Filetto et al., 2019) provided that at least 22% of strands showed a very high level of corrosion comprised between 50% and 70%, whereas in the remaining 78% the lower level of corrosion was comprised between 30% and 50%. As a consequence, it is conservative assuming an overall level of corrosion approximately of 35%. It is worth noting that the critical level of corrosion with respect to the static load is much higher, and above 60% (Calvi et al., 2018). In addition, if the decompression of the concrete did not occur, the stress range in the tendons would have been much lower and the critical accumulated damage would have been avoided. Finally, it is evident that the concept of fatigue limit can be unsafe, and that is worthy of deeper investigations in order to better account for the influence of aggressive environment, structural size-scale, and damage accumulation in very-high cycle regime.
