Fatigue assessment of the collapsed XXth Century cable-stayed Polcevera Bridge in Genoa

25th International Conference on Fracture and Structural Integrity

Fatigue assessment of the collapsed XXth Century cable-stayed
Polcevera Bridge in GenoaStefano Invernizzi^{a,*}, Francesco Montagnoli^a, Alberto Carpinteri^a^aPolitecnico di Torino, Corso Duca degli Abruzzi 24, Torino, 10129, Italy**Abstract**

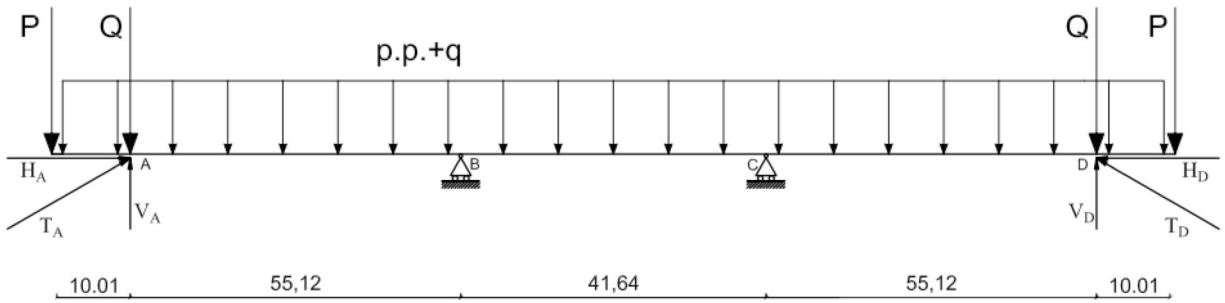
According to Morandi's design concept (Morandi, 1967), the principal stay cables were supposed to support the permanent loads. The tension in the strands was set such as the vertical displacement of the deck at the connection point with the stay cables would vanish. As a consequence, the static scheme shown in Fig. 3 allows for an easy determination of the axial force in the two couples of stay cables due to the permanent loads, whose values are reported in Tab. 1. The tensile forces in the stay cables are obtained by projection of the vertical reaction forces in A and D on the cable direction. The statically indeterminate reactions in A and D are identical due to structural symmetry and can be derived imposing compatibility equations.

Fig. 3. Static scheme used for the evaluation of stresses in the stay cables due to the permanent loads.

Notice that the construction process was highly complex also because of the use of temporary strands, which were removed once the main stays were in place. It is worth noting that, the structural scheme represented in Fig. 3 provides the value of the axial force in the stay cables with a good approximation.

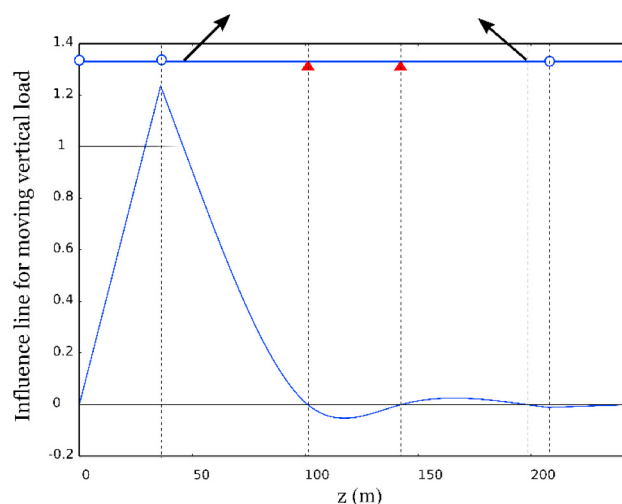
Fig. 4. Influence line of vertical reaction V_A for moving vertical load.

If we consider the couple of stay cables that support the deck at point A, in order to assess the stress range in each cable, it is necessary to calculate the influence line of the vertical reaction due to vertical moving unit load. Thanks to the reciprocity theorem, this is equivalent to trace the deflection line corresponding to the imposed unit deflection at the point A. The stress in the stay cable can be subsequently obtained by projection according to Eq. (1).

Fig. 4 shows the obtained line of influence. Taking into consideration the safety distance between lorries and according to the standard prescription, it appears that each heavy vehicle will correspond to one main load cycle (EN 1991-2, 2003). The amplitude of the cycle can be calculated multiplying the weight of the lorry by the difference between the highest peak and the lowest valley values of the influence line.

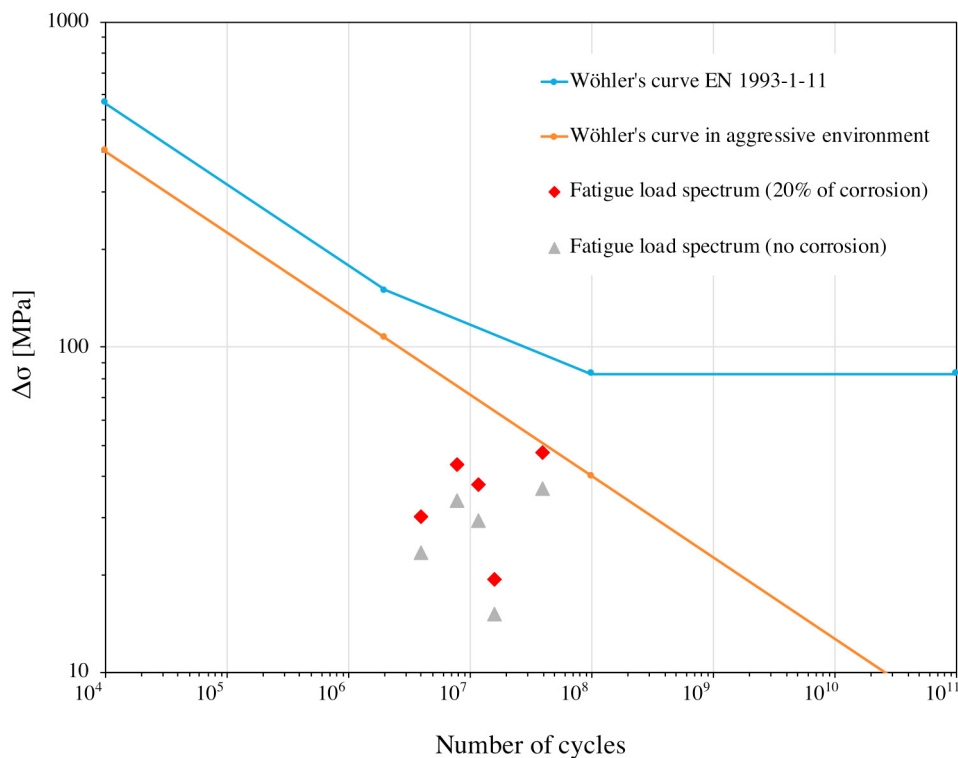
Fig. 5. Application of Palmgren-Miner's rule according to different corrosion scenarios.

Different scenarios can be considered, as shown in Fig. 5. If no corrosion is considered, Wöhler's curve is provided by EN 1993-1-11 (2006) and the failure due to the damage accumulation for the given fatigue load spectrum can be excluded. If the aggressive environment is considered, Wöhler's curve changes, because the curve is translated downwards and because the horizontal asymptote is missing (Løtsberg, 2016). Analogous modification of Wöhler's curve would be obtained if the influence of structural size were additionally considered (Carpinteri & Montagnoli, 2018).

In this context, it is possible to look for the level of absolute corrosion necessary for the damage accumulation to approach unity. Since Eq.(3) can not be inverted directly, the calculation must be performed iteratively. The critical level of corrosion is estimated to be approximately equal to 20%. It is worth noting that the level of corrosion detected during inspections, carried out in 2015, was estimated comprised between 10% and 20% (Relazione Commissione Ispettiva Mit, 2018). In addition, recent analyses carried out on the bridge's stay cable ruins (Filetto et al., 2019) provided that at least 22% of strands showed a very high level of corrosion comprised between 50% and 70%, whereas in the remaining 78% the lower level of corrosion was comprised between 30% and 50%. As a consequence, it is conservative assuming an overall level of corrosion approximately of 35%. It is worth noting that the critical level of corrosion with respect to the static load is much higher, and above 60% (Calvi et al., 2018). In addition, if the decompression of the concrete did not occur, the stress range in the tendons would have been much lower and the critical accumulated damage would have been avoided. Finally, it is evident that the concept of fatigue limit can be unsafe, and that is worthy of deeper investigations in order to better account for the influence of aggressive environment, structural size-scale, and damage accumulation in very-high cycle regime.
