Frost resistance of natural stones – a case study from Finland

Nike Luodes, Heikki Pirinen, Rossana Bellopede and Olavi Selonen

Geotechnical report 13

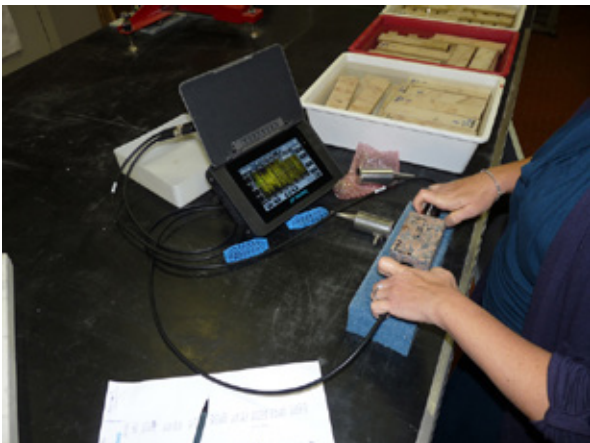
Figure 4. Ultrasonic pulse velocity (UPV) testing. Photo: Rossana Bellopede.

fresh material and on the same samples after 56 cycles of frost salt (Fig. 4).

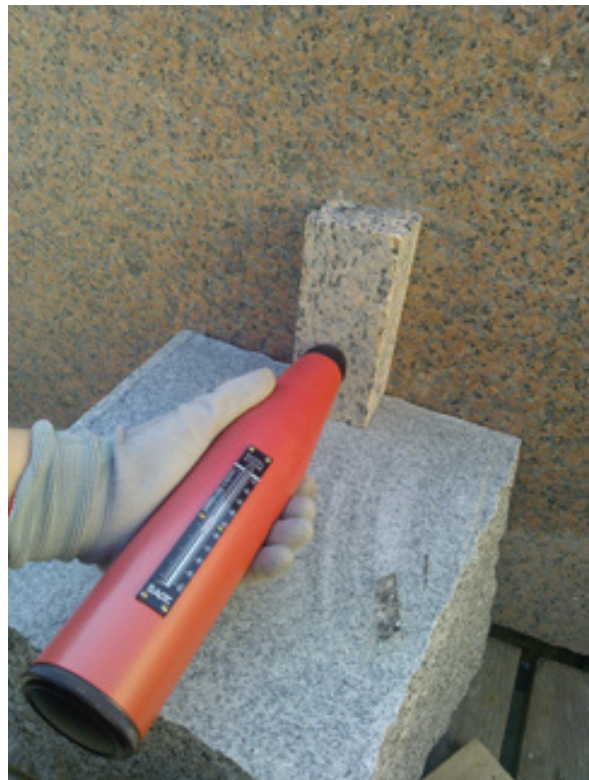
Figure 5. Schmidt rebound hammer instrument in testing position. Photo: Nike Luodes.

Schmidt rebound hammer (Fig. 5) test can be used to evaluate the weathering state of rocks in

Schmidt hammer tests were performed using a SADT Model HT225A hammer, performing three set of measurements of a chosen sample from the fresh and weathered material. Each set of measurement were composed by five horizontal rebounds per point, evaluating the average on the sample. The aim was to assess the surface weathering, also possible surface cracks, chipping, or rusting of the minerals. The test were performed keeping the instrument perpendicular to the vertically placed material (Fig. 5), as it had been used in previous site investigations on building walls by Luodes et al. (2014).

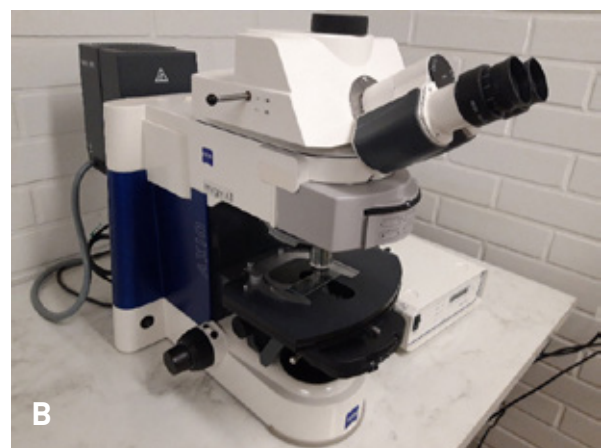
Figure 6. A. Analysis at the Scanning Electron Microscope (SEM). Photo: Nike Luodes. B. Optical fluorescent microscope. Photo: Akseli Torppa. Equipments in the GTK Mintec unit in Outokumpu.

Scanning electron microscope (SEM) was used in some cases to measure the dimension of the cracks (Fig. 6A), but the picture of the material got did not allow to distinguish open and accessible cracks from closed ones. In this case, the section of 15 mm x 25.5 mm was divided into five vertical sections and 17 horizontal measuring lines, and a total length of 255 mm in one direction and 127 mm in the other direction was tested. The results can also be affected by sample preparation and by natural variations of the material.

Optical fluorescent microscope Zeiss Axio Imager A1 was used for counting open cracks (Fig. 6B). Thin sections of approx. 20 mm x 35 mm were prepared with addition of a fluorescent substance. Methodology adopted was based on the one used in the Swedish Cement and Concrete Research Institute CBI for crack frequency. The methodology aims to distinguish material that might suffer weathering from those who might not suffer. The methodology consisted of the count of vertical and horizontal cracks on the thin section along a line of 100 mm in each direction along an imaginary grid. Results are expressed as cracks/mm, and 40x magnification was used. The procedure also evaluate the presence of intergranular cracks

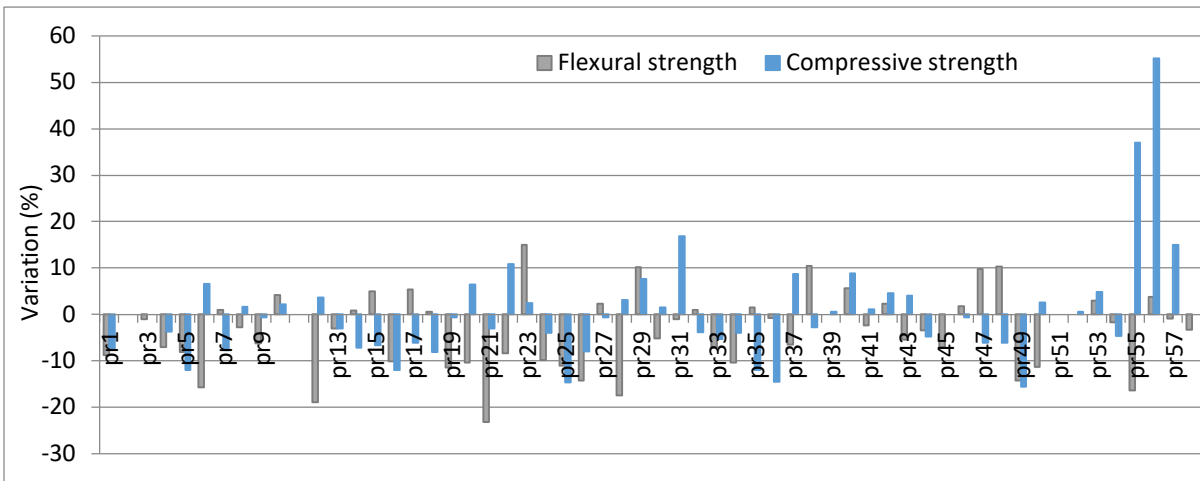
Figure 8. Percentage variation of flexural and compressive strength.

Most of the tested materials in this study showed a variation of strength between fresh and weathered material lower than 20 %; a percentage defined by the reference standard to discriminate the freeze resistance of a material. Only three of the materials showed a higher variation as visible from graph in Fig. 8.

The variations have not only been loss of strength, but also increase of strength after freeze-thaw cycles (Fig. 8). Sometimes freeze-thaw results are higher compared to fresh material. This is most probably due to natural variation of geological and mineralogical properties of the material that gives a stronger effect compared to the one caused by weathering.

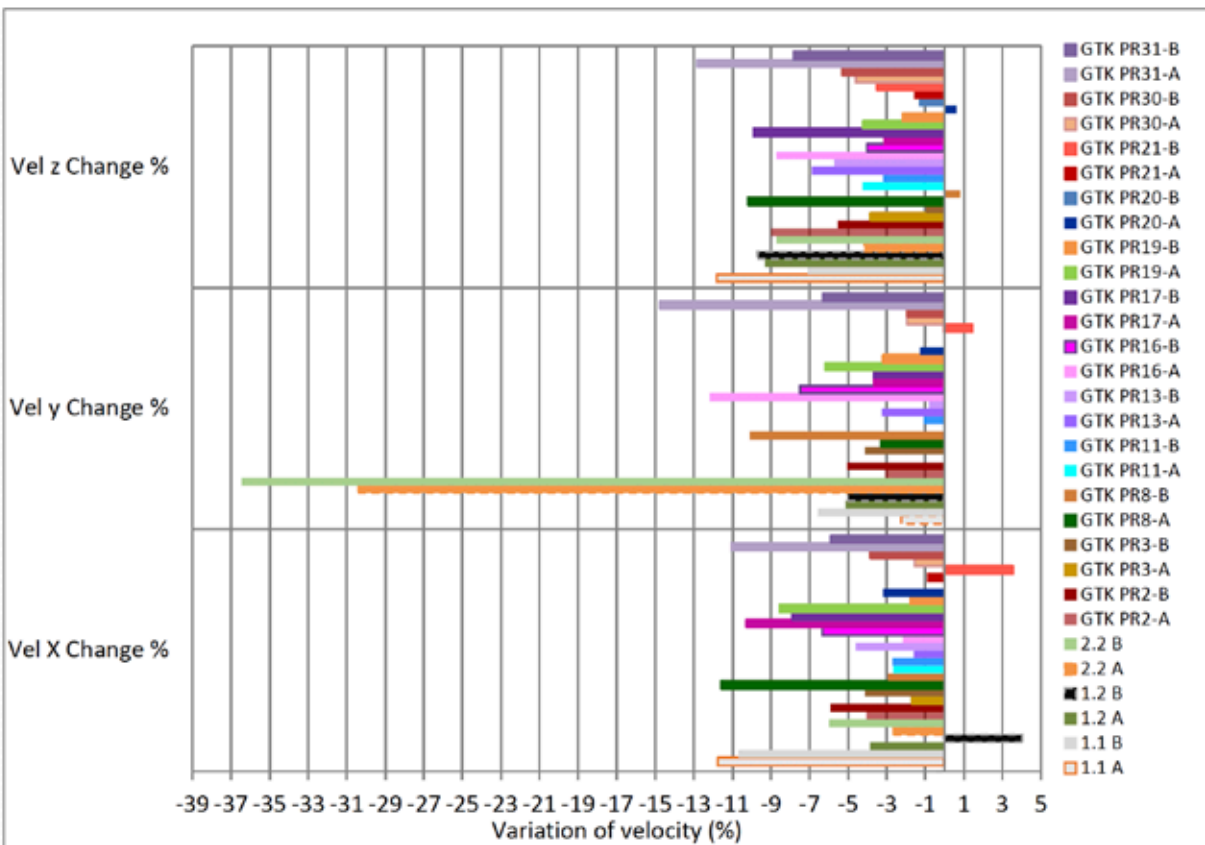
Figure 12. Variation of ultrasonic pulse velocities after weathering cycles.

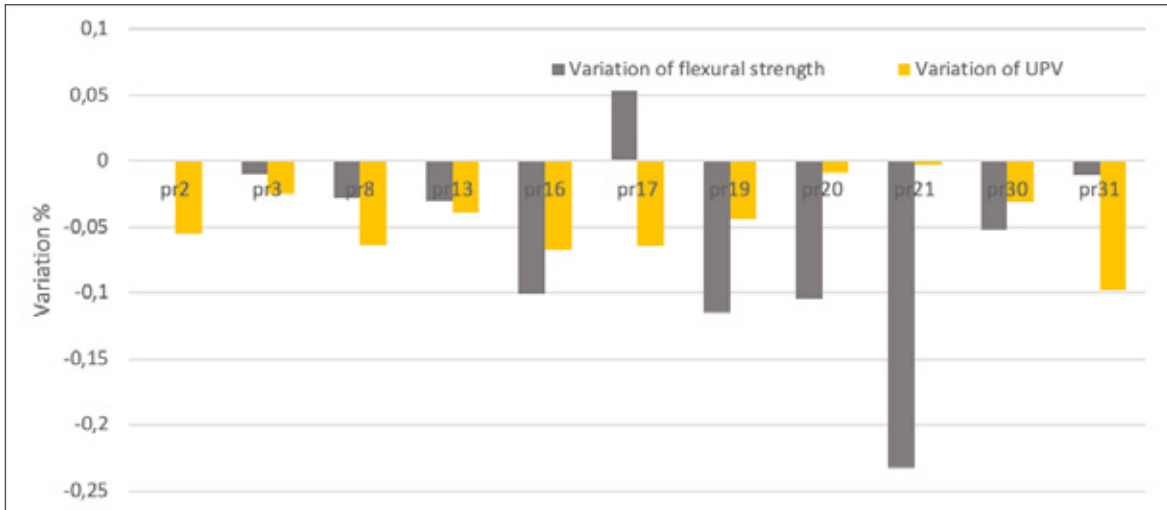
Figure 14. Comparison of variation of ultrasonic pulse velocity and flexural strength before and after frost cycles. See text for explanation.

Ultrasonic pulse velocity was obtained by averaging along the three directions the results of the P-waves, and averaging the two specimens tested. Specimens of Pr20, diabase, and Pr21, quartzite, had a bigger change in flexural strength after frost cycles, compared to the changes

within the UPV (Fig. 14). The diabase showed consistency of measurements between the two methodologies: high speed and high strength, being a compact homogenous material. The fact that ultrasonic pulse velocity was not diminished, it is an evidence that it is a durable material and loss of flexural strength might be caused by natural heterogeneity of the sample. Results performed on specimen Pr21 might have been affected by foliation. Other measurements show that a loss of flexural strength correspond to a loss of speed, meaning that a slight weathering had occurred in the material. These aspects can also be seen in the diagram of Fig. 14, where the variation of strength against those of speed after frost cycles are compared. The variation are calculated as $(\text{Strength after frost} - \text{Strength on fresh material}) / \text{Strength on fresh material}$, and $(\text{average UPV after frost} - \text{average UPV on fresh material}) / \text{average UPV on fresh material}$. Specimen Pr17, a medium-grained granite, shows that there was a deviation between the flexural strengths affected by mineral structure.

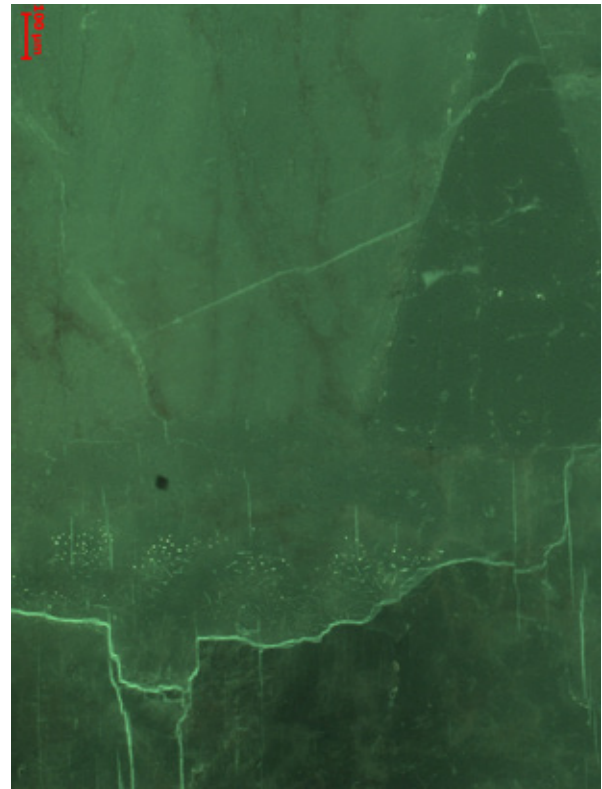
Figure 17. Image from the analysis performed at the fluorescent microscope (40x magnification).

Analysis performed with the fluorescent microscope (Fig.17) was an easy and fast method for counting the cracks. The fluorescent substance bring in evidence the fractures. Studying of the images was immediate and the test was performed without the support of the computer.
