Frost resistance of natural stones – a case study from Finland

Nike Luodes, Heikki Pirinen, Rossana Bellopede and Olavi Selonen

Geotechnical report 13

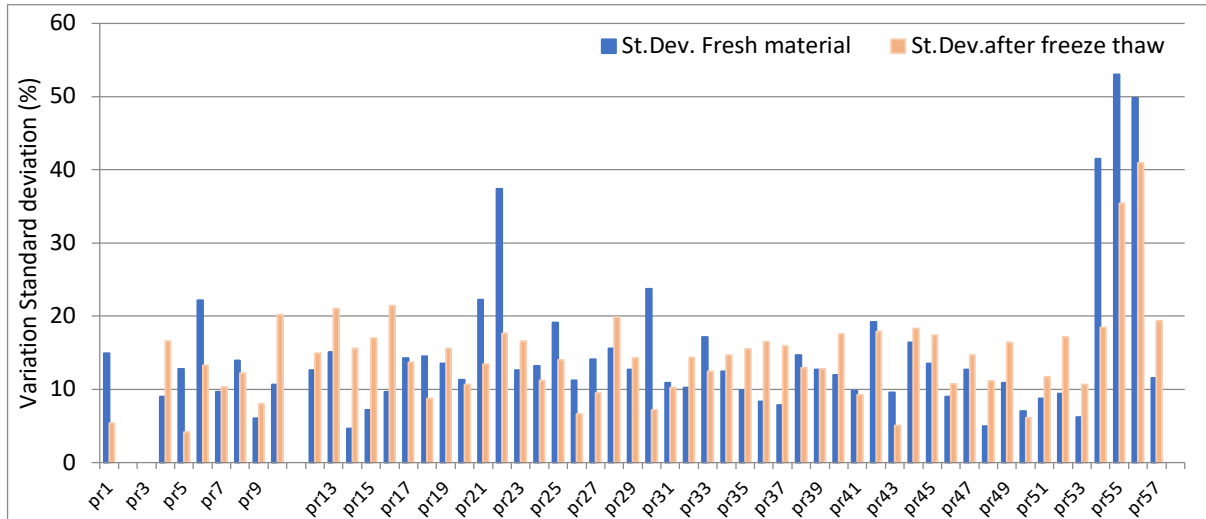
Figure 10. The rate of variation of the standard deviation for compressive strength before and after the freeze thaw cycles.

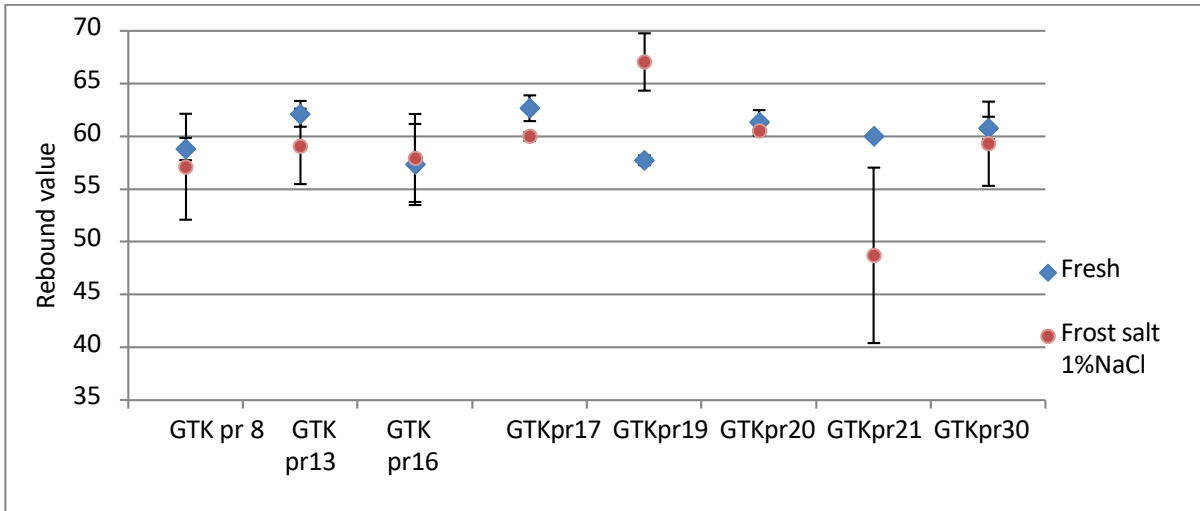
Figure 11. Schmidt rebound values of tests on fresh and weathered samples.

Small weathering effect might be seen in the Schmidt hammer results for some materials, but in general the average loss was low as visible from the graph of the Fig. 11.

The materials generally showed a small decrease of rebound after the salt frost cycles except for two cases where most probably the results have been affected by the natural mineralogical variations of the material. The Schmidt test is evaluating the strength in a punctual way, and for highly heterogeneous or coarse-grained rocks, the results might differ because of the strength of the single minerals. In our study, the strength of more than one mineral of the stone was evaluated, and the precision in choosing similar minerals before and after the freeze thaw cycle might affect the result.

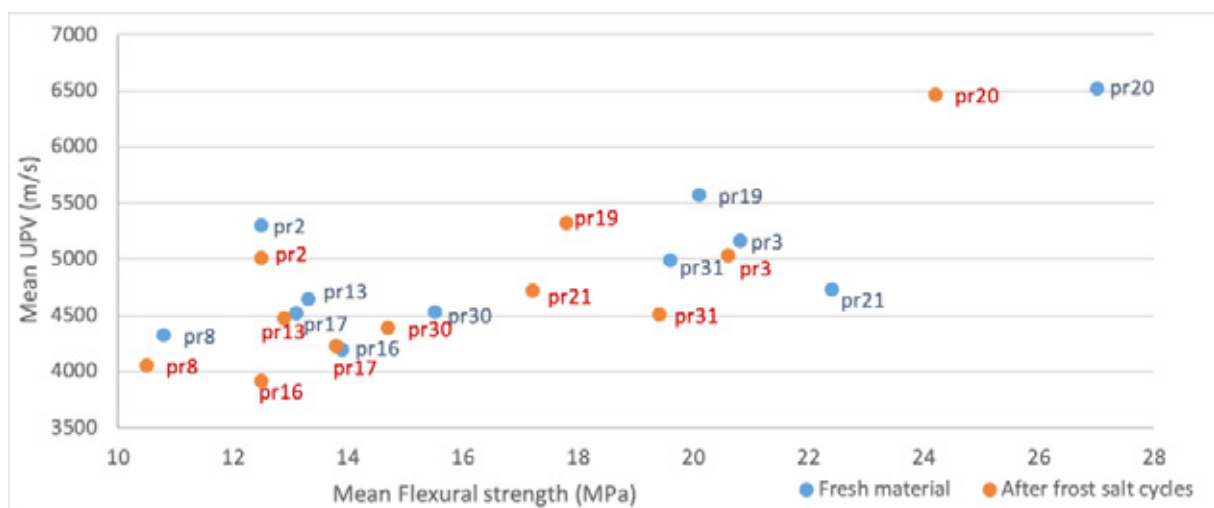
Figure 13. Comparison of average ultrasonic pulse velocity with flexural strength. Soapstone and PR11 was not tested for flexural strength after frost cycles, hence omitted from the graph.
