Sonic and Impact Test for Structural Assessment of Historical Masonry

Featured Application: Non-destructive diagnostic techniques for historical masonry buildings by the correlation of sonic and impact tests.

This study describes the results of sonic and impact tests performed on the masonry walls of the Sanctuary of Santa Maria delle Grazie in Varoni, near Amatrice, damaged by the 2016 Central Italy earthquake. The purpose of the tests was the characterization of the mechanical properties of the wall texture to better understand the seismic vulnerabilities of the church. Some more destructive tests were also needed, such as endoscopy and flat jacks. It was very important to correlate the results of the different tests, confirming the potential to extract, from the non-destructive tests, a lot of information then confirmed by the more destructive ones. Therefore, the sonic and impact tests allowed us to

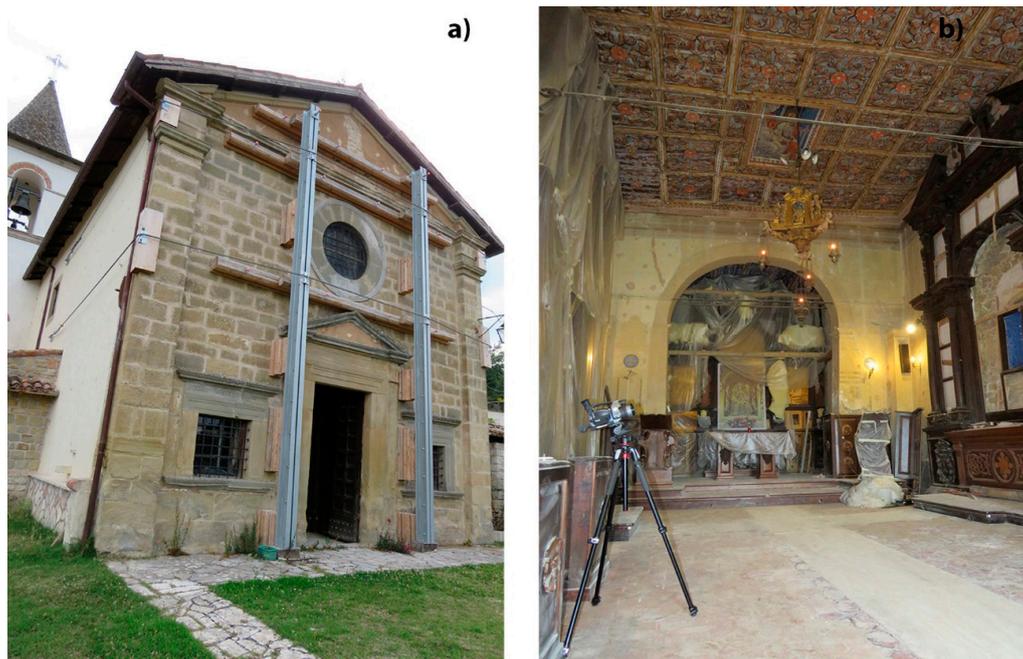
Figure 1. (a) Shoring works on the facade of the Sanctuary of Santa Maria delle Grazie at Varoni after 2016 Central Italy earthquake; (b) Interior of the single nave of the church.

The Sanctuary of Santa Maria delle Grazie is a church from the 15th century built by unordered masonry stone. The church suffered limited damage after the big seismic shock of 24 August 2016, concentrated, above all, in a slight principle of out of plane mechanism of the façade and some failures in the masonry structures (Figure 1). During the long seismic swarm of the 2016 Amatrice earthquake, the Government Department responsible for monuments carried out some punctual safety works. They consisted in a preliminary execution of lime mortar injections inside the stone walls in order to offer greater strength to the contrast of the new tie rods inserted in the façade plane, in the arch triumphal interior and contrast to the shoring of the facade (Figure 2).

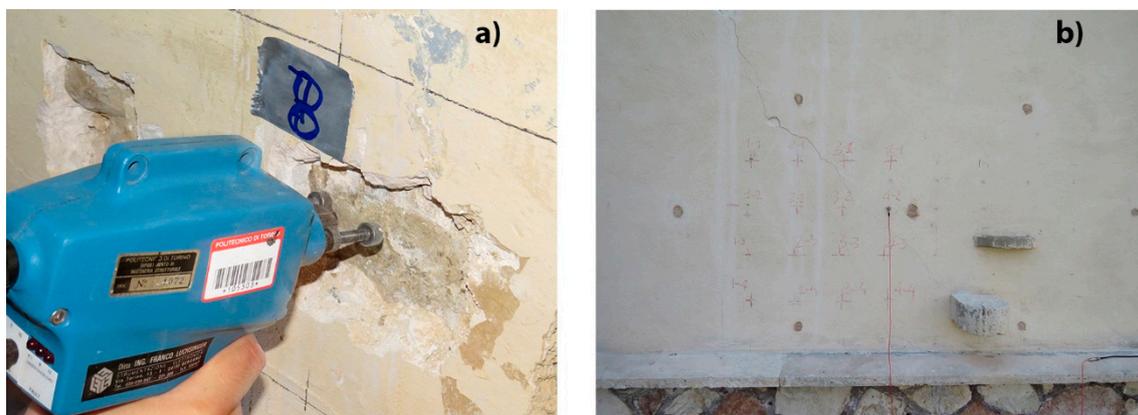
Figure 3. (a) Electric instrumented hammer during the sonic test; (b) Monoaxial accelerometer applied in the other surface of the analysed masonry wall.

The electric impact hammer used was PCB Piezotronics; model 086B09; variable force from 44.48 N to 4448.26 N; force sensor PCB model 208M51; 2.47 mV/N load sensor sensitivity. An accelerometer was used to receive the impulsive signal (Figure 3). The Dytran monoaxial accelerometer used in conjunction with an amplifier had the following technical characteristics: Dytran model 4102 C; model 3055B4; sensitivity 51.6 mV/g; measuring range: ± 100 g; frequency response: $1 \div 10,000$ Hz; mass: 10 g. Finally, a signal analyzer recorded both the applied load pulse and the sonic wave signal.

A wall surface of 1 m × 1 m was subdivided into a grid of equidistant points 20 cm, by removing the plaster around the points of application of the impact hammer (Figures 3b and 4a). Each single point of this grid consisted of a punctual sonic survey in order to obtain an average value of sonic velocity inside the analysed area of an highly inhomogeneous materials such as the masonry. At least three measurements were performed for each point, the average of which is shown in Table 1. The type of sonic survey was trasversal to the thickness (85 cm) of the masonry wall. Unfortunately, there were no surveys of the sonic wave before the mortar injections technique. Table 1 shows the sonic results of some significant points of the mesh, as the average of those of the entire test grid.

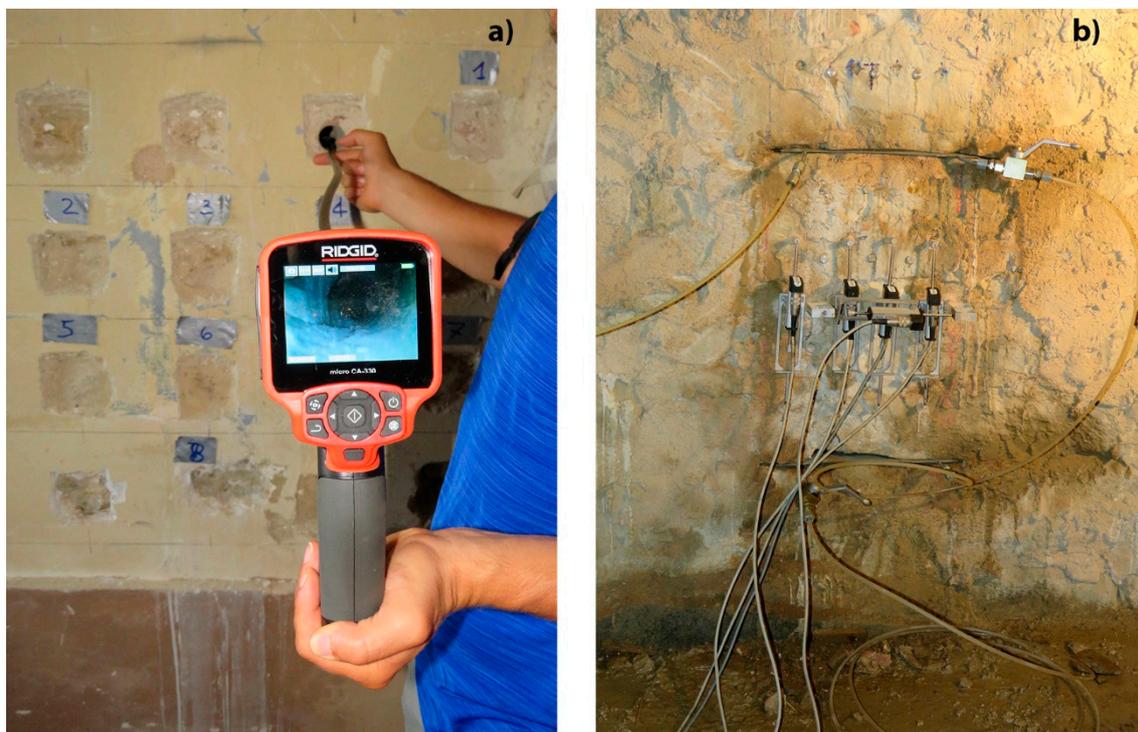
Figure 4. (a) Endoscopy test performed in the same area of the sonic test; (b) Double flat jacks test.

Endoscopy was performed with a RIDGID micro-CA 330 endoscope model (Figure 4a). The semi-destructive test to assess the main mechanical characteristics of the masonry was carried out using 4 mm thick and 77,765 mm² area flat jacks [9] (Figure 4b) through a hydraulic pump equipped by a DMM2 digital pressure gauge (linearity and 0.05% hysteresis) with a flow rate of 100 bar. The measurement of length variations was performed continuously by potentiometric displacement transducers (manufacturer: Novotechnik; model: TR50; stroke: 50 mm; deviation from linearity: 0.2%). The pressure and displacement values were acquired continuously using the HBM Spider8 acquisition device with a sampling frequency of 5 Hz. A hydraulic saw with a diamond disc was used to make the cut in which the jacks are to be positioned. Usually the pressure of the liquid in the jack was greater than the effort that the jack exerted on the masonry. In fact, the flat jack, because of its stiffness, was opposed to expansion when it was inflated, so the jack must be calibrated to obtain a conversion factor (km) that correlated the internal pressure of the fluid with the force applied to the masonry. The jack was calibrated in the laboratory through a compression test machine with a capacity of at least 450 kN. Through the loading-unloading cycles, entering the liquid under pressure inside the jack bound to the test machine plates, it was possible to obtain the conversion factor (km) as the angular coefficient of the straight line in the pressure-load diagram. The calibration, performed at the laboratory of the Politecnico di Torino according to the technical code ASTM C1197-04 [8], provided a value of km equal to 0.842. Moreover, the cutting area coefficient (ka) was given by the ratio between the area of the flat jack (77,765 mm²) and that of the cut performed (84,200 mm²) and was equal to 0.923. To obtain the value of compression stress acting on the masonry, it was necessary to multiply the pressure value detected by the liquid introduced inside the jack for the two correction coefficients (km) and (ka).

texture consisting of much larger stones (Figure 7) than that of the longitudinal walls of the church (Figure 4) on which the test was performed with flat jacks, endoscopy and sonic technique. This different texture, which was already uniform and without discontinuity, was present only along the piers of the main arch of the apse to ensure a greater strength against the thrusts of the arch. Therefore, this wall texture probably had superior mechanical characteristics than those detected on the longitudinal walls of the church. Therefore, it was not possible to make comparisons with the results obtained from the tests on the longitudinal walls, which revealed a more disarticulated texture, with stones that were smaller and irregular.

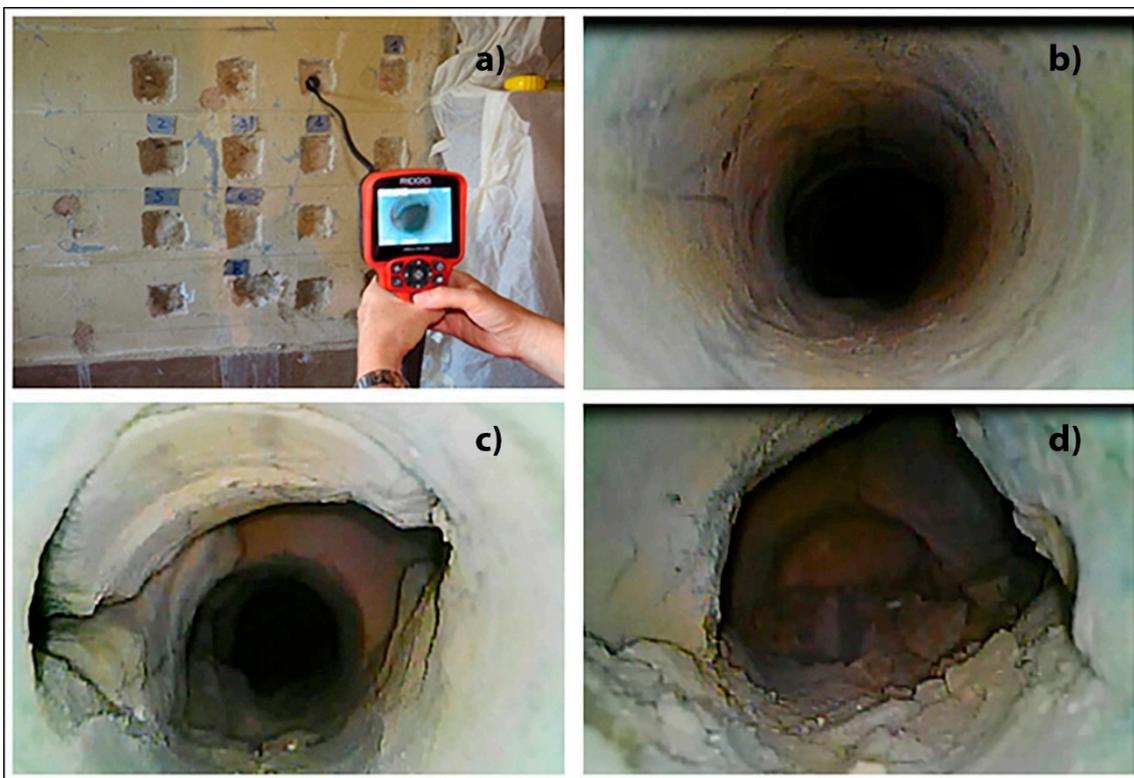
Figure 5. (a) Endoscopy surveys; (b) Initial section of compact masonry; (c) First discontinuity; (d) Central discontinuity between two walls.

The low sonic results also increased uncertainties about the presence of voids or cavities within the wall texture. Therefore, at one point of the sonic test mesh, a 48 cm long hole (half the thickness of the wall) was made for inserting the endoscope in order to visually investigate the masonry stratigraphy (Figure 5). In fact, the test shows, after an initial section of compact masonry, the presence of a first discontinuity. After the first layer of whole stone, the stratigraphy is characterized by the alternation of stones smaller than the first interspersed with discontinuities that are not entirely filled by the injections. Subsequently, there was a central discontinuity between two walls of equivalent thicknesses, the sum of which constitutes the thickness of the masonry. The acquired images also show the total absence of injections in the deeper layers of the masonry. The stratigraphy detected is the following:

- 0–15 cm: compact stone (Figure 5b);
- 15–22 cm: first discontinuity (Figure 5c)
- 22–48 cm: stones interspersed with discontinuity (Figure 5d).

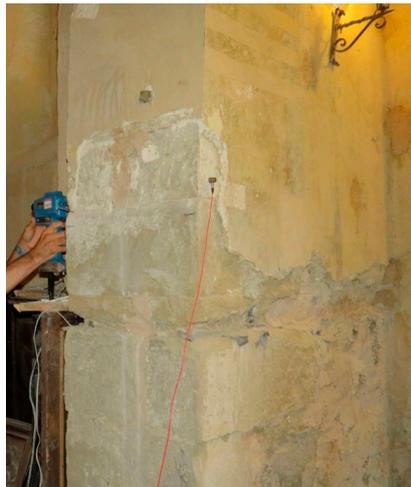
Figure 7. Impact test on single big sandstone constituting the masonry texture.

The analysis of the diagrams obtained from the tests on the single sandstone constituting the masonry texture (Figure 7) revealed a value of the elastic modulus equal to 15.978 MPa, in accordance with the values present in the scientific literature [21].

The instrumented hammer was also used for the impact test on a homogeneous material such as the large sandstone stones that characterized some points of the church walls, in correspondence of the arch of the apse. Although the impact test was not applicable to determine the elastic modulus of the masonry as a non-homogeneous structure, the knowledge of the elastic modulus of the single constituent of the masonry could represent a useful value in the determination of the mechanical characteristics of the masonry through the use of experimental formula and table suggested in the scientific literature [16]. The masonry area analysed with the impact test had a more homogeneous
