Sonic and Impact Test for Structural Assessment of Historical Masonry

# Sonic and Impact Test for Structural Assessment of Historical Masonry

This study describes the results of sonic and impact tests performed on the masonry walls of the Sanctuary of Santa Maria delle Grazie in Varoni, near Amatrice, damaged by the 2016 Central Italy earthquake. The purpose of the tests was the characterization of the mechanical properties of the wall texture to better understand the seismic vulnerabilities of the church. Some more destructive tests were also needed, such as endoscopy and flat jacks. It was very important to correlate the results of the different tests, confirming the potential to extract, from the non-destructive tests, a lot of information then confirmed by the more destructive ones. Therefore, the sonic and impact tests allowed us to

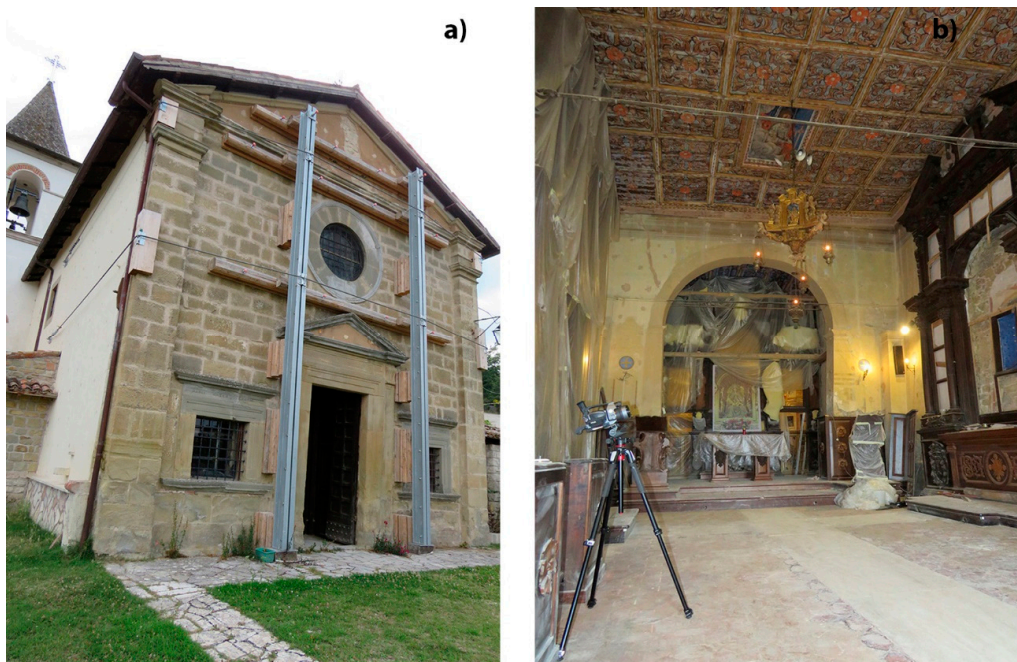
The Sanctuary of Santa Maria delle Grazie is a church from the 15th century built by unordered masonry stone. The church suffered limited damage after the big seismic shock of 24 August 2016, concentrated, above all, in a slight principle of out of plane mechanism of the façade and some failures in the masonry structures (Figure 1). During the long seismic swarm of the 2016 Amatrice earthquake, the Government Department responsible for monuments carried out some punctual safety works. They consisted in a preliminary execution of lime mortar injections inside the stone walls in order to offer greater strength to the contrast of the new tie rods inserted in the façade plane, in the arch triumphal interior and contrast to the shoring of the facade (Figure 2).

**Figure 1.** (a) Shoring works on the facade of the Sanctuary of Santa Maria delle Grazie at Varoni after 2016 Central Italy earthquake; (b) Interior of the single nave of the church.

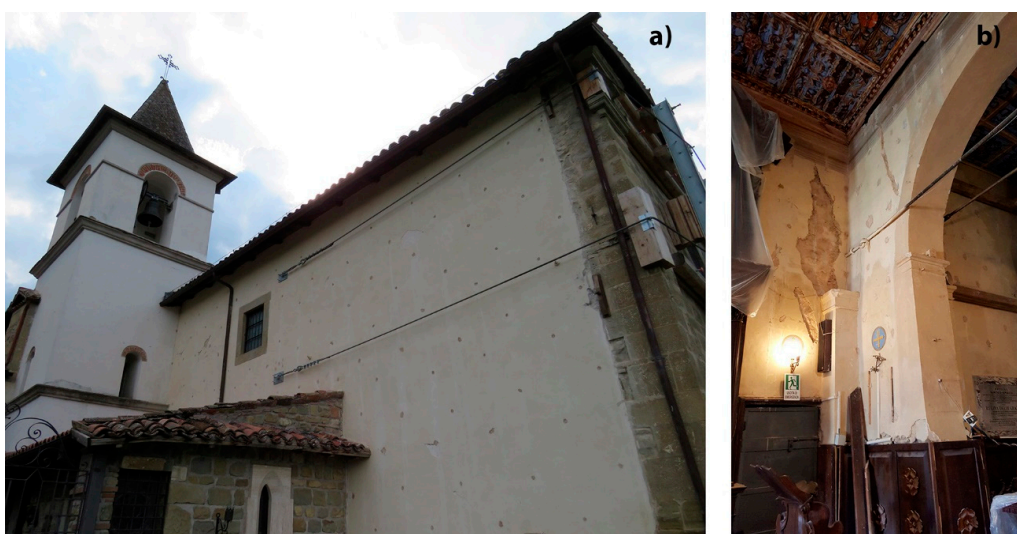
**Figure 2.** (a) Signs of the execution of mortar injections on the walls of the church; (b) Second iron tie carried out in pairs with the one existing at the triumphal arch.

The mortar injections were carried out for a limited depth inside the masonry wall, since there were uncertainties about the possible presence of a multi-layer stone masonry empty between the wall layers.

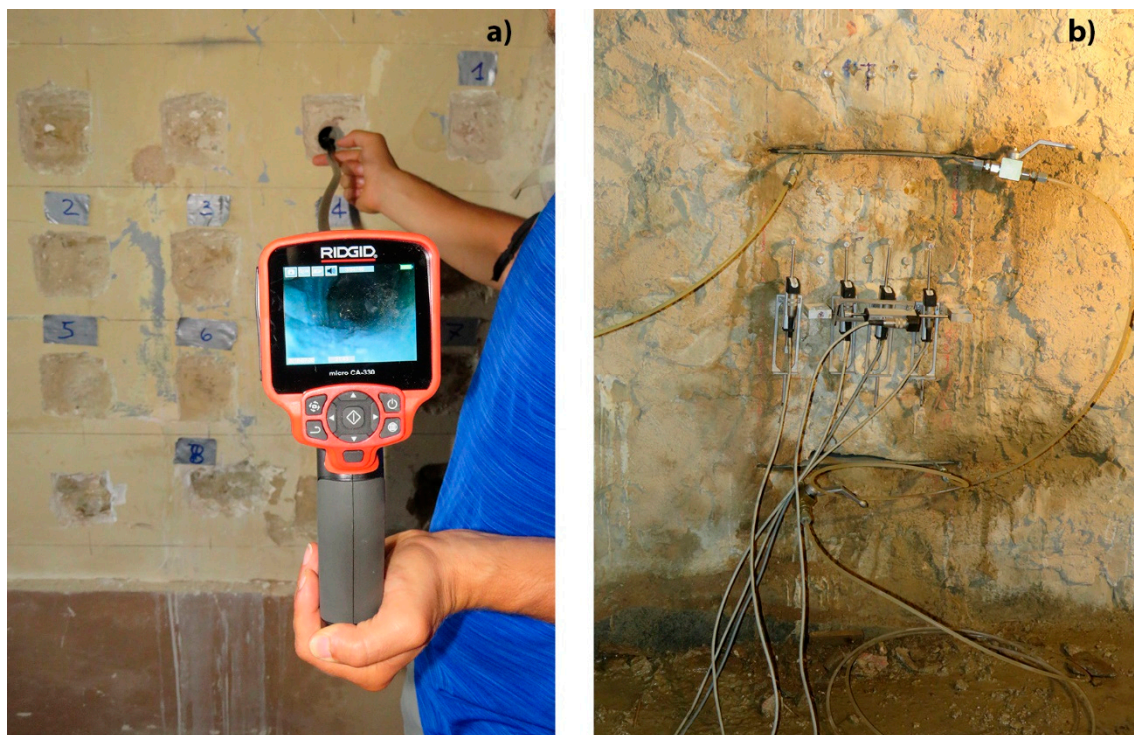
Endoscopy was performed with a RIDGID micro-CA 330 endoscope model (Figure 4a). The semi-destructive test to assess the main mechanical characteristics of the masonry was carried out using 4 mm thick and 77,765 mm<sup>2</sup> area flat jacks [9] (Figure 4b) through a hydraulic pump equipped by a DMM2 digital pressure gauge (linearity and 0.05% hysteresis) with a flow rate of 100 bar. The measurement of length variations was performed continuously by potentiometric displacement transducers (manufacturer: Novotechnik; model: TR50; stroke: 50 mm; deviation from linearity: 0.2%). The pressure and displacement values were acquired continuously using the HBM Spider8 acquisition device with a sampling frequency of 5 Hz. A hydraulic saw with a diamond disc was used to make the cut in which the jacks are to be positioned. Usually the pressure of the liquid in the jack was greater than the effort that the jack exerted on the masonry. In fact, the flat jack, because of its stiffness, was opposed to expansion when it was inflated, so the jack must be calibrated to obtain a conversion factor (km) that correlated the internal pressure of the fluid with the force applied to the masonry. The jack was calibrated in the laboratory through a compression test machine with a capacity of at least 450 kN. Through the loading-unloading cycles, entering the liquid under pressure inside the jack bound to the test machine plates, it was possible to obtain the conversion factor (km) as the angular coefficient of the straight line in the pressure-load diagram. The calibration, performed at the laboratory of the Politecnico di Torino according to the technical code ASTM C1197-04 [8], provided a value of km equal to 0.842. Moreover, the cutting area coefficient (ka) was given by the ratio between the area of the flat jack (77,765 mm<sup>2</sup>) and that of the cut performed (84,200 mm<sup>2</sup>) and was equal to 0.923. To obtain the value of compression stress acting on the masonry, it was necessary to multiply the pressure value detected by the liquid introduced inside the jack for the two correction coefficients (km) and (ka).

**Figure 4.** (a) Endoscopy test performed in the same area of the sonic test; (b) Double flat jacks test.

A wall surface of 1 m × 1 m was subdivided into a grid of equidistant points 20 cm, by removing the plaster around the points of application of the impact hammer (Figures 3b and 4a). Each single point of this grid consisted of a punctual sonic survey in order to obtain an average value of sonic velocity inside the analysed area of an highly inhomogeneous materials such as the masonry. At least three measurements were performed for each point, the average of which is shown in Table 1. The type of sonic survey was trasversal to the thickness (85 cm) of the masonry wall. Unfortunately, there were no surveys of the sonic wave before the mortar injections technique. Table 1 shows the sonic results of some significant points of the mesh, as the average of those of the entire test grid.

texture consisting of much larger stones (Figure 7) than that of the longitudinal walls of the church (Figure 4) on which the test was performed with flat jacks, endoscopy and sonic technique. This different texture, which was already uniform and without discontinuity, was present only along the piers of the main arch of the apse to ensure a greater strength against the thrusts of the arch. Therefore, this wall texture probably had superior mechanical characteristics than those detected on the longitudinal walls of the church. Therefore, it was not possible to make comparisons with the results obtained from the tests on the longitudinal walls, which revealed a more disarticulated texture, with stones that were smaller and irregular.

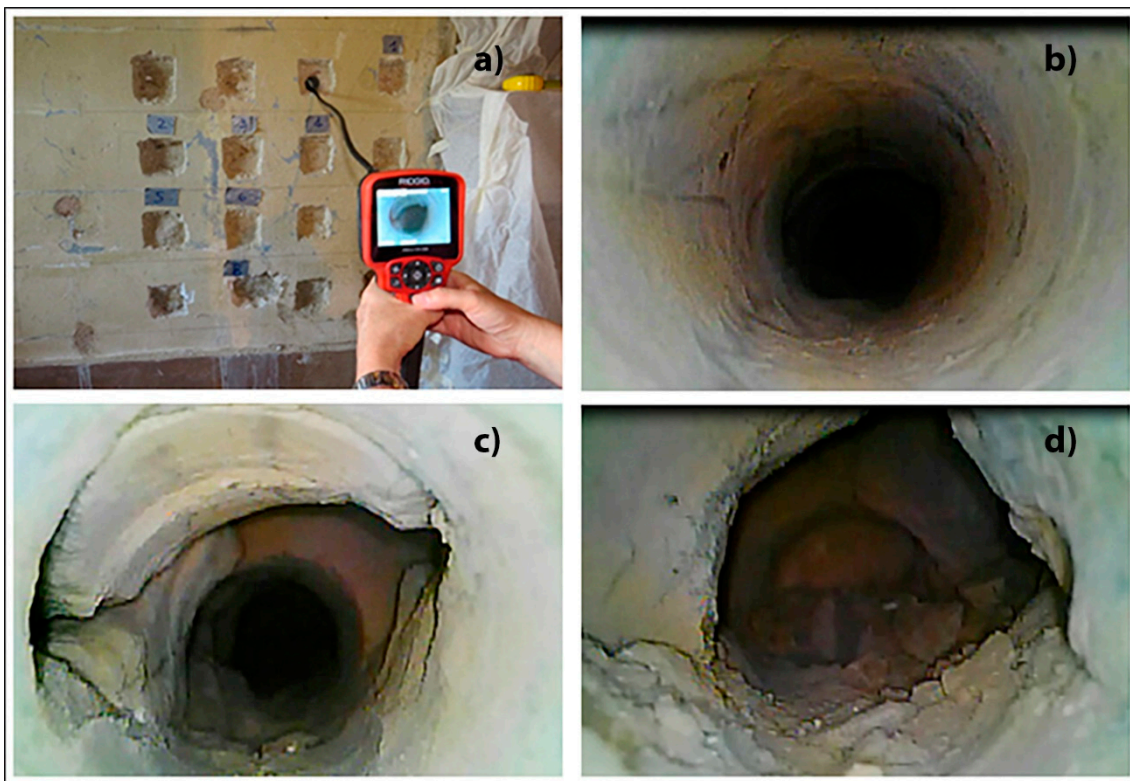
The low sonic results also increased uncertainties about the presence of voids or cavities within the wall texture. Therefore, at one point of the sonic test mesh, a 48 cm long hole (half the thickness of the wall) was made for inserting the endoscope in order to visually investigate the masonry stratigraphy (Figure 5). In fact, the test shows, after an initial section of compact masonry, the presence of a first discontinuity. After the first layer of whole stone, the stratigraphy is characterized by the alternation of stones smaller than the first interspersed with discontinuities that are not entirely filled by the injections. Subsequently, there was a central discontinuity between two walls of equivalent thicknesses, the sum of which constitutes the thickness of the masonry. The acquired images also show the total absence of injections in the deeper layers of the masonry. The stratigraphy detected is the following:

- 0–15 cm: compact stone (Figure 5b);
- 15–22 cm: first discontinuity (Figure 5c)
- 22–48 cm: stones interspersed with discontinuity (Figure 5d).

**Figure 5.** (a) Endoscopy surveys; (b) Initial section of compact masonry; (c) First discontinuity; (d) Central discontinuity between two walls.

The sonic survey carried out on the injected masonry revealed very low speed values, attributable both to the presence of internal micro-cavities in the masonry and to the ineffectiveness of the mortar injections performed at a very reduced depth. The speed values were almost all below 1000 m/s, which, in the scientific literature [18], identifies the threshold value below which low-quality wall textures fall, with the presence of voids and discontinuities. Moreover, this qualitative assessment was according to the values of compressive strength and elastic modulus obtained from the double flat jacks test. The sonic values obtained also demonstrated the ineffectiveness of the mortar injections to penetrate and therefore, to contribute to the increase in masonry strength [22,23]. Although a comparison with the sonic values cannot be performed before the injection operation, such low values cannot correspond to an effectively injected masonry. Even the survey carried out with the endoscope confirmed the absence of penetration of the mortar injections into the wall texture and the presence of a central discontinuity within the masonry which would confirm the presence of a wall with two large layers joined but not structurally connected.

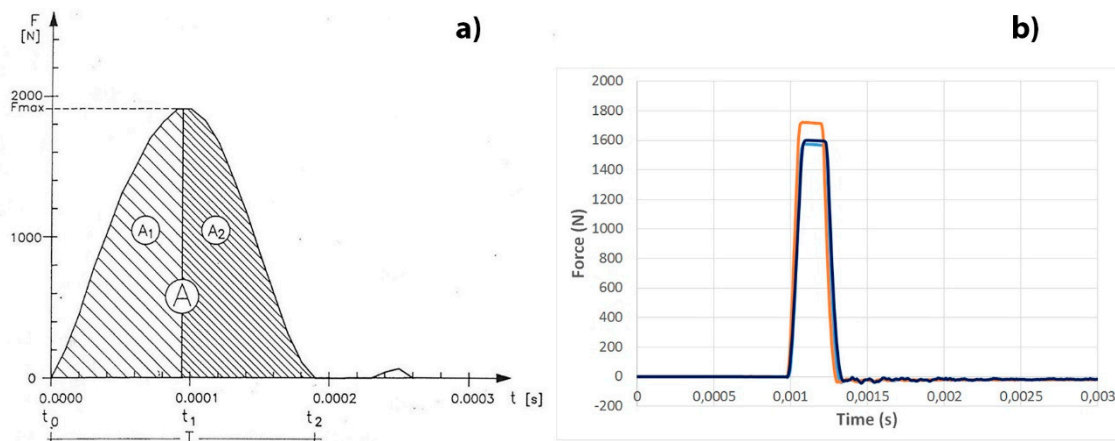
where  $A_1$  is the area under the  $(F,t)$  diagram (Figure 6), T is the contact time between the two surfaces;  $R$ ,  $E_0$ ,  $m$ ,  $\nu_0$  are, respectively, the radius of curvature (10 mm), the elastic modulus (222.000 MPa), the mass (0.207 kg) and the Poisson’s ratio (0,2) of the spherical mass which struck the surface of the material to be analyzed;  $\nu$  was the Poisson’s ratio of the analysed material, in this case,  $\nu = 0.25$  was used for a sandstone.

**Figure 6.** (a) Example of a force-time diagram; (b) force-time diagram of the impact test at the Sanctuary of Santa Maria delle Grazie.

The contact time  $t^*$  corresponding to the maximum deformation  $\delta^*$  which in the Figure 6a was called  $t_1$  was given by (A8):

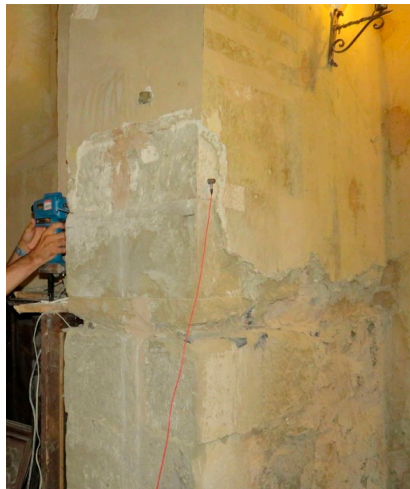
The analysis of the diagrams obtained from the tests on the single sandstone constituting the masonry texture (Figure 7) revealed a value of the elastic modulus equal to 15.978 MPa, in accordance with the values present in the scientific literature [21].

**Figure 7.** Impact test on single big sandstone constituting the masonry texture.

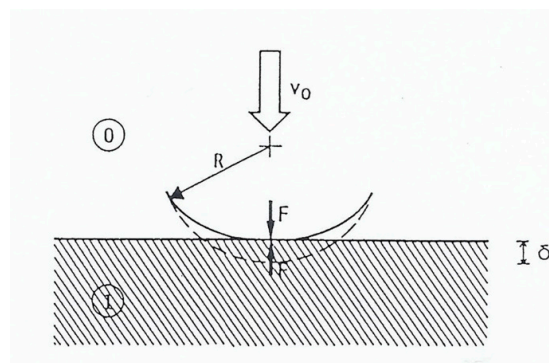
The following considerations on the impact of a sphere on the flat surface of a semi-infinite space (Figure A1) derive from the classical theory of the elastic collision between two bodies in the absence of friction due to Hertz [20]:

**Figure A1.** Movable mass in contact with the test surface.
