Acoustic emission and numerical analysis of the delamination process in repair plasters applied to historical walls

Acoustic emission and numerical analysis of the delamination process in repair plasters applied to historical walls / Grazzini, Alessandro; Accornero, Federico; Lacidogna, Giuseppe; Valente, Silvio. - In: CONSTRUCTION AND BUILDING MATERIALS. - ISSN 0950-0618. - STAMPA. - 236:(2020). [10.1016/j.conbuildmat.2019.117798]

<sup>1</sup> Department of Structural Geotechnical and Building Engineering, Politecnico di Torino, Italy

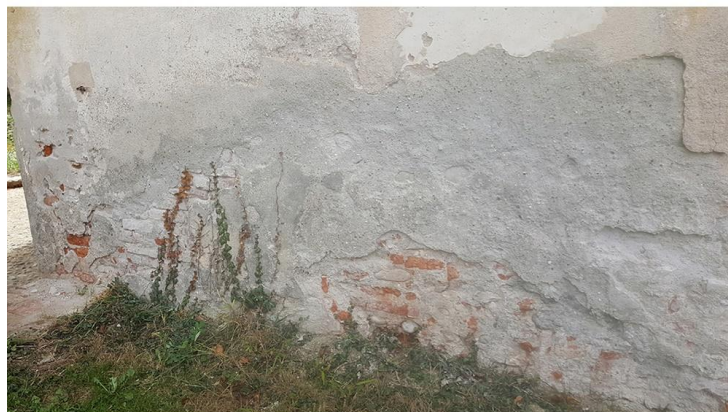
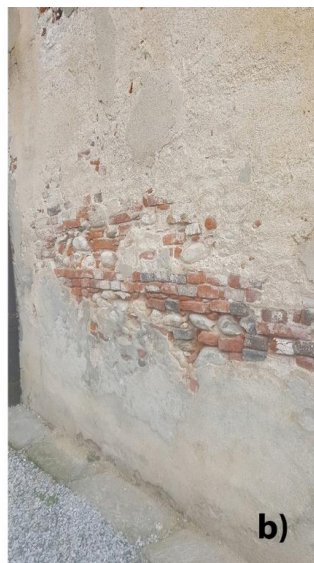
**Fig. 1.** Some examples of plaster detachment on historical walls due to: a) damp action from capillary rising,  
b) the action of freezing-thawing cycles.

Elsevier

*Published*

«Fig. 1. Some examples of plaster detachment on historical walls due to: a) damp action from capillary rising, b) the action of freeze-thaw cycles.»

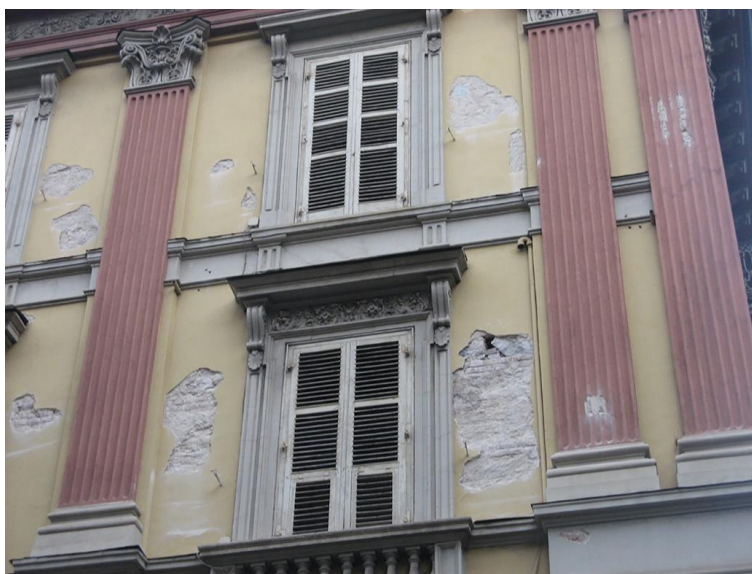
**Fig. 2.** Example of the mechanical incompatibility of patches made by cement mortar in a historical plaster based on lime mortar. The noticeable difference in stiffness of the concrete patch against the original lime-based plaster has favored the detachment under thermo-hygrometric stress.

DOI:10.1016/j.conbuildmat.2019.117798
