Realization and Use of an IR Camera for Laboratory and On-field Electroluminescence Inspections of Silicon Photovoltaic Modules

Alessandro Ciocia¹, Alessio Carullo², Paolo Di Leo¹, Gabriele Malgaroli¹, and Filippo Spertino¹

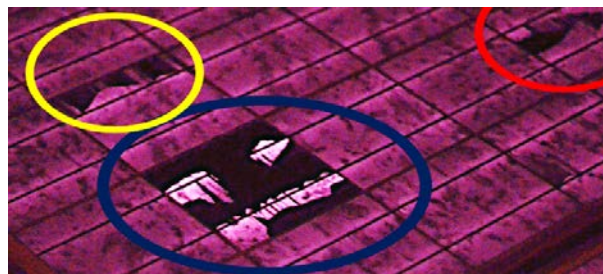
Fig. 11. EL detail of defective cells in the modules of Fig. 9.

In case of defects detection (Fig. 10), the module is analyzed more closely and details about failures are stored with high resolution (Fig. 11). The *I-V* curve characterization shows high power deviations for all the 18 strings composing the plants, with values from -12% up to -20%. The *I-V* and power-voltage (*P-V*) curves of one string are shown in Fig.12. The shape of *I-V* curve is not smooth near the maximum power point due to broken cells. Moreover, the current starts decreasing from short circuit condition, due to a decreased shunt resistance with respect to a well working module. Thus, to recover the energy production of the plant, the replacement of the modules will start with those affected by the highest number of defects in those strings with the highest power losses.
