Icelandic Concrete Surfaces: Guðjón Samúelsson's *Steining* (1930–50)

Sofia Nannini

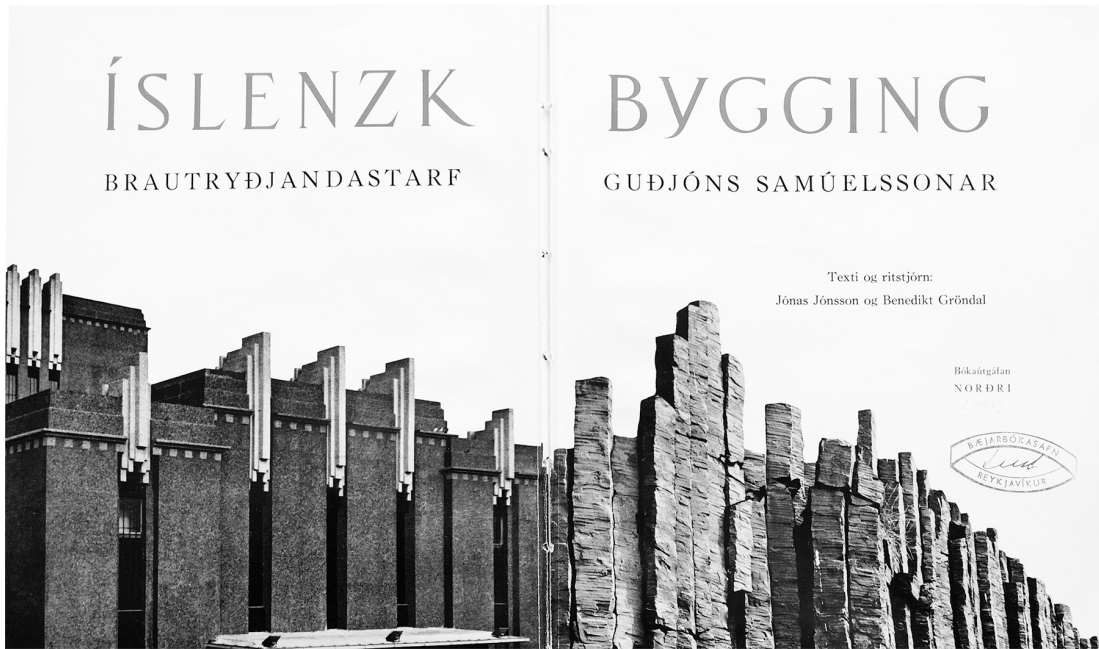
Figure 1. Jónas Jónsson, Íslenzk Bygging. Brautryðjandastarf Guðjóns Samúelssonar [Icelandic Architecture. The Pioneer Work of Guðjón Samúelsson]. Reykjavík: Norðri, 1957. Copy available at the National and University Library of Iceland.

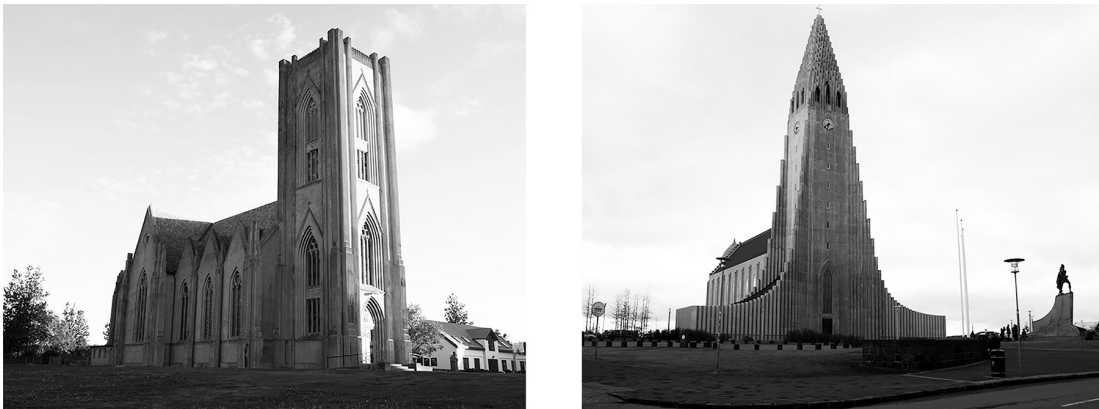
Figure 2. Left, Landakotskirkja (1925–29); right, Hallgrímskirkja (1937–86). Reykjavík. Photos by Sofia Nannini.

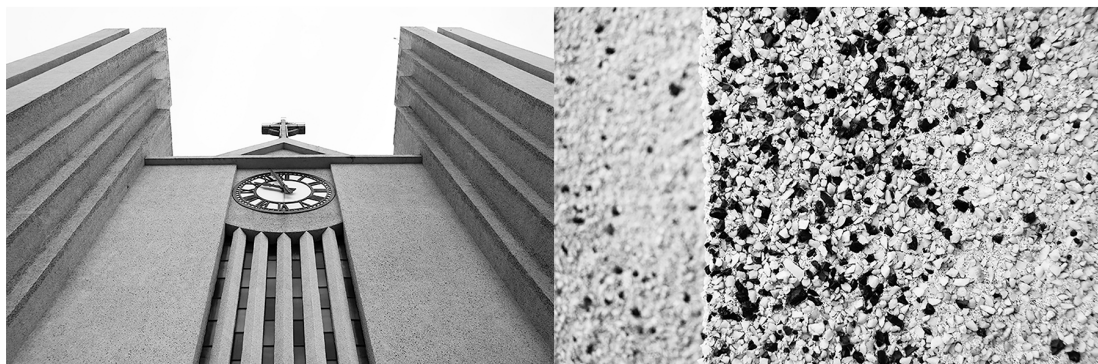
Figure 7. Steining on the church of Akureyri. Detail on the right. Photos by Sofia Nannini.

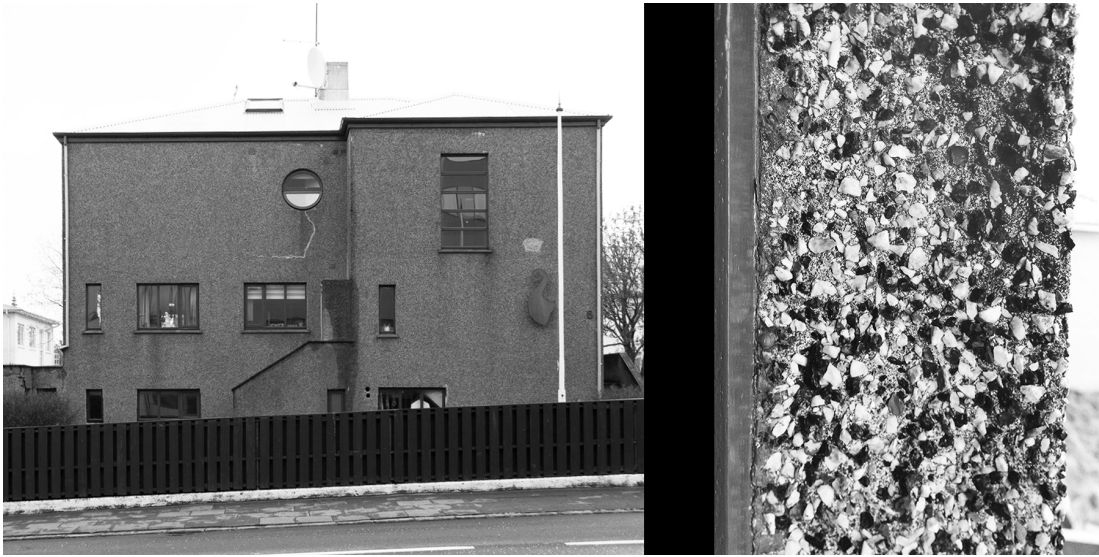
Figure 8. The villa in Eiríksgata 6, Reykjavik, designed by Guttormur Andrússon and commissioned by Trausti Ólafsson. Detail of Steining on the right. Photos by Sofia Nannini.
