Non-Destructive Tests for Damage Evaluation of Stone Columns: The Case Study of Sacro Monte in Ghiffa (Italy)

Non-Destructive Tests for Damage Evaluation of Stone Columns: The Case Study of Sacro Monte in Ghiffa (Italy) / Grazzini, Alessandro; Fasana, Sara; Zerbinatti, Marco; Lacidogna, Giuseppe. - In: APPLIED SCIENCES. - ISSN 2076-3417. - ELETTRONICO. - 10:2673(2020), pp. 1-15. [10.3390/app10082673]

# Non-Destructive Tests for Damage Evaluation of Stone Columns: The Case Study of Sacro Monte in Ghiffa (Italy)

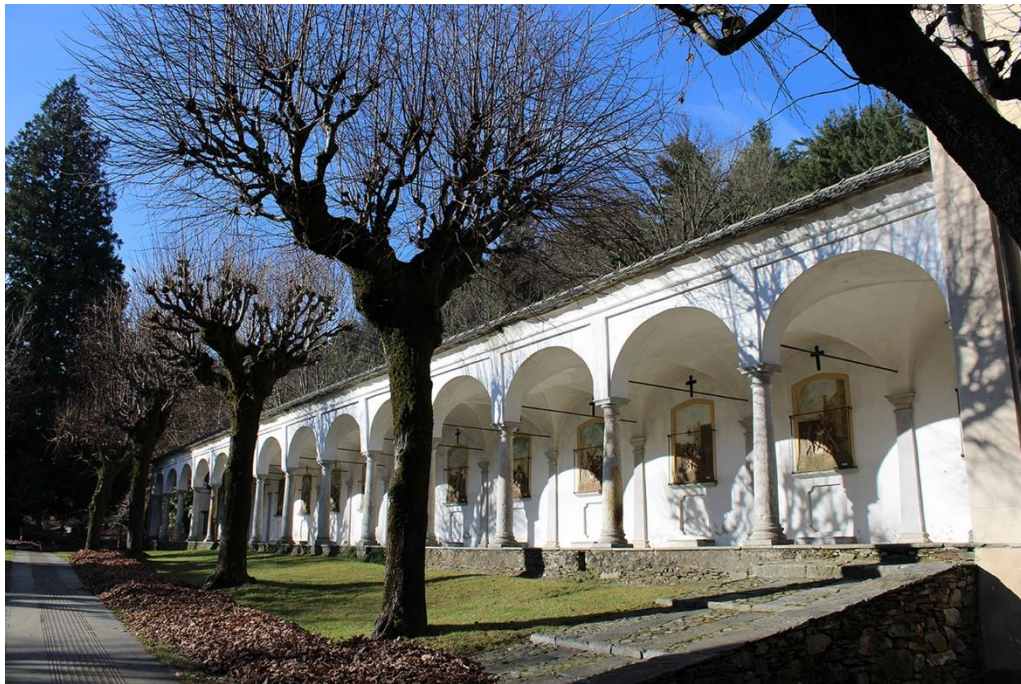
In the specific case of the Sacro Monte at Ghiffa, the Via Crucis portico (Figure 1) is supported by 13 stone columns with evident intense superficial material degradation. The portico was built between 1752 and 1761. It is marked by 14 spans and has columns and capitals made by stones derived both from local “granitic stones”. It is possible that the origin of the stone of columns is not from historical quarries but from erratic boulders found near the construction site (aplite is the current interpretation, but other investigations are in progress), referred to in slang as “trovanti”, while for the capitals there is a strong similarity with a serizzo quarried near Locarno (Valle Verzasca, Switzerland) (Figure 2). Considering a macroscopic mineralogical analysis with a 10x magnifying glass, the rock is mainly made up of more than 90% of crystalline clear silica minerals (quartz and feldspar), with little biotitic dark mica and rare light mica. The main accessory mineral is a small red-vined garnet that characterizes the stone. The veins present confirm the low quality of the stone, almost certainly extracted from makeshift material, greatly influencing the variability of mechanical characteristics. Perhaps, also for the lower quality, it is very prone to degradation phenomena, worsened by atmospheric moisture, the presence of salts, freeze–thaw cycles and thermal expansion, which is also due to strong summer radiation, which can produce erosion and exfoliation on the stone surface [24,25] (Figure 3). The material degradation is increasing from the inside to the outside of the structural section of the columns, and the result is a decay of their compressive strength, the residual value of which needs to be investigated.

**Figure 1.** The Via Crucis portico inside the Sacro Monte of Ghiffa (Piedmont, Italy).

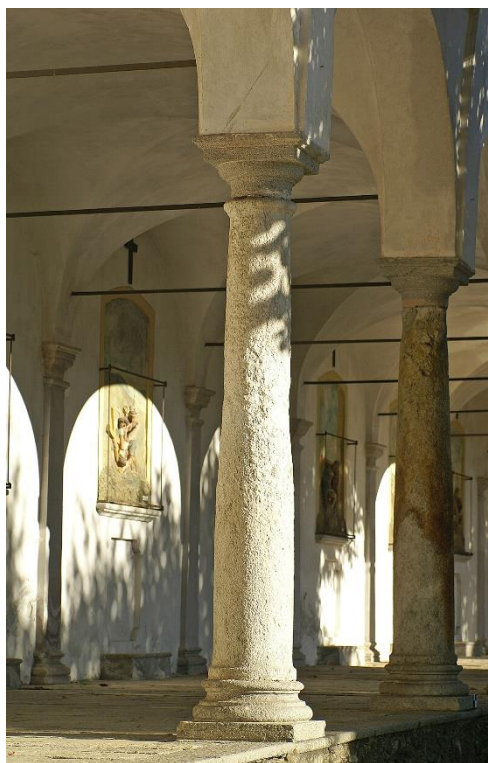
**Figure 2.** The stone columns of the Via Crucis portico in the Sacro Monte at Ghiffa.

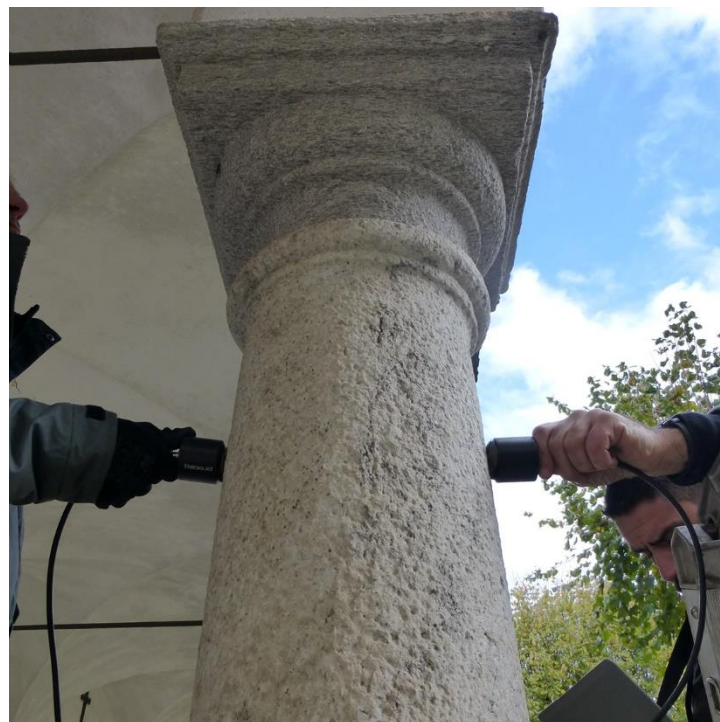
Direct tests were carried out by positioning the transducers on the two opposite faces of the element under investigation, as indicated in Figure 4. The coupling of the transducer on the stone surface was facilitated through the application of a thin layer of modeling clay in order to avoid air interpositions and facilitate the transmission of the wave in the material. The measurements were conducted in accordance with the methods proposed in American Society for Testing and Materials (ASTM) rules D2845 1995 and in Ente Nazionale Italiano di Unificazione, Comité Européen de Normalisation, (UNI EN) rules 12504-4: 2005 [26,27]. The tests are based on the determination of the propagation speed ( $v$ ) of the pulses of the ultrasonic longitudinal waves in the material, the values of which, in the first approximation, are related to the dynamic modulus ( $E_d$ ) of the material, which consequently is related to its mechanical strength [16]:

**Figure 4.** Ultrasonic test carried out on columns of Via Crucis, Ghiffa.

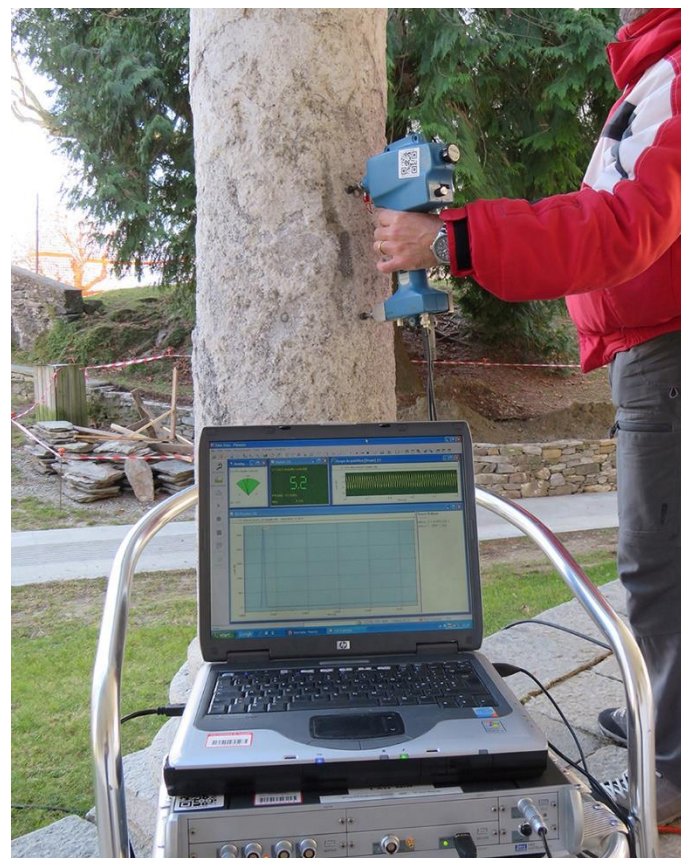
The electric impact hammer (Figure 5) is a device produced by Piezotronic PCB Inc Company (Depew, NY, USA). It is characterized by a variable force from 44.48 N to 4448.26 N, and a force sensor sensitivity of 2.47 mV/N. It performs the impact of a 10 mm diameter steel ball with a total mass of 207 grams, connected to a piezoelectric pulse transducer. The impact is generated by the hammer by means of a predetermined energy, characterized by a level of amplifier and impedance adapter. The acquisition is performed by a Pimento model multichannel LMS signal analyzer (Figure 5).

Figure 5. Setup of the impact test.

The hammer was positioned perpendicular to the surface to be investigated. Perpendicularity alignment was achieved thanks to four fixed metal brackets. The impact of the small impact mass was generated by pressing a trigger on the electric hammer. The intensity of the impact is very low and therefore not invasive even for surfaces of artistic value. The elastic modulus of the stone was

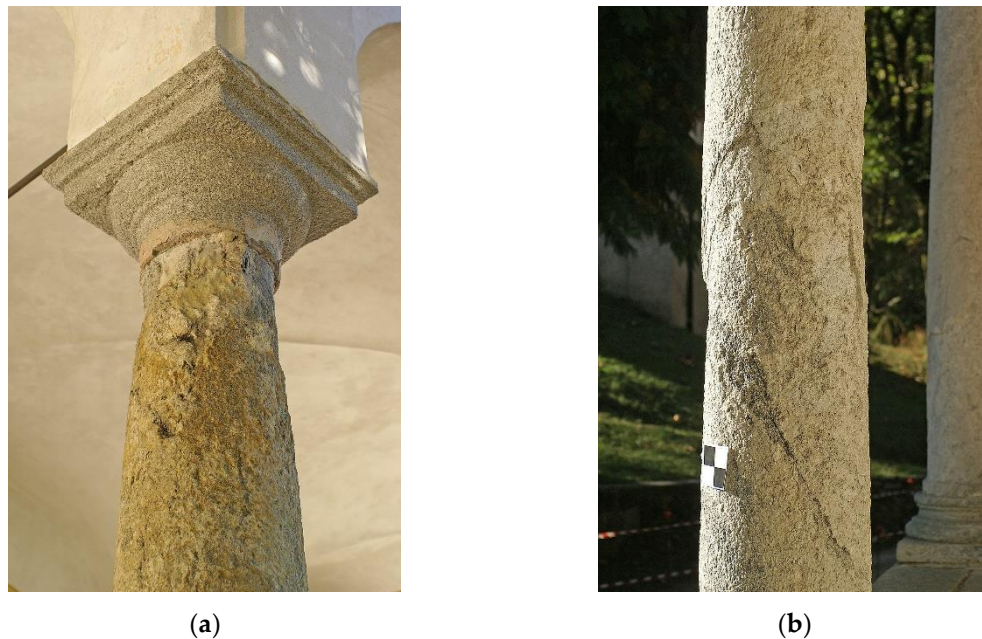
**Figure 7.** Different types of surface material degradation on the columns of the Via Crucis portico: (a) erosion; (b) exfoliation.

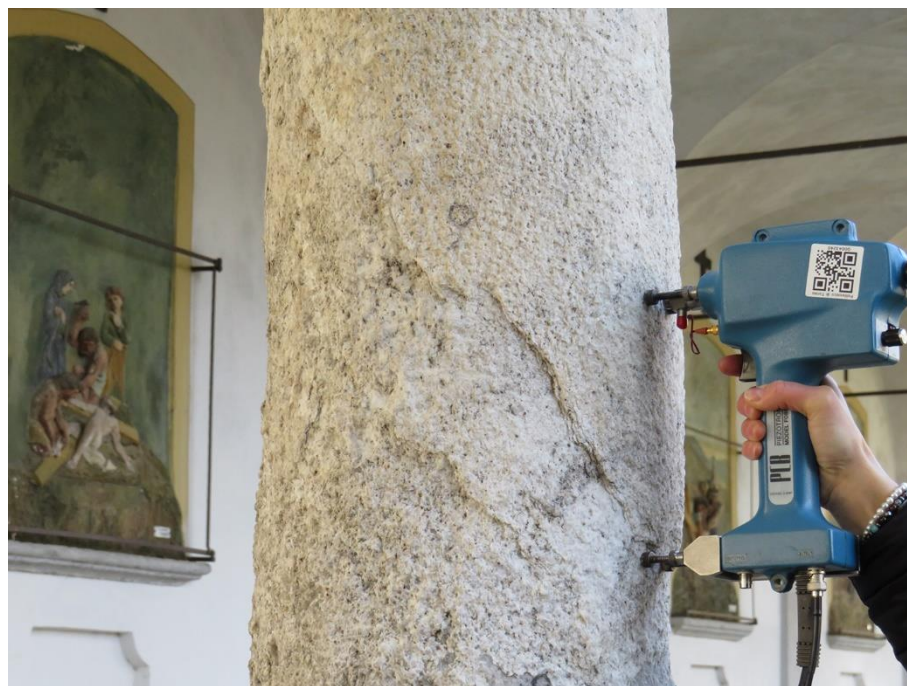
The purpose of the impact test was to verify the surface resistance of the stone elements, considering their surface degradation. The impact test, when performed on homogeneous material such as concrete or stone, can provide through Equation (2) values of the elastic modulus completely comparable to those obtained by the ultrasonic technique [29]. It should be remembered that the value obtained with the impact test represents a static elastic modulus ( $E_s$ ), the conversion of which into a dynamic value deserves separate research considering the many different formulas present in scientific literature for the different types of stones and rocks [32]. To obtain a correct and reliable correlation formula for each type of stone, a large number of tests must be performed in the laboratory and correlated with non-destructive tests; this correlation could then be calibrated as a suitable diagnostic technology to be applied on specific architectural elements. However, since the test is based on an energetic evaluation relative to the impact on the surface of the element (Figure 8), in presence of a surface degradation,

**Figure 8.** Impact test carried out on a column of Via Crucis portico.

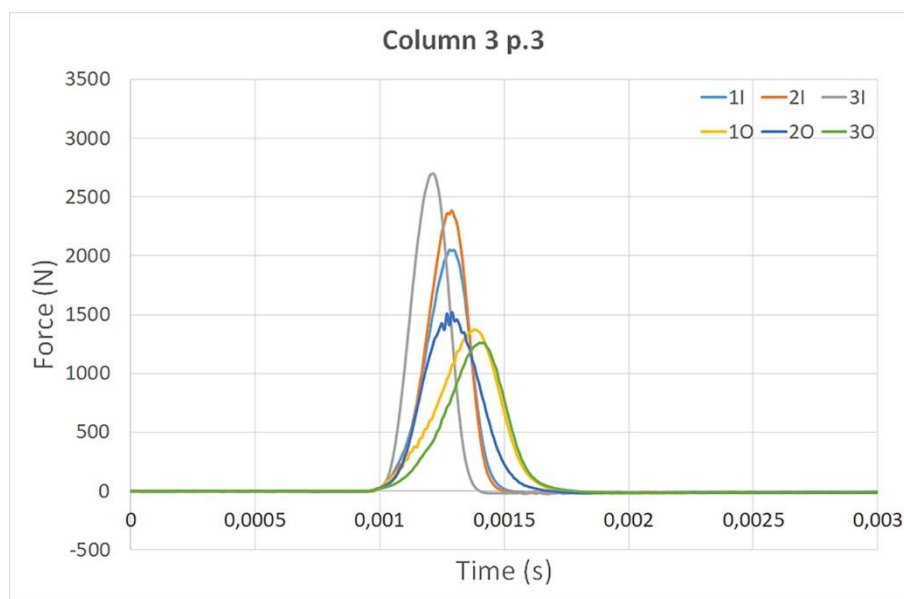
Figure 9 shows, for example, the time–force curves between two different points of the same test on column 3. In presence of surface degradation, the curves are characterized by lower peak force and wider response times. The ratio between the returned  $A_2$  and supplied energy  $A_1$  (Figure 6a) provided indications regarding the detachment of the degraded matter crust [17,33].

**Figure 9.** Time–force diagrams of third point of column 3 (I = point inside of the portico; O = outside of the portico).
