Post-collapse analysis of Morandi's Polcevera viaduct in Genoa Italy

Post Collapse Analysis of Morandi's Polcevera Viaduct in Genoa Italy

Maurizio Morgese ^a, Farhad Ansari ^b, Marco Domaneschi ^c, and Gian Paolo Cimellaro ^d

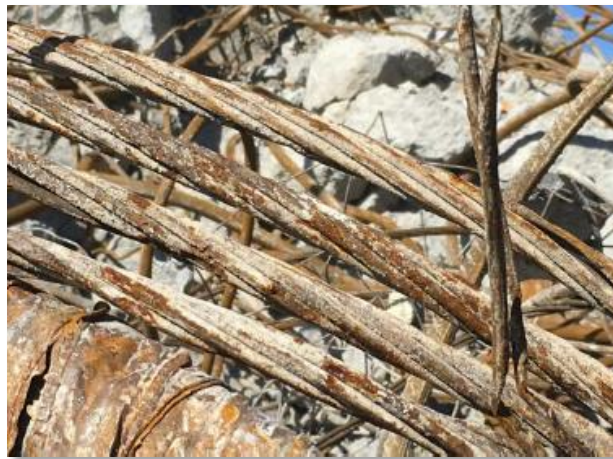
Figure 2. Pitting corrosion of prestressing tendons.

Transport (MIT) [16, 17]. Fig. 2 pertains to a photo of the corroded tendons, taken by Autostrade, which is the operating entity for the highway system that includes the Polcevera viaduct.

Following the failure of Polcevera viaduct, some considered the influence of bad weather and lightning on the collapse. However, degradation of the cables due to corrosion was confirmed by an investigation carried out by the inspection commission of the Ministry of Infrastructure and

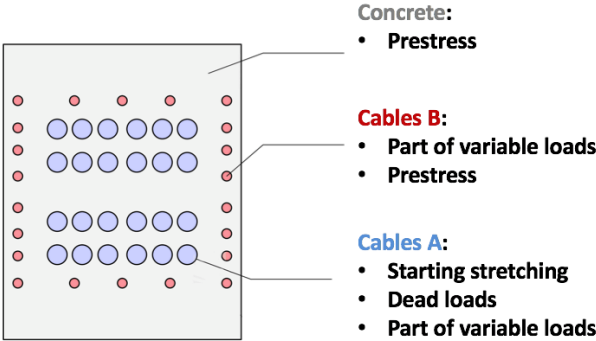
With reference to construction phases, the intent was to assure support for the main deck dead loads by Tendons A and compression of the concrete stay cover by Tendons B. Both cable types contributed in supporting the Gerber beams (Phase 5) and the live loads.

Figure 7. Load configuration per Morandi's design specifications for the stays

comprised of 24 tendons, each tendon with 12 strands for a total of 288 strands per cable. The external cables (Cables-B), were comprised of 28 tendons, each with 4 strands for a total of 112 strands. A typical tendon pattern signifying the positions of cables-A and B is shown in Fig. 7.

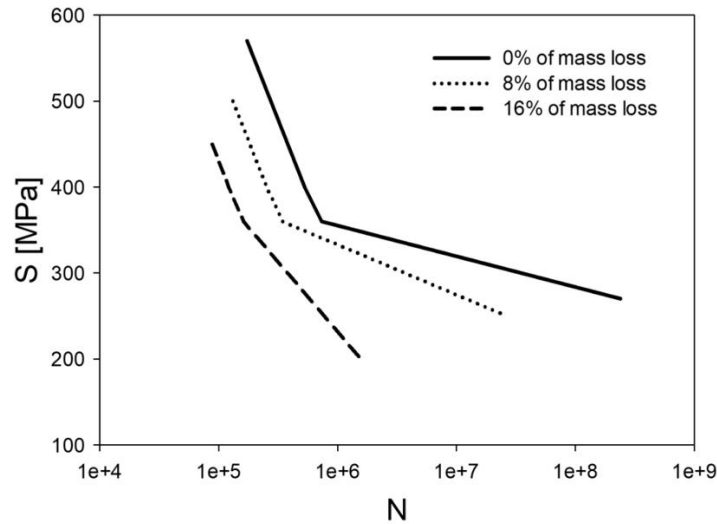
Where, N is the number of cycles, S is the stress range and η is the percent corrosion in steel wires. Eq. (9) is valid for the stress range $S \geq 360$ MPa, and Eq. (10) pertains for stress range, $S < 360$. In considering the deterioration of S-N curve for the tendons of the Morandi Bridge, Eqs. (9) and (10) were employed for development of S-N curves corresponding to each and every individual year of service beginning in 1968, corresponding to the yearly increase in percent corrosion, per earlier discussions. Typical S-N curves for the steel wires without corrosion (0%) in 1968, as well as those with 8 percent, and 16 percent corrosion induced mass losses in the subsequent years, respectively are shown in Fig. 12.

Figure 12. Typical S – N curves at 0%, 8% 16% of mass loss due to corrosion
