Post-collapse analysis of Morandi's Polcevera viaduct in Genoa Italy

Post-collapse analysis of Morandi's Polcevera viaduct in Genoa Italy / Morgese, M.; Ansari, F.; Domaneschi, M.; Cimellaro, G. P.. - In: JOURNAL OF CIVIL STRUCTURAL HEALTH MONITORING. - ISSN 2190-5452. - STAMPA. - 10:(2020), pp. 69-85. [10.1007/s13349-019-00370-7]

Post Collapse Analysis of Morandi's Polcevera Viaduct in Genoa Italy

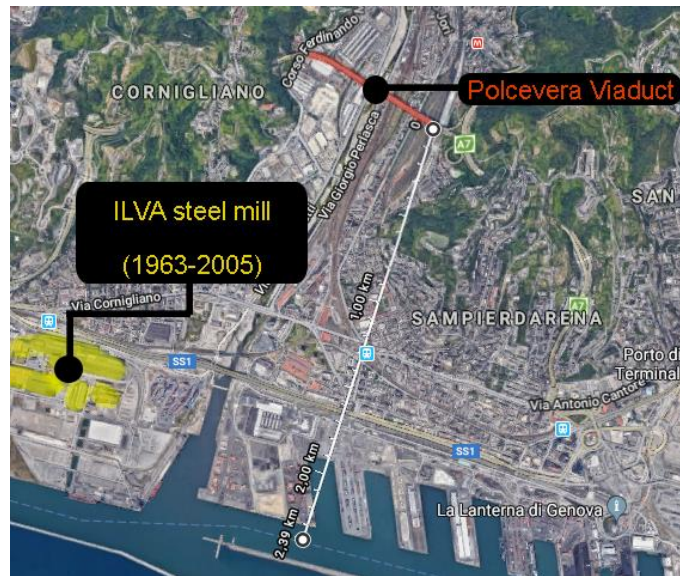
Figure 1: Proximity of the Polcevera viaduct to the main sources of corrosive emissions: the sea and an industrial hub

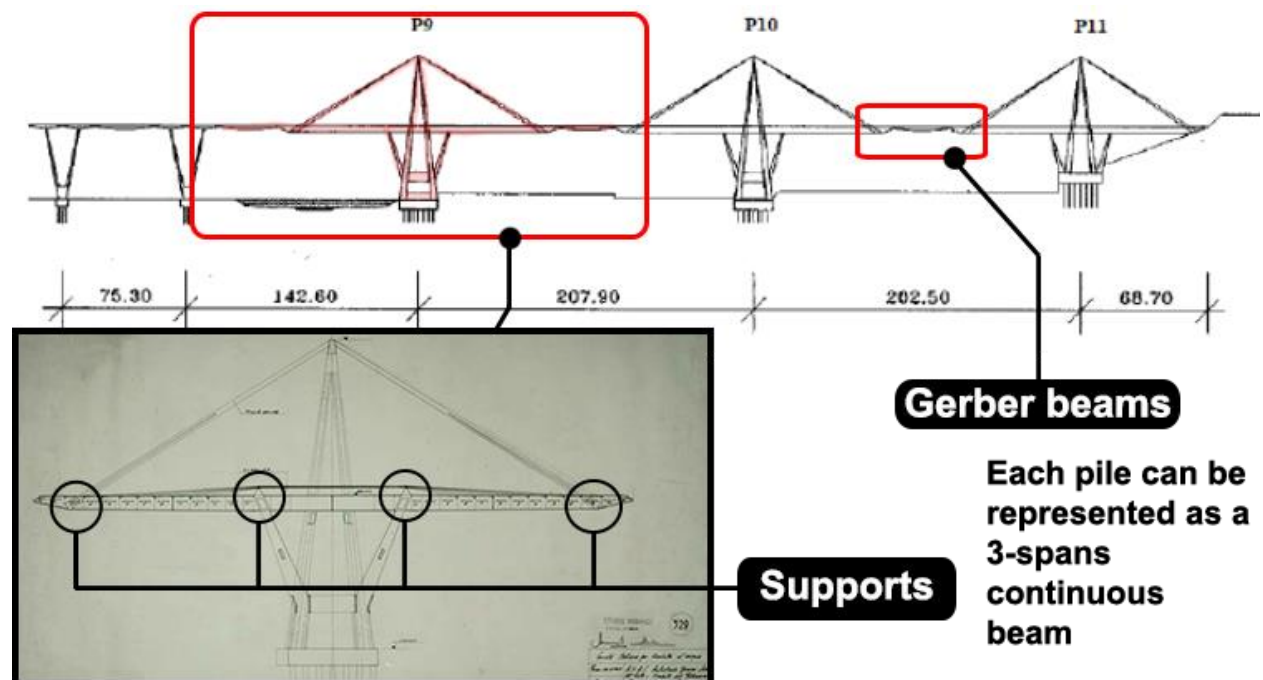
19]. The bridge deck was made of a partially prestressed concrete slab. The pylons of the bridge formed a double V, one to support the deck beam and the other, which was an upside-down V to support the stays over the saddle. The schematic diagram of the bridge and details for a typical pylon-girder assembly as well as the Gerber beam connecting the three sections are shown in Fig. 3.

Figure 3. Schematic diagram of the Polcevera Viaduct.

The design had features that were characteristically different from conventional methods, such as the fact that the individual pylon-deck systems of the bridge were only supported by two stays on each side running over the pylons over saddle seats. This design did not allow for redundancy, especially when the stay cables were made of prestressed concrete and difficult to inspect for corrosion. Nevertheless, the bridge lasted for over 50 years, without much maintenance, especially at the cable stays, except at one of the pylons, which did not collapse (P 11 in Fig. 3).

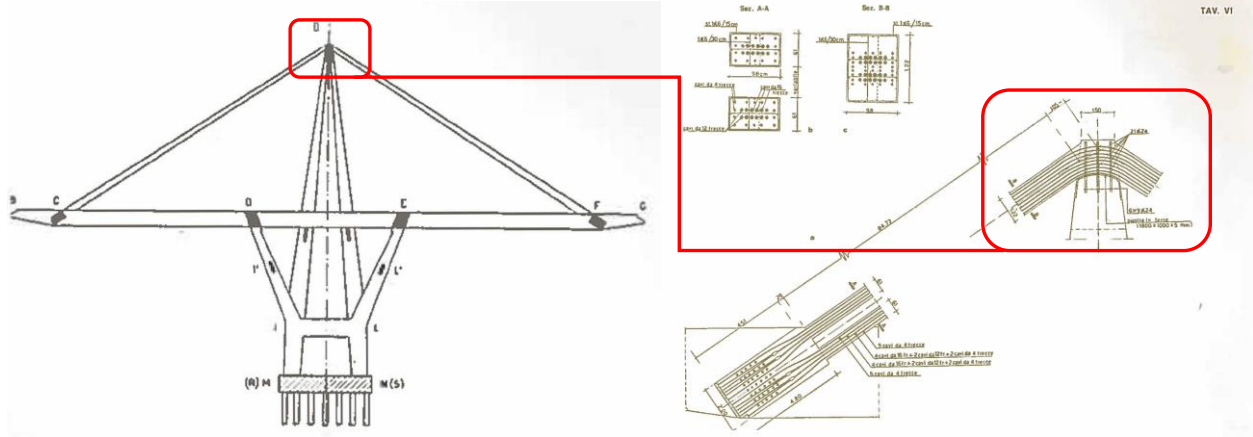
Figure 4. Typical view of the stay cable system with the saddle detail from the design tables.

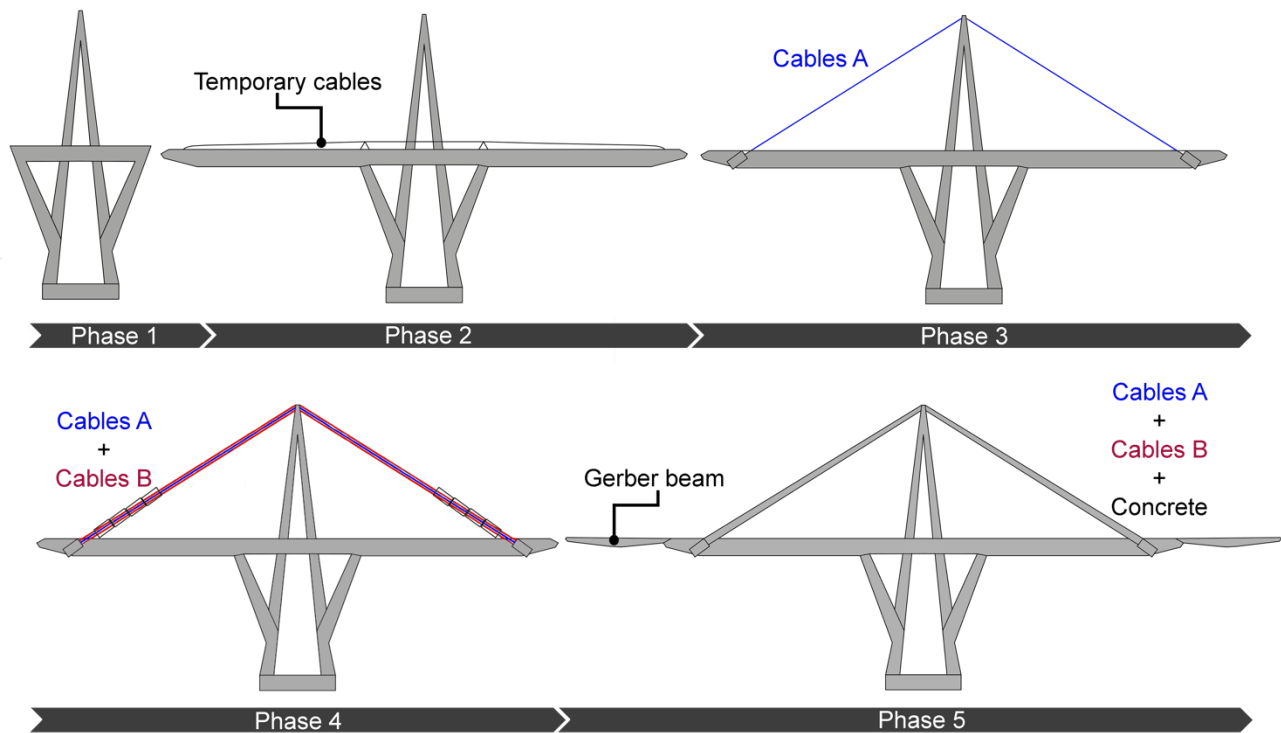
Construction of the bridge took place in five phases, which are enumerated in the following, and depicted in Fig.5 [18, 19]:

Figure 5. Construction phases of Polcevera Viaduct.

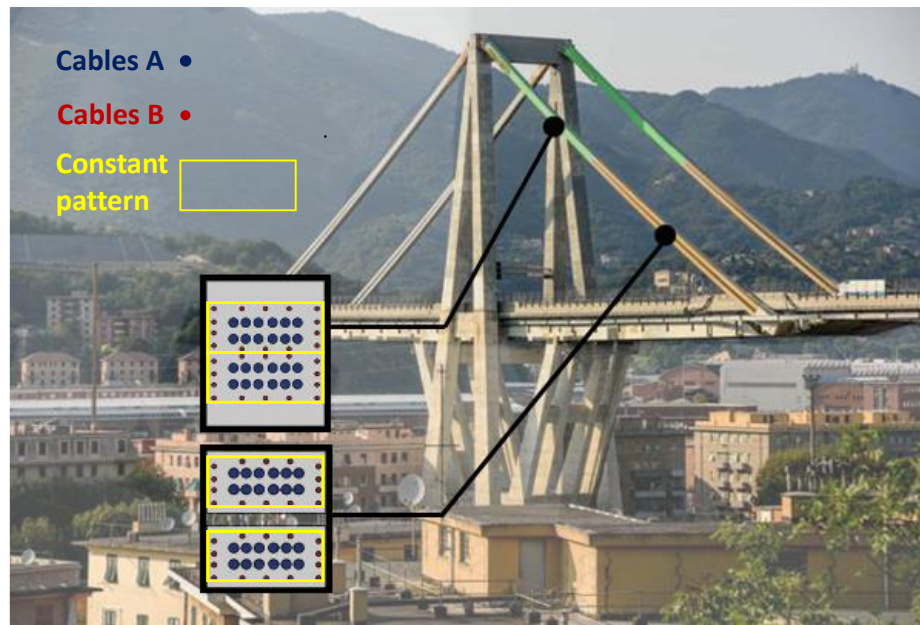
The prestressing tendon details within the cross-sections of the cable stays are shown in the photo of a typical deck-pylon structure of the bridge in Fig.6. The two different cross-sections portray the transition of the stay cable from a single cross-section on the upper portion of the stay on both sides of the saddle to double sections in the lower region, at the connecting points to the bridge deck. The larger single cross section around the saddle was necessary in order to assure smooth transition over the highly concentrated stresses at the saddle. Division of the cross section at the deck was necessary to spread the effect of the concentrated force. Despite the transition, the cross-sectional area and the number of prestressing tendons within each cross-section remained the same (Fig.6). The inner cables (Cables-A), which were installed during phase-3 of the construction

comprised of 24 tendons, each tendon with 12 strands for a total of 288 strands per cable. The external cables (Cables-B), were comprised of 28 tendons, each with 4 strands for a total of 112 strands. A typical tendon pattern signifying the positions of cables-A and B is shown in Fig. 7.

Figure 6. Cross-sections of the stays at Polcevera Viaduct

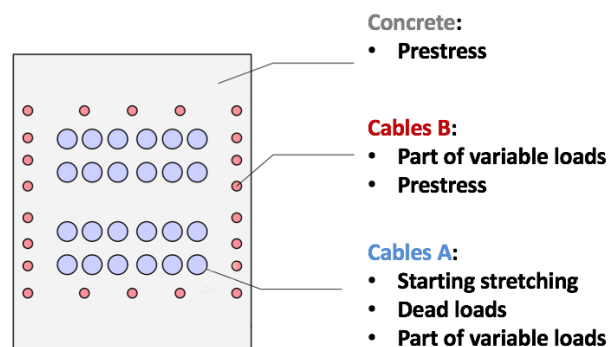
With reference to construction phases, the intent was to assure support for the main deck dead loads by Tendons A and compression of the concrete stay cover by Tendons B. Both cable types contributed in supporting the Gerber beams (Phase 5) and the live loads.

Figure 7. Load configuration per Morandi's design specifications for the stays

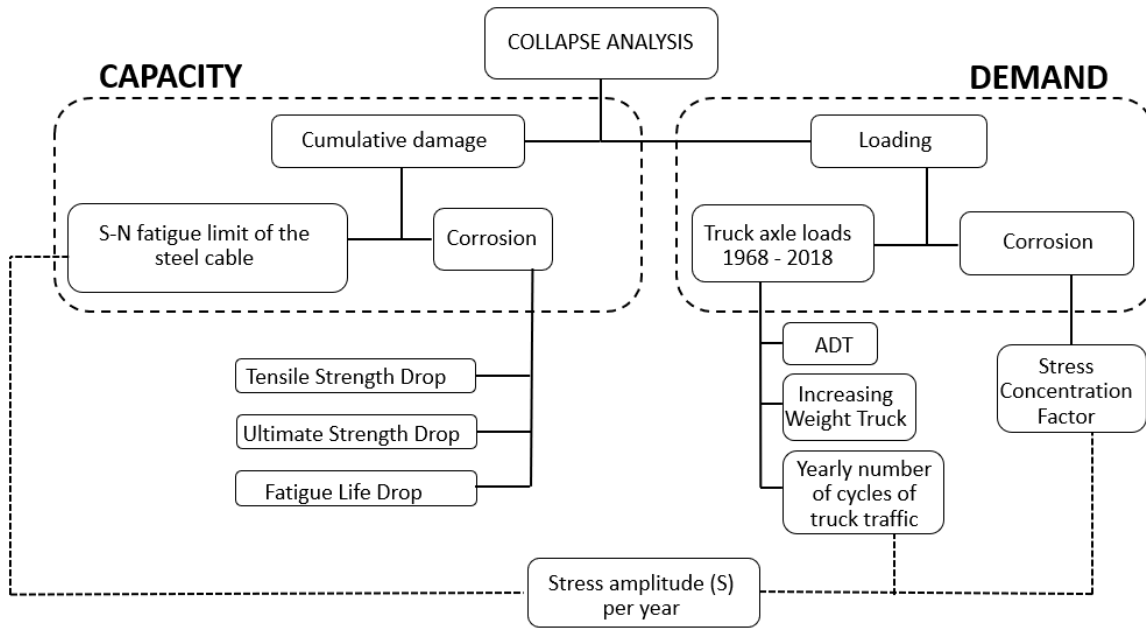
Figure 8. Flow diagram for the analysis of capacity and demand of the Polcevera Viaduct

Based on the general processes depicted in Fig. 8, post collapse analysis of the bridge requires realistic portrayal of degradation (corrosion and fatigue) and loads over the period of its service life. For estimation of capacity loss due to corrosion and fatigue, the first step in the process involved survey of technical literature for the selection of appropriate models. On the other hand, computation of demand required estimation of loads on the bridge. In addition to the self-weight as the dead load, truck traffic information was employed for the computation of the live loads. Live loads were computed as a representative set of truck axle loads typical of trucks in the Italian design standard guidelines. The number of passenger cars travelling over the bridge increased over the years. However, contribution of passenger cars to the loads were not considered in the post collapse analysis. This was a conservative assumption for the post collapse analysis. A model was also necessary to compute the corrosion related stress changes in the bridge elements over the period of its service. Once sufficient amounts of data and information became available, it was then possible to use the original design drawings of the Morandi bridge for development of a detailed 3D finite element model of the pylon-deck system (P9 in Fig. 3). Influence lines were also computed in order to identify the maximum effect of truck axle loads on internal forces at critical members. Computation of demand and capacity was repeated for each year of service until the

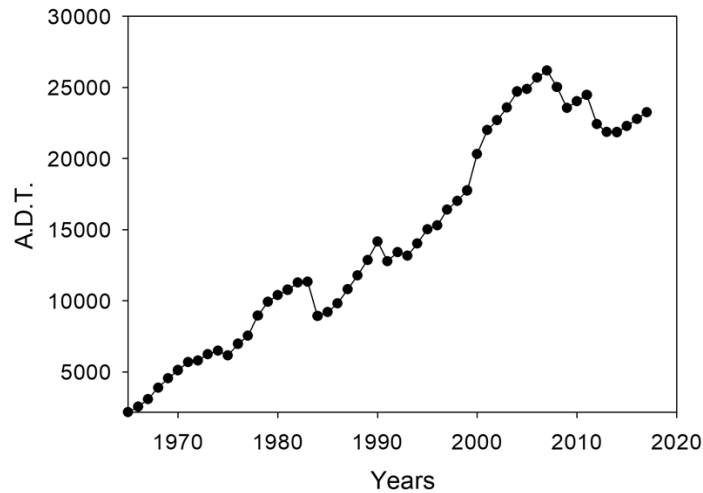
The load combination for post collapse analysis of the bridge composed of both dead loads and live loads. Dead loads were computed based on the weights of structural elements from the original design drawings of the bridge and the estimated weight of the wearing surface on the deck. Accurate portrayal of the live loads was important considering their importance both in design as well as for estimating the effects of fatigue on the degradation of the bridge [26]. In the context of present study, database from the Italian Association of Motorways and Tunnel Operators, AISCAT [27] was employed for the estimation of truck traffic over the Morandi bridge. It was possible to extract the traffic data from the AISCAT's database, covering the period between 1968 and 2018. As shown in Fig. 9, the number of trucks traveling over the bridge (Average Daily Traffic, ADT) increased from 3,885 in 1968 to 24,640 in 2018.

Figure 9. Truck ADT (AISCAT, 2019)

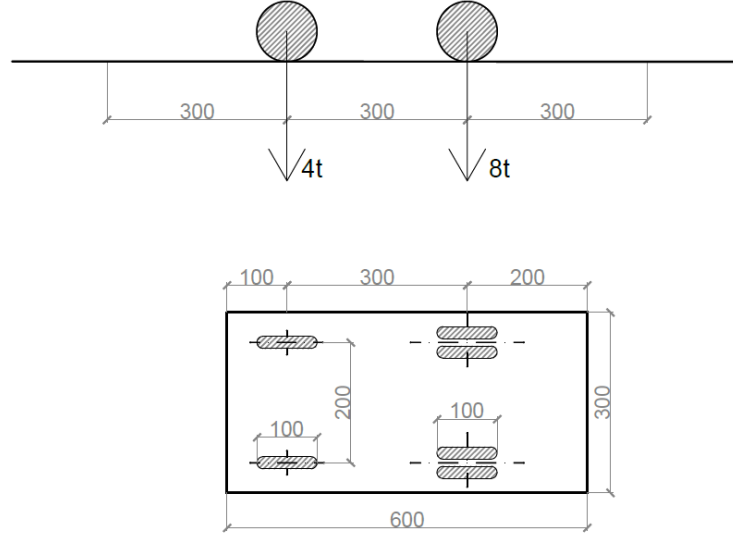
specified at 120 kN, at 40 kN for the front axle, and 80 kN for the rear axle (Fig. 10). These numbers have increased since then.

Figure 10. Design truck from Guideline number 384 (1962)

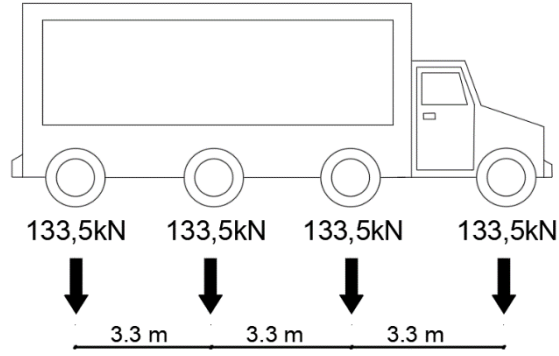
Figure 11. Equivalent average truck

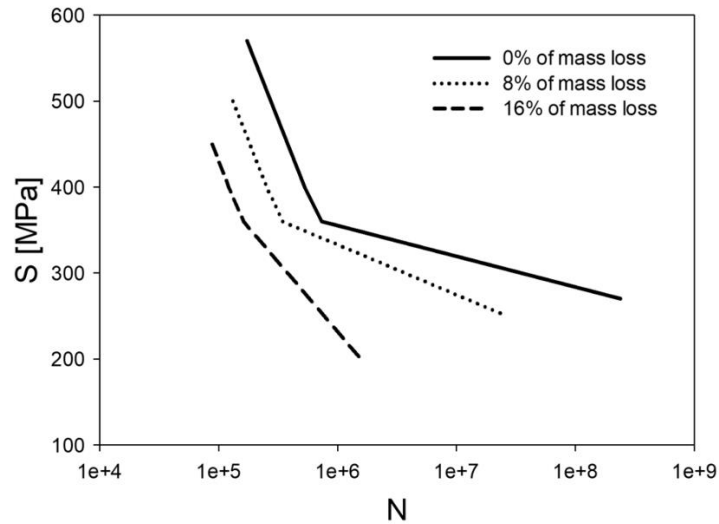
Where, N is the number of cycles, S is the stress range and η is the percent corrosion in steel wires. Eq. (9) is valid for the stress range $S \geq 360$ MPa, and Eq. (10) pertains for stress range, $S < 360$. In considering the deterioration of S-N curve for the tendons of the Morandi Bridge, Eqs. (9) and (10) were employed for development of S-N curves corresponding to each and every individual year of service beginning in 1968, corresponding to the yearly increase in percent corrosion, per earlier discussions. Typical S-N curves for the steel wires without corrosion (0%) in 1968, as well as those with 8 percent, and 16 percent corrosion induced mass losses in the subsequent years, respectively are shown in Fig. 12.

Figure 12. Typical S – N curves at 0%, 8% 16% of mass loss due to corrosion

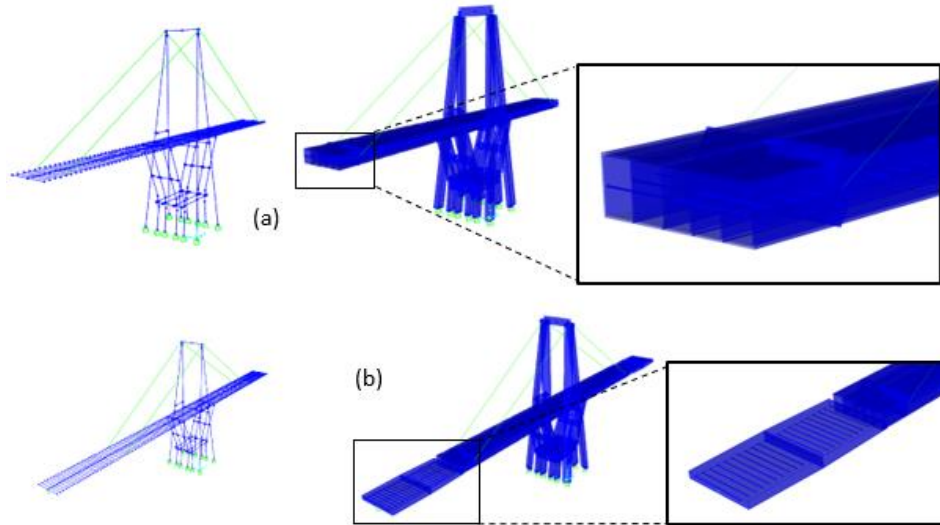
Figure 13. Finite Element model of the Deck-Pylon system (a): wireframe and solid model with detail of the cellular section. Complete model of the collapsed portion of the Polcevera viaduct (b): wireframe and solid model with detail of the Gerber systems.

The tower, the pier and the deck with the Gerber beams are modeled by using 399 *frame* elements, which were employed for representation of the beams, columns, braces, and truss elements in planar and 3D systems. The frame elements consist of linear segments, with a node on each side, accounting for biaxial bending, torsion, axial deformation, and biaxial shear in the beam-column formulation. The deck self-weight and added dead loads are carried by the cable stays and pylon, which were modeled as *frame elements*. Tendons A (352 strands) and B (112 strands) were modeled by *cable* elements, pretensioned with a force necessary to transform the bridge profile into the intended design shape following the release of the self-weight on the main girder. The concrete surrounding the stays were modeled by using a distributed load on the *cable* elements.

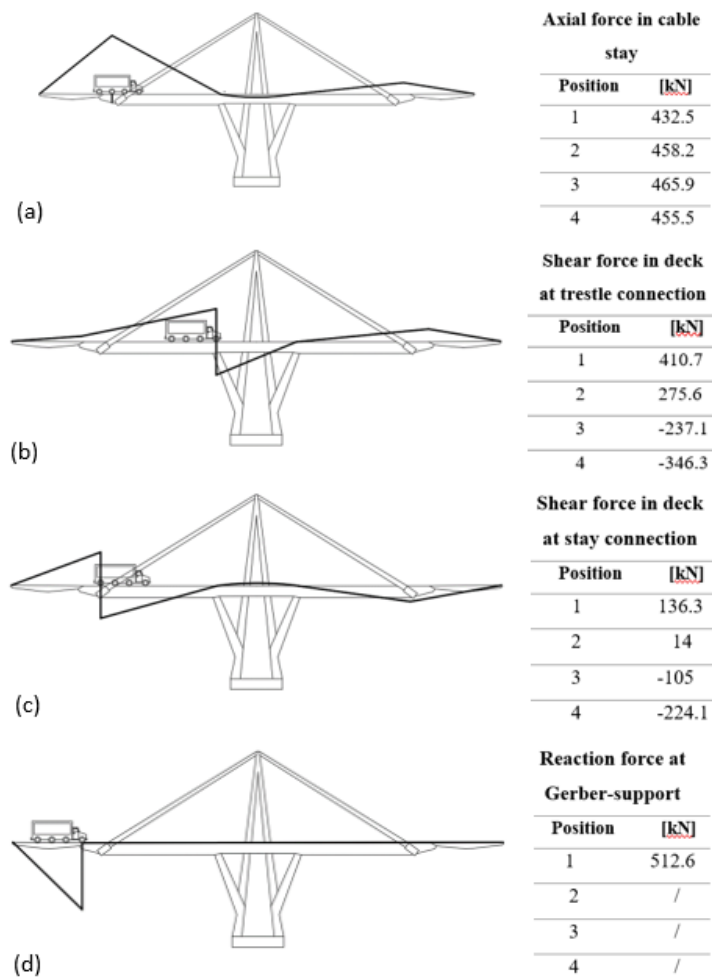
The effect of moving loads on the major components of the bridge were determined by computing the influence lines. The classical approach by movement of a unit concentrated force across the bridge deck was employed for the computation of the influence lines. Axial force in cable stays, shear force in deck at pylon connection, shear force in deck at stay connection, and the reaction force at Gerber-support were identified as critical sections for analysis. Hence, the axles of the equivalent truck were placed on the critical sections identified by the influence lines, and for each case it was possible to figure out the truck position that created the maximum effect. The table style legends in Fig. 14 indicate the position of the truck axles and corresponding forces generated due to the position of the axle. For example, the maximum tension in the stay was obtained by placing the third axle of the truck on the critical section (Fig. 14a).

Figure 14. Influence lines: (a) axial force in cable stays, (b) shear force in deck at trestle connection, (c) shear force in deck at stay connection, (d) reaction force at Gerber-support

Considering the load path and the reaction influence line at the Gerber beam support in Fig. 14d, partial or full positioning of the truck axles on the Gerber beam would not affect the main girder of the bridge, even though it exerts a large load on the Gerber beam support. Therefore, the influence of the Gerber beam loads on the failure of girder-pylon system was discounted in the present study. Failure of the cable stay as indicated by the forces shown in Fig. 14a was considered as the main culprit for the collapse of the girder-pylon system.

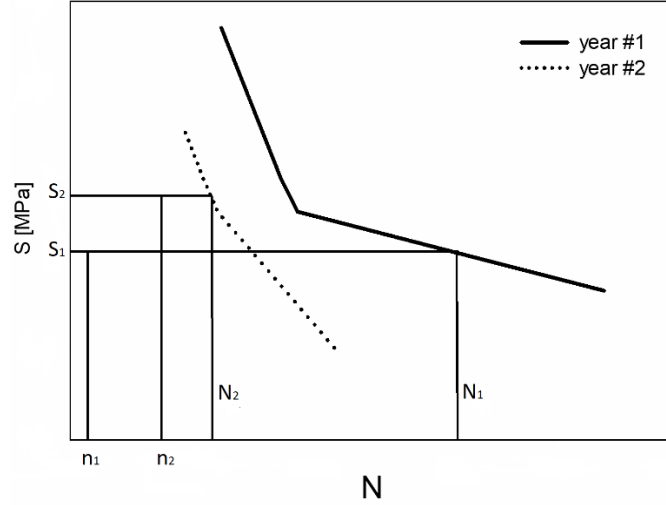
Figure 15. Component cyclic life determined from Palmgren-Miner law

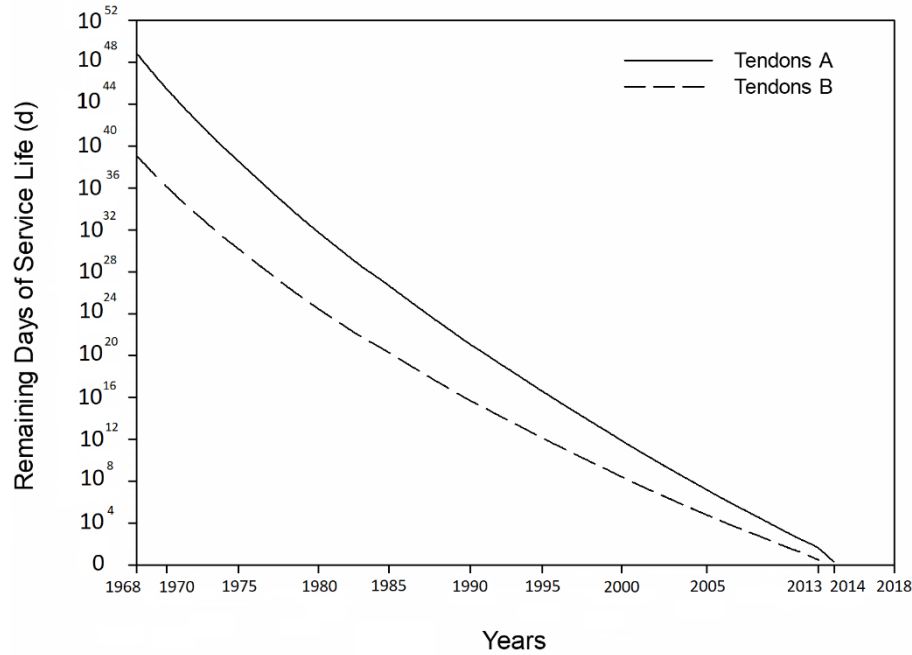
Repeating this procedure for every year of bridge service life since its inception, it was possible to compute the remaining days of service life per year as shown in Fig. 16. It is possible to observe as tendons B reach failure in 2013 and tendons A fail in 2014, leading to total collapse. The cumulative damage model based on Palmgren-Miner-law predicted the collapse date of the Morandi bridge 4 years earlier than the actual collapse date of 2018.

Figure 16. Remaining days of service life Tendons A and Tendons B.

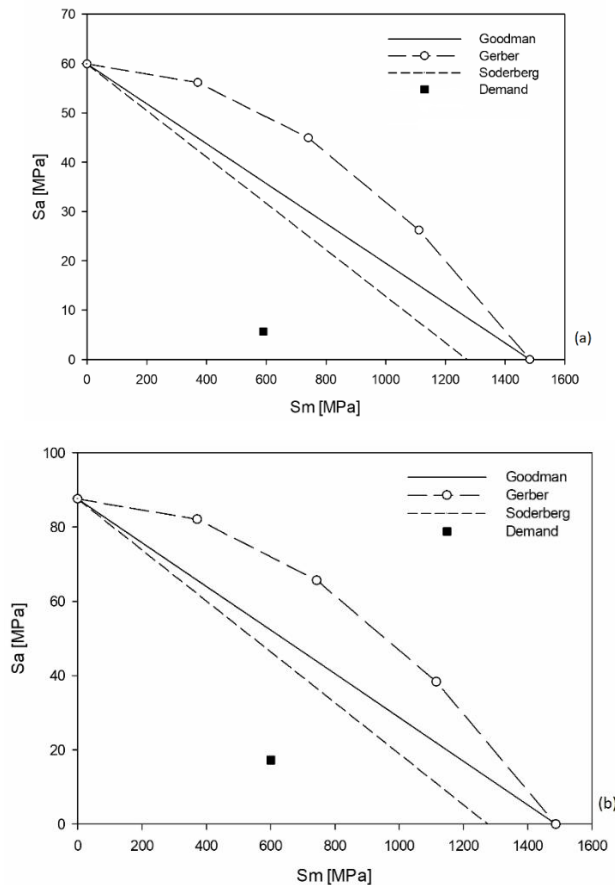
Fig. 17 corresponds to the Goodman, Gerber, and Soderberg diagrams for the years 2013, and 2014, respectively, the years in which tendons B, and A failed based on the cumulative damage computations of Palmgren-Miner-law. Comparison of the results shown in Fig. 17 reveals the contrast between the timing of stay cable failure predicted by the Palmgren-Miner-law, and the Goodman, Gerber, and Soderberg diagrams. According to these diagrams, the bridge would not collapse in 2014, as predicted by the cumulative damage model. However, As shown by the Gerber, and Goodman diagrams in the subsequent years, shown in Fig. 18, the stay cables A and B fail in 2015, and 2016, respectively. The stay cables would have still remained in service by the Soderberg S_a - S_m law, which is less conservative than its counterparts (Gerber, and Goodman).

Figure 17. Goodman, Gerber and Soderberg surface (a) Tendons A in 2014, (b) Tendons B in 2013.

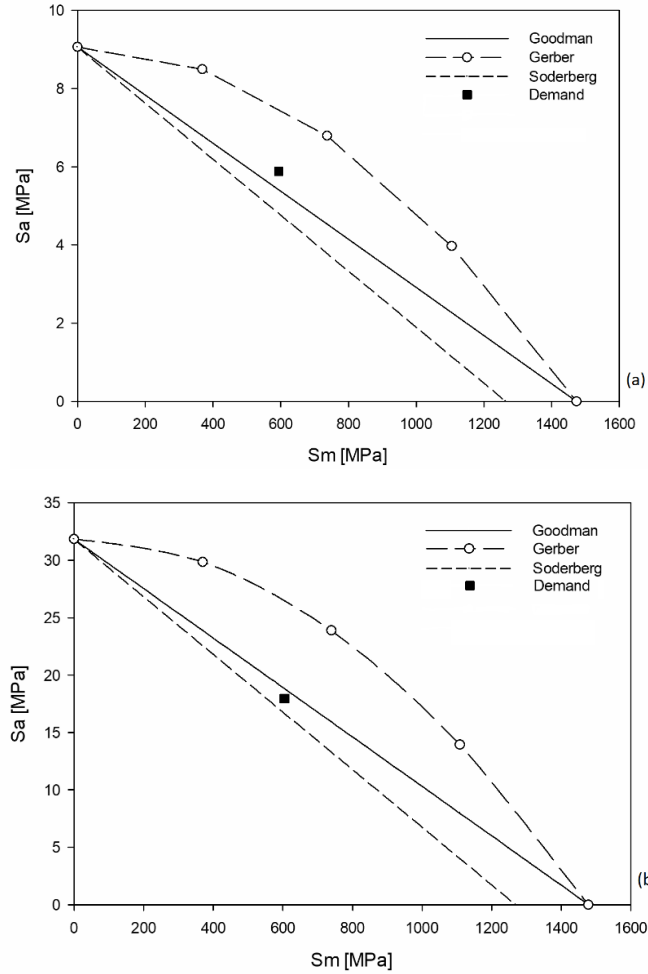
Figure 18. Goodman, Gerber and Soderberg surface (a) Tendons A in 2016, (b) Tendons B in 2015.
