Post-collapse analysis of Morandi's Polcevera viaduct in Genoa Italy

Post-collapse analysis of Morandi's Polcevera viaduct in Genoa Italy / Morgese, M.; Ansari, F.; Domaneschi, M.; Cimellaro, G. P.. - In: JOURNAL OF CIVIL STRUCTURAL HEALTH MONITORING. - ISSN 2190-5452. - STAMPA. - 10:(2020), pp. 69-85. [10.1007/s13349-019-00370-7]

Post Collapse Analysis of Morandi's Polcevera Viaduct in Genoa Italy

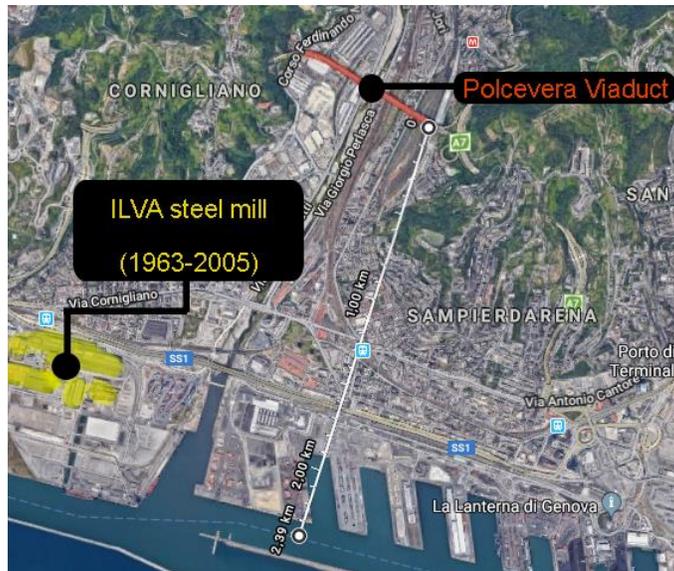
Figure 1: Proximity of the Polcevera viaduct to the main sources of corrosive emissions: the sea and an industrial hub

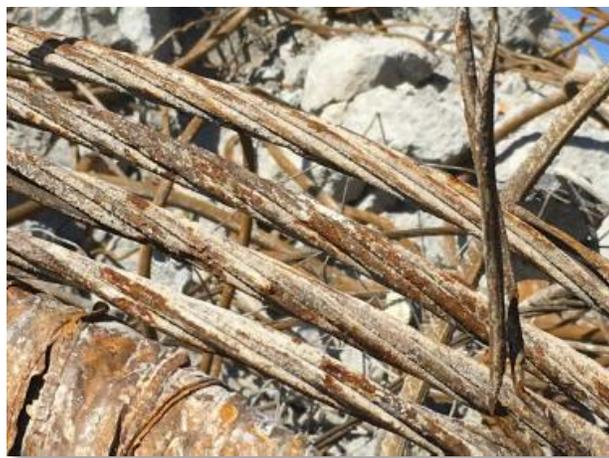
Figure 2. Pitting corrosion of prestressing tendons.

Transport (MIT) [16, 17]. Fig. 2 pertains to a photo of the corroded tendons, taken by Autostrade, which is the operating entity for the highway system that includes the Polcevera viaduct.

Following the failure of Polcevera viaduct, some considered the influence of bad weather and lightning on the collapse. However, degradation of the cables due to corrosion was confirmed by an investigation carried out by the inspection commission of the Ministry of Infrastructure and

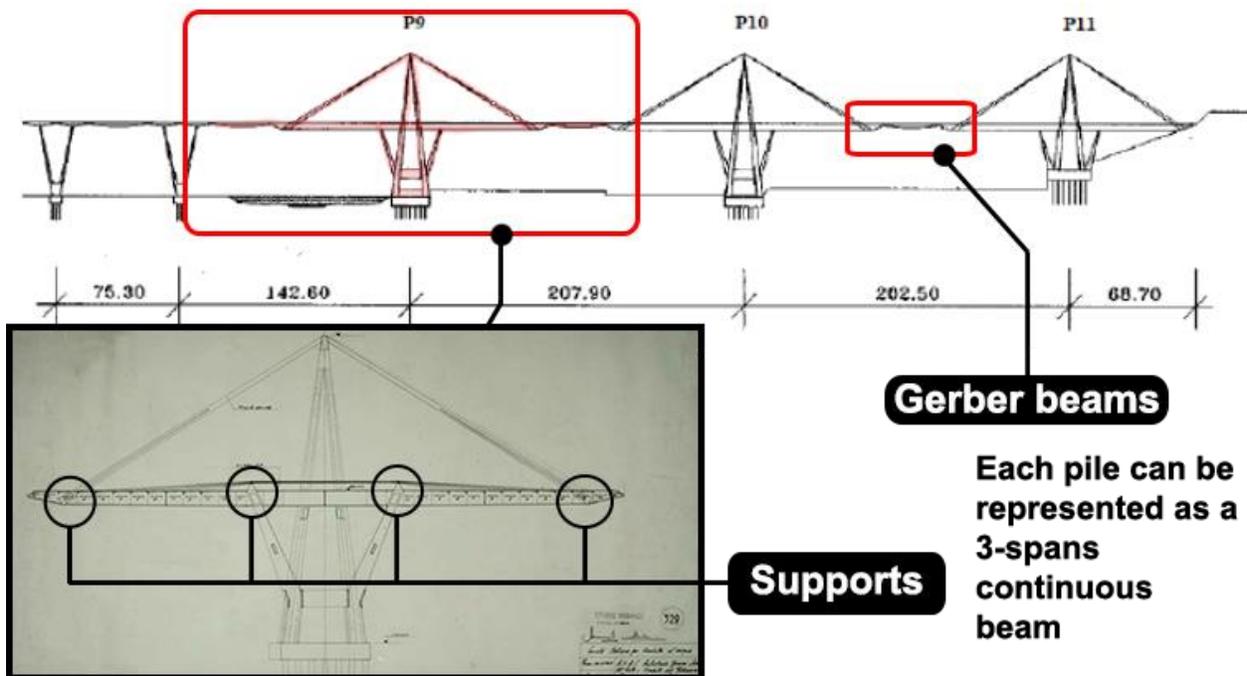
19]. The bridge deck was made of a partially prestressed concrete slab. The pylons of the bridge formed a double V, one to support the deck beam and the other, which was an upside-down V to support the stays over the saddle. The schematic diagram of the bridge and details for a typical pylon-girder assembly as well as the Gerber beam connecting the three sections are shown in Fig. 3.

Figure 3. Schematic diagram of the Polcevera Viaduct.

The design had features that were characteristically different from conventional methods, such as the fact that the individual pylon-deck systems of the bridge were only supported by two stays on each side running over the pylons over saddle seats. This design did not allow for redundancy, especially when the stay cables were made of prestressed concrete and difficult to inspect for corrosion. Nevertheless, the bridge lasted for over 50 years, without much maintenance, especially at the cable stays, except at one of the pylons, which did not collapse (P 11 in Fig. 3).

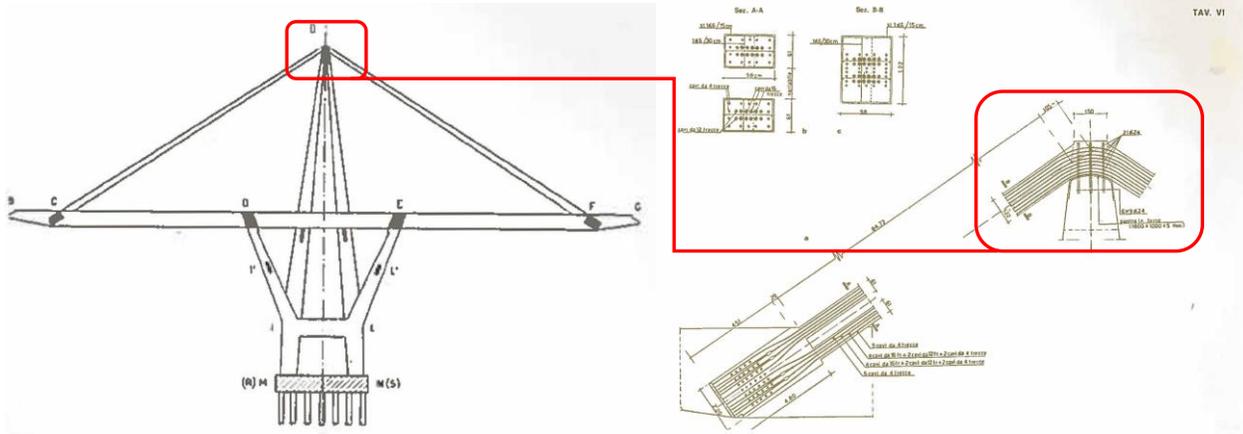
Figure 4. Typical view of the stay cable system with the saddle detail from the design tables.

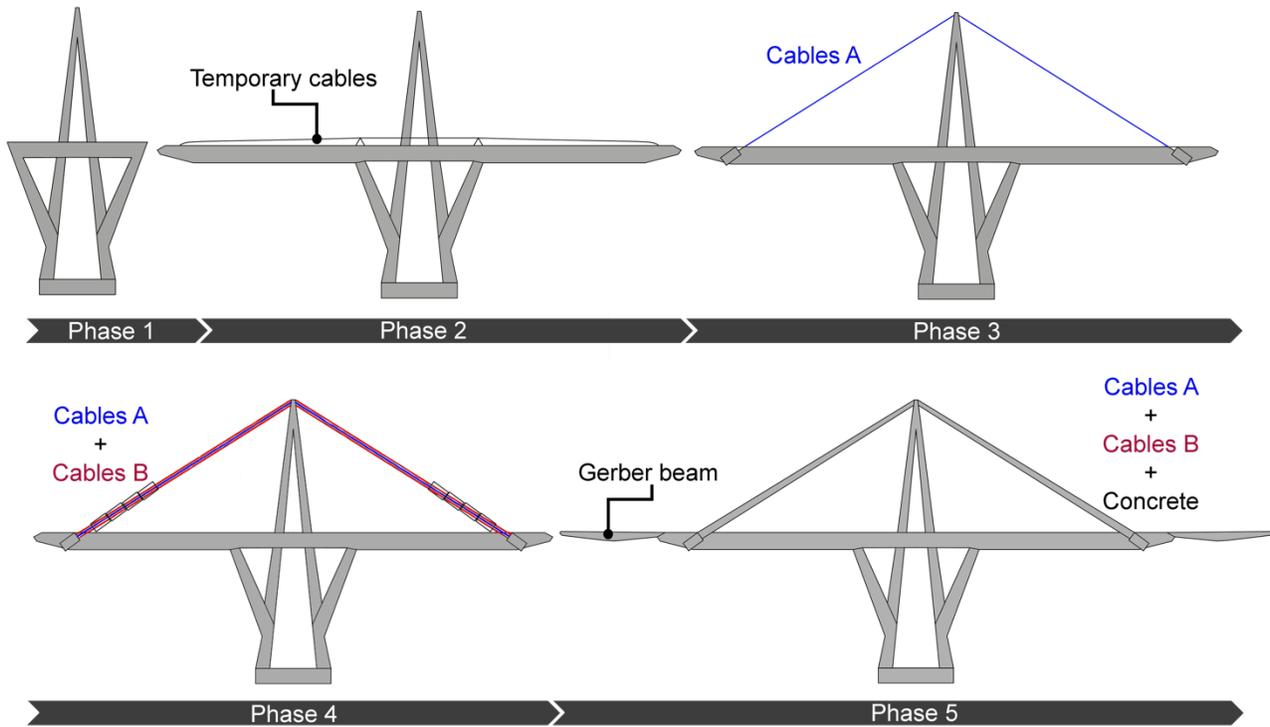
1. The pylons were constructed first, consisting of two V-shaped elements, one of them an inverted V. The V-shaped elements were connected together by transverse beams at top and mid-height, and at the base to the foundation.

under full compression due to the above-mentioned post tensioning processes. The final segment of this phase involved connecting the prestressed concrete stays to the deck girders.

- Phase 5 involved construction of the simply supported transfer (Gerber) beams, which were employed for connecting the three sets of deck-pylon structures.

Figure 5. Construction phases of Polcevera Viaduct.

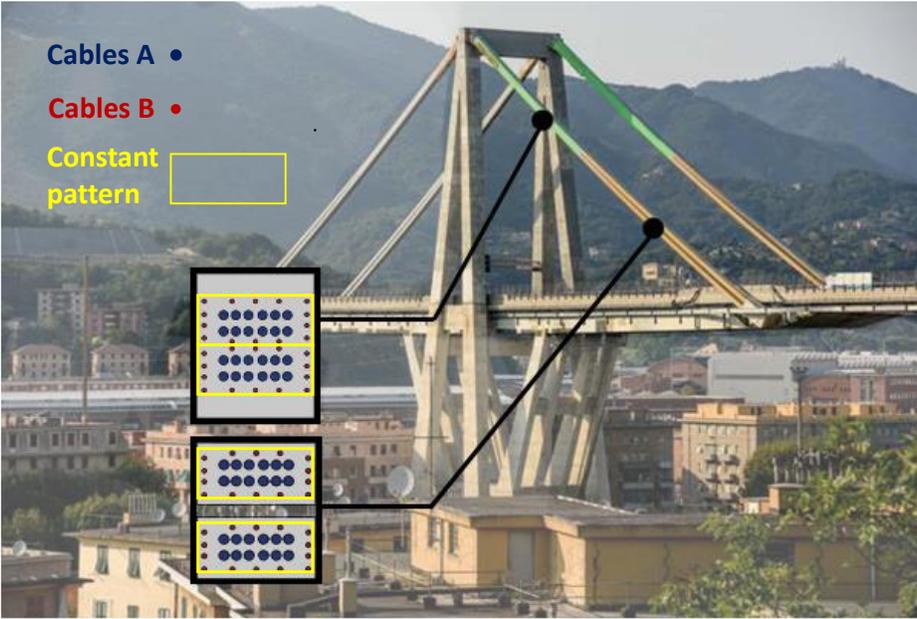
The prestressing tendon details within the cross-sections of the cable stays are shown in the photo of a typical deck-pylon structure of the bridge in Fig.6. The two different cross-sections portray the transition of the stay cable from a single cross-section on the upper portion of the stay on both sides of the saddle to double sections in the lower region, at the connecting points to the bridge deck. The larger single cross section around the saddle was necessary in order to assure smooth transition over the highly concentrated stresses at the saddle. Division of the cross section at the deck was necessary to spread the effect of the concentrated force. Despite the transition, the cross-sectional area and the number of prestressing tendons within each cross-section remained the same (Fig.6). The inner cables (Cables-A), which were installed during phase-3 of the construction

comprised of 24 tendons, each tendon with 12 strands for a total of 288 strands per cable. The external cables (Cables-B), were comprised of 28 tendons, each with 4 strands for a total of 112 strands. A typical tendon pattern signifying the positions of cables-A and B is shown in Fig. 7.

Figure 6. Cross-sections of the stays at Polcevera Viaduct

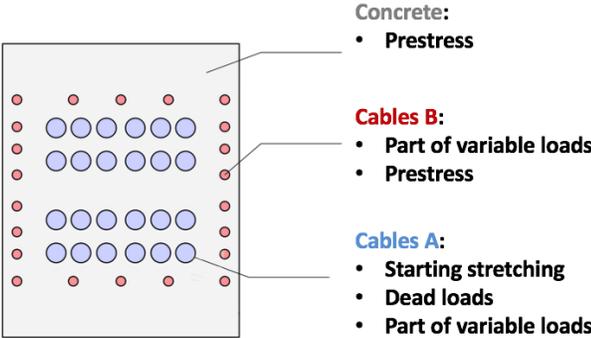
With reference to construction phases, the intent was to assure support for the main deck dead loads by Tendons A and compression of the concrete stay cover by Tendons B. Both cable types contributed in supporting the Gerber beams (Phase 5) and the live loads.

Figure 7. Load configuration per Morandi's design specifications for the stays

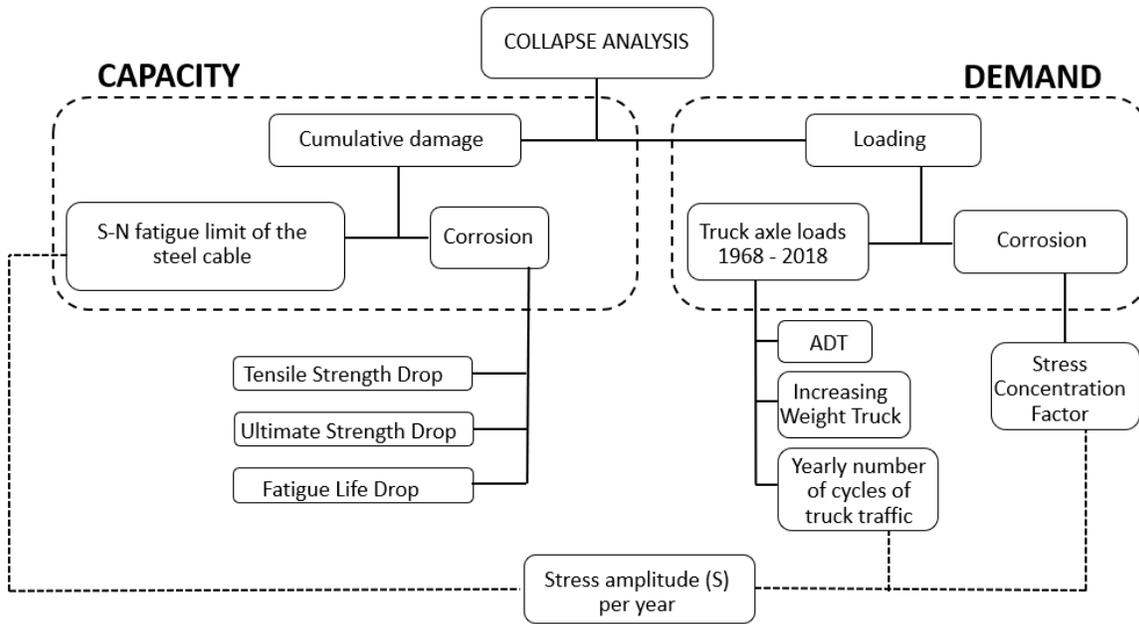
Figure 8. Flow diagram for the analysis of capacity and demand of the Polcevera Viaduct

Based on the general processes depicted in Fig. 8, post collapse analysis of the bridge requires realistic portrayal of degradation (corrosion and fatigue) and loads over the period of its service life. For estimation of capacity loss due to corrosion and fatigue, the first step in the process involved survey of technical literature for the selection of appropriate models. On the other hand, computation of demand required estimation of loads on the bridge. In addition to the self-weight as the dead load, truck traffic information was employed for the computation of the live loads. Live loads were computed as a representative set of truck axle loads typical of trucks in the Italian design standard guidelines. The number of passenger cars travelling over the bridge increased over the years. However, contribution of passenger cars to the loads were not considered in the post collapse analysis. This was a conservative assumption for the post collapse analysis. A model was also necessary to compute the corrosion related stress changes in the bridge elements over the period of its service. Once sufficient amounts of data and information became available, it was then possible to use the original design drawings of the Morandi bridge for development of a detailed 3D finite element model of the pylon-deck system (P9 in Fig. 3). Influence lines were also computed in order to identify the maximum effect of truck axle loads on internal forces at critical members. Computation of demand and capacity was repeated for each year of service until the

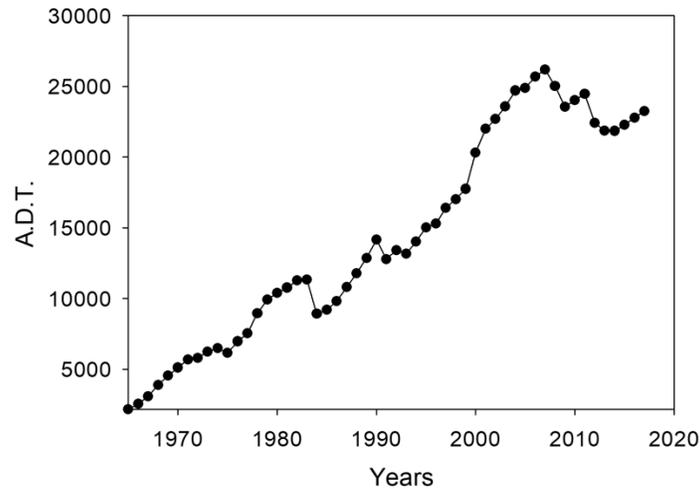
The load combination for post collapse analysis of the bridge composed of both dead loads and live loads. Dead loads were computed based on the weights of structural elements from the original design drawings of the bridge and the estimated weight of the wearing surface on the deck. Accurate portrayal of the live loads was important considering their importance both in design as well as for estimating the effects of fatigue on the degradation of the bridge [26]. In the context of present study, database from the Italian Association of Motorways and Tunnel Operators, AISCAT [27] was employed for the estimation of truck traffic over the Morandi bridge. It was possible to extract the traffic data from the AISCAT's database, covering the period between 1968 and 2018. As shown in Fig. 9, the number of trucks traveling over the bridge (Average Daily Traffic, ADT) increased from 3,885 in 1968 to 24,640 in 2018.

Figure 9. Truck ADT (AISCAT, 2019)

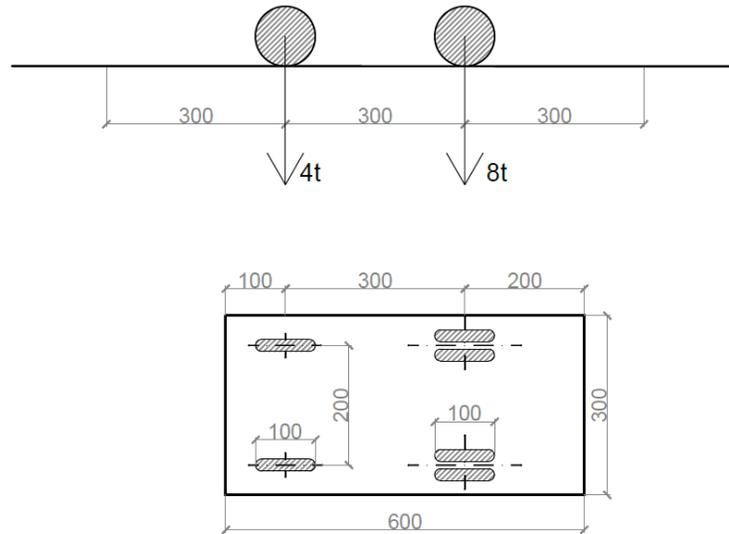
specified at 120 kN, at 40 kN for the front axle, and 80 kN for the rear axle (Fig. 10). These numbers have increased since then.

Figure 10. Design truck from Guideline number 384 (1962)

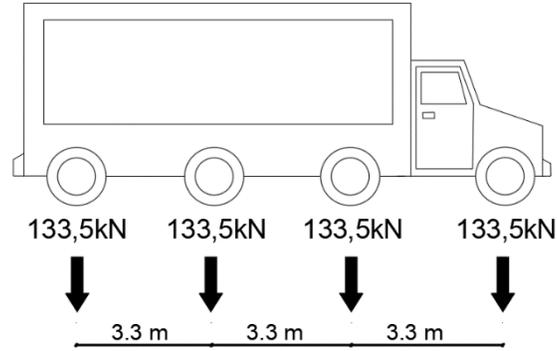
Figure 11. Equivalent average truck

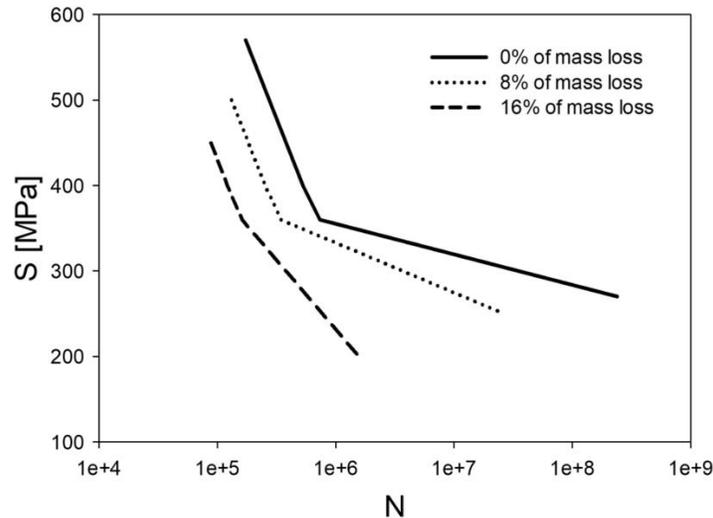
Where, N is the number of cycles, S is the stress range and η is the percent corrosion in steel wires. Eq. (9) is valid for the stress range $S \geq 360$ MPa, and Eq. (10) pertains for stress range, $S < 360$. In considering the deterioration of S-N curve for the tendons of the Morandi Bridge, Eqs. (9) and (10) were employed for development of S-N curves corresponding to each and every individual year of service beginning in 1968, corresponding to the yearly increase in percent corrosion, per earlier discussions. Typical S-N curves for the steel wires without corrosion (0%) in 1968, as well as those with 8 percent, and 16 percent corrosion induced mass losses in the subsequent years, respectively are shown in Fig. 12.

Figure 12. Typical S – N curves at 0%, 8% 16% of mass loss due to corrosion

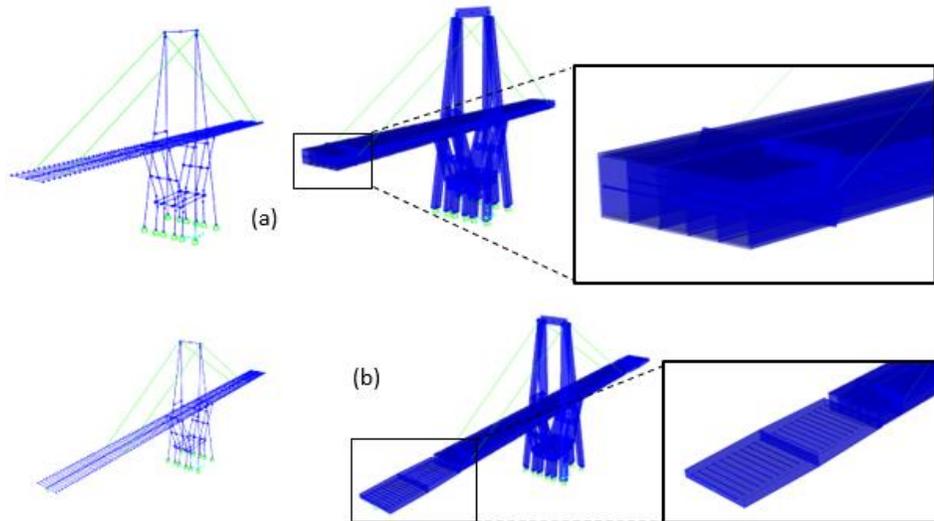
Figure 13. Finite Element model of the Deck-Pylon system (a): wireframe and solid model with detail of the cellular section. Complete model of the collapsed portion of the Polcevera viaduct (b): wireframe and solid model with detail of the Gerber systems.

The tower, the pier and the deck with the Gerber beams are modeled by using 399 *frame* elements, which were employed for representation of the beams, columns, braces, and truss elements in planar and 3D systems. The frame elements consist of linear segments, with a node on each side, accounting for biaxial bending, torsion, axial deformation, and biaxial shear in the beam-column formulation. The deck self-weight and added dead loads are carried by the cable stays and pylon, which were modeled as *frame elements*. Tendons A (352 strands) and B (112 strands) were modeled by *cable* elements, pretensioned with a force necessary to transform the bridge profile into the intended design shape following the release of the self-weight on the main girder. The concrete surrounding the stays were modeled by using a distributed load on the *cable* elements.

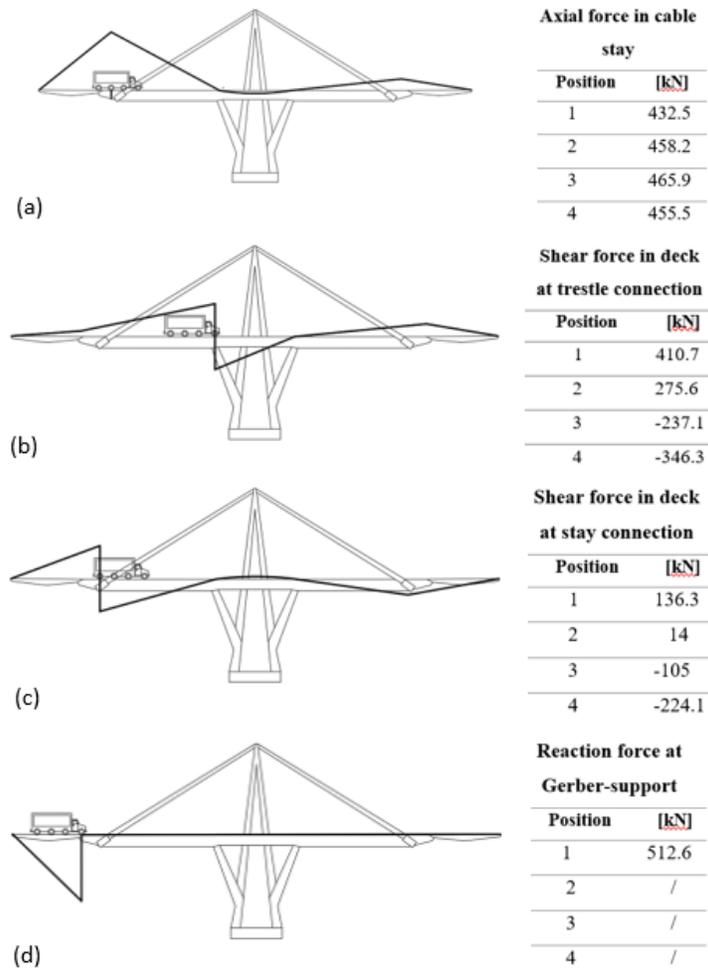
The effect of moving loads on the major components of the bridge were determined by computing the influence lines. The classical approach by movement of a unit concentrated force across the bridge deck was employed for the computation of the influence lines. Axial force in cable stays, shear force in deck at pylon connection, shear force in deck at stay connection, and the reaction force at Gerber-support were identified as critical sections for analysis. Hence, the axles of the equivalent truck were placed on the critical sections identified by the influence lines, and for each case it was possible to figure out the truck position that created the maximum effect. The table style legends in Fig. 14 indicate the position of the truck axles and corresponding forces generated due to the position of the axle. For example, the maximum tension in the stay was obtained by placing the third axle of the truck on the critical section (Fig. 14a).

Figure 14. Influence lines: (a) axial force in cable stays, (b) shear force in deck at trestle connection, (c) shear force in deck at stay connection, (d) reaction force at Gerber-support

Considering the load path and the reaction influence line at the Gerber beam support in Fig. 14d, partial or full positioning of the truck axles on the Gerber beam would not affect the main girder of the bridge, even though it exerts a large load on the Gerber beam support. Therefore, the influence of the Gerber beam loads on the failure of girder-pylon system was discounted in the present study. Failure of the cable stay as indicated by the forces shown in Fig. 14a was considered as the main culprit for the collapse of the girder-pylon system.

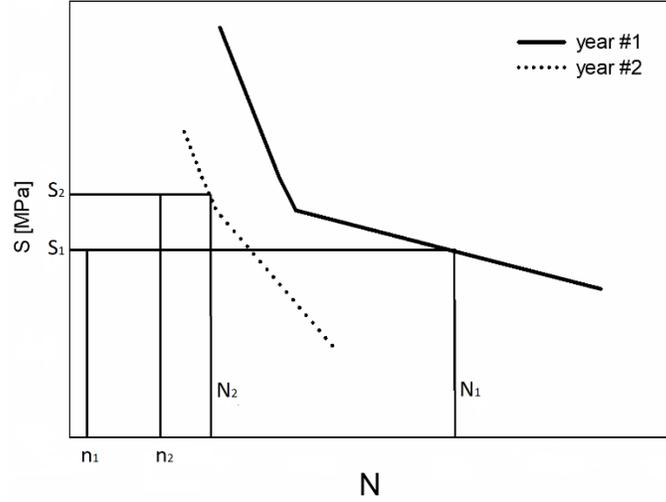
Figure 15. Component cyclic life determined from Palmgren-Miner law

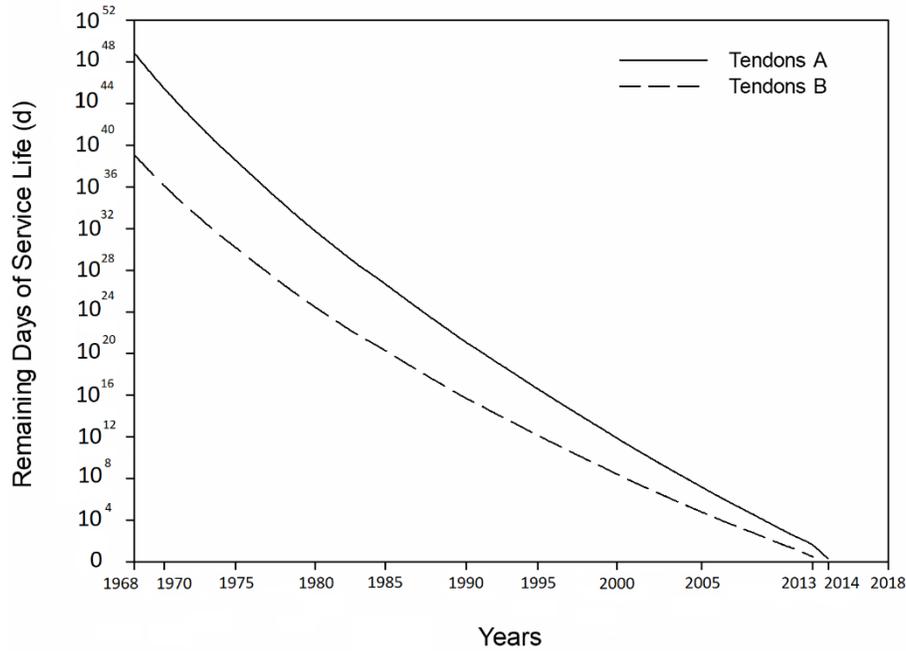
Repeating this procedure for every year of bridge service life since its inception, it was possible to compute the remaining days of service life per year as shown in Fig. 16. It is possible to observe as tendons B reach failure in 2013 and tendons A fail in 2014, leading to total collapse. The cumulative damage model based on Palmgren-Miner-law predicted the collapse date of the Morandi bridge 4 years earlier than the actual collapse date of 2018.

Figure 16. Remaining days of service life Tendons A and Tendons B.

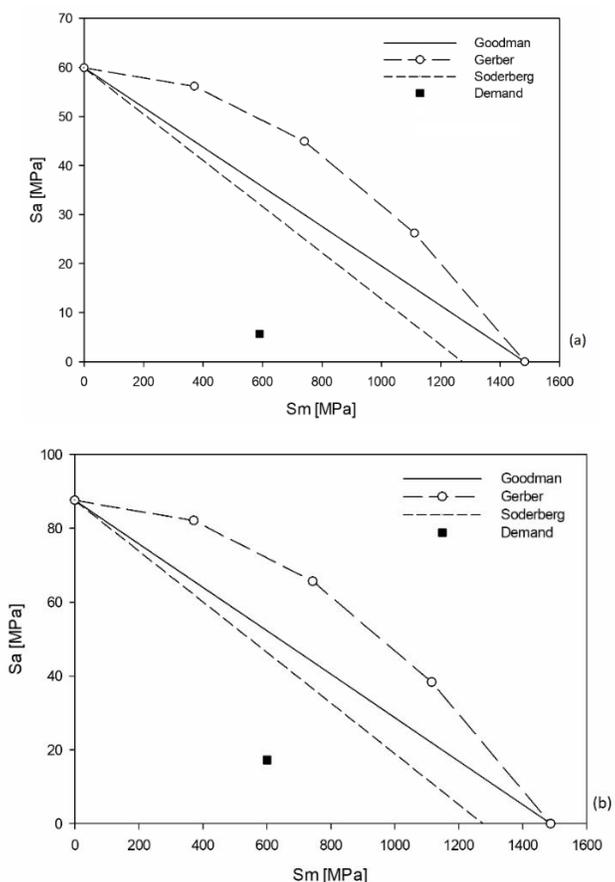
Fig. 17 corresponds to the Goodman, Gerber, and Soderberg diagrams for the years 2013, and 2014, respectively, the years in which tendons B, and A failed based on the cumulative damage computations of Palmgren-Miner-law. Comparison of the results shown in Fig. 17 reveals the contrast between the timing of stay cable failure predicted by the Palmgren-Miner-law, and the Goodman, Gerber, and Soderberg diagrams. According to these diagrams, the bridge would not collapse in 2014, as predicted by the cumulative damage model. However, As shown by the Gerber, and Goodman diagrams in the subsequent years, shown in Fig. 18, the stay cables A and B fail in 2015, and 2016, respectively. The stay cables would have still remained in service by the Soderberg S_a - S_m law, which is less conservative than its counterparts (Gerber, and Goodman).

Figure 17. Goodman, Gerber and Soderberg surface (a) Tendons A in 2014, (b) Tendons B in 2013.

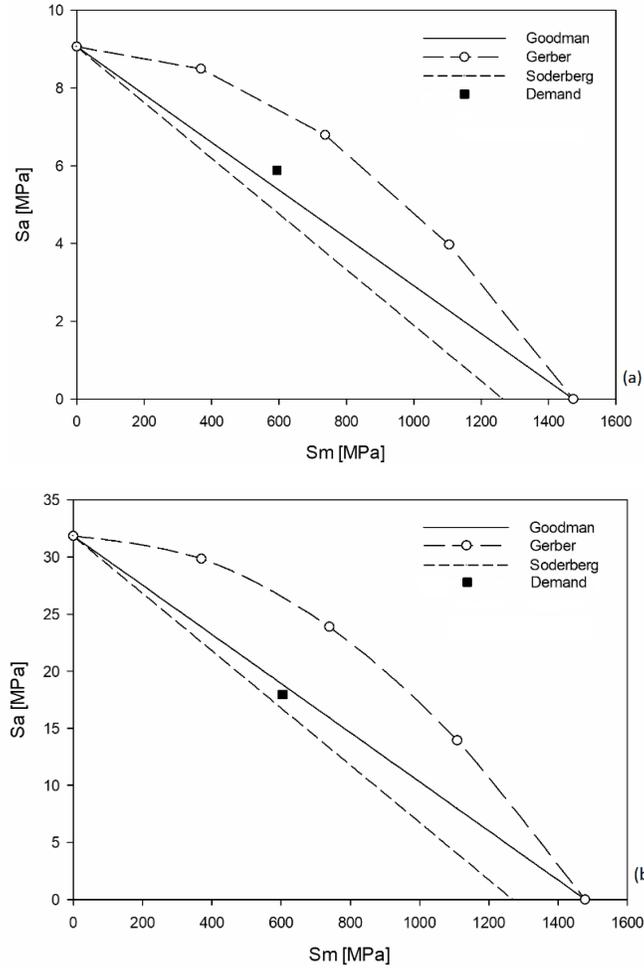
Figure 18. Goodman, Gerber and Soderberg surface (a) Tendons A in 2016, (b) Tendons B in 2015.
