Collapse analysis of the Polcevera viaduct by the applied element method

Collapse analysis of the Polcevera viaduct by the applied element method / Domaneschi, M.; Pellecchia, C.; De Iuliis, E.; Cimellaro, G. P.; Morgese, M.; Khalil, A. A.; Ansari, F.. - In: ENGINEERING STRUCTURES. - ISSN 0141-0296. - STAMPA. - 214:(2020), pp. 1-11. [10.1016/j.engstruct.2020.110659]

Collapse analysis of the Polcevera Viaduct by the Applied Element Method

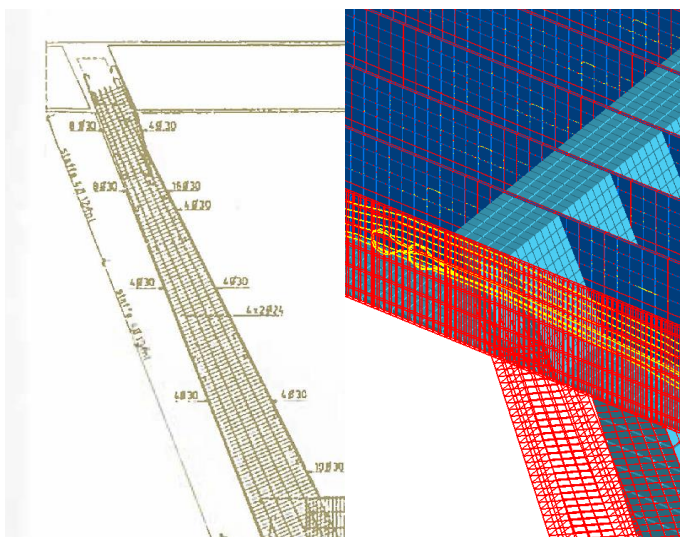
Fig. 4 – RC trestle reinforcements detail. Comparison between as-built drawings (L'Industria Italiana del Cemento, 1967) [2] and the AEM model

In the following, a description of the adopted model with respect to the original design tables of the balanced system is provided. It consists of: (i) a reinforced concrete trestle composed by four H-shaped frames connected by cross girders (Fig. 4); (ii) An A-shaped tower, completely independent

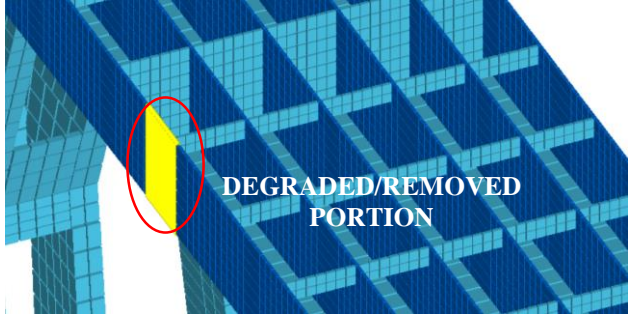
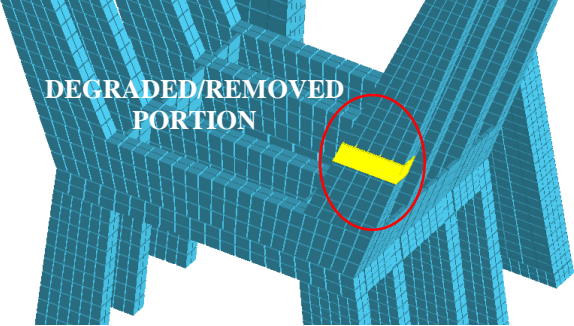
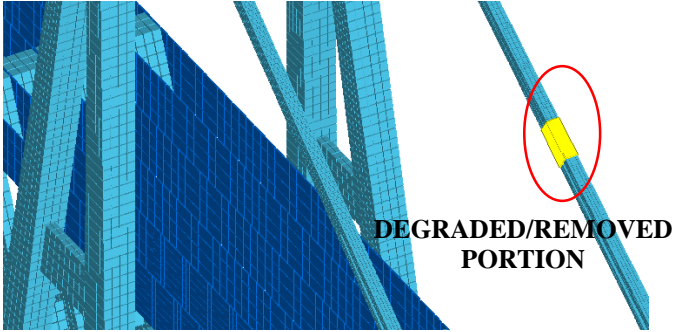
3 RIBS	<i>No-collapse: the structure is able to redistribute the loads between the other elements</i>
		4 RIBS	<i>Collapse</i>
TRESTLE

4 COLUMNS	<i>No-collapse: the structure is able to redistribute the loads between the other elements</i>
		5 COLUMNS	<i>Collapse</i>
STAY

1 STAY	<i>Collapse</i>

Table 2 summarizes the local incremental section removal assumptions employed in this study. For the deck and the trestle, removal corresponded to the transvers section reduction of both steel reinforcements and concrete. For stays, damage corresponded to the transvers section reduction of steel reinforcements only. The proposed damage analysis approach was implemented through incremental reduction of the properties of the spring elements that connect the rigid elements of the model.

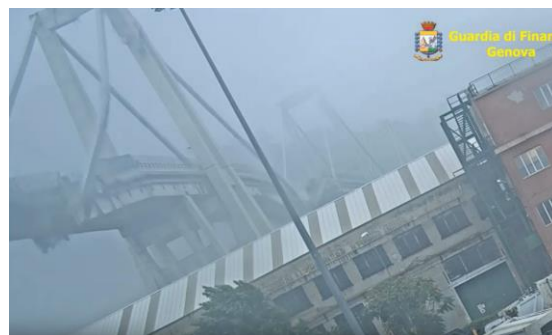
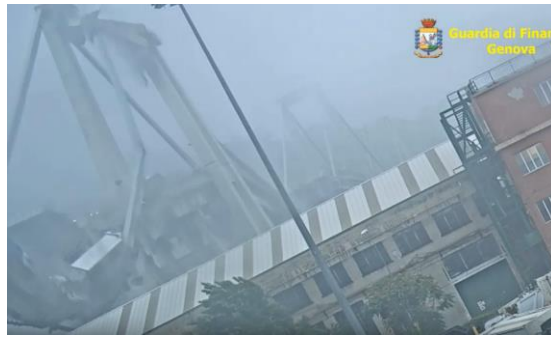
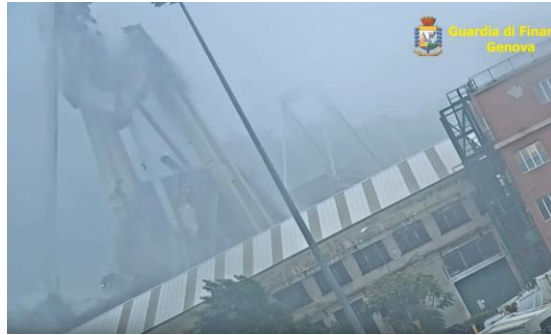
The first step at the 1-second time instant in Fig. shows the collapsing bridge deck that has lost its support at the South-East stay. The bridge starts to collapse, and the end of the deck at the east side undergoes relevant displacements in vertical direction. The southwest stay breaks the tower, and at the same time, the deck breaks in two points.

At the 2-second time instant, the deck twists around the longitudinal axis because of the pull from the standing support at the north side stay. By the 3-second time instant, the deck has already broken into a “V” shape. The south saddle at the top of the A-shaped tower has also collapsed during this time interval. It is also worth noticing that the western portion of the deck sticks vertically into the ground.

However, a discrepancy can be observed in the video footage from the 5 second time instant onwards, when the downstream (South) part of the tower is still standing up until the 9-second time instant, but in the model it collapses much earlier.

Correspondence between the computational model and the footage at the 3-second time instant can be also observed by the rotation of the western section of the deck with respect to the transvers axis of the bridge. In

Fig. 18 – Side by side comparison of the collapse mechanism of the bridge. Analysis results (left), actual collapse images (right) [9].
