Collapse analysis of the Polcevera viaduct by the applied element method

Collapse analysis of the Polcevera Viaduct by the Applied Element Method

Numerical Simulations
Applied Element Method
Collapse
Bridge

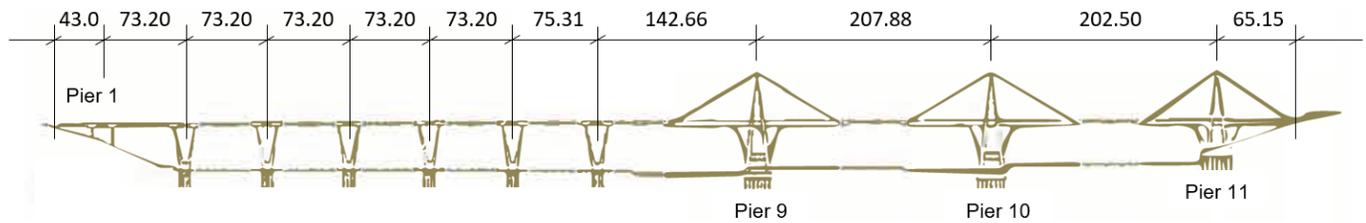
Fig. 1 – The Polcevera Viaduct [m] (L'Industria Italiana del Cemento, 1967) [2]

The viaduct over the Polcevera Valley in Genoa, Italy, was built in the years between 1963 and 1967. It was about 1100 m long and 18 m wide, supported by twelve piers between two bents, Piers #1 and #12 at the extremities (Fig. 1). To overcome the Polcevera River and two sets of Railway lines, three *balanced systems* were built (Fig. 2). They consisted of A-shaped towers connected to the extremities of the main girder by prestressed concrete stays. The A-shaped towers were 90 m tall, and the deck height above the river was around 45 m. The daily traffic count over the 4-lane bridge ranged from 2×10^4 at the inception to 1.5×10^5 during the last years of the service life of the bridge [1-3].

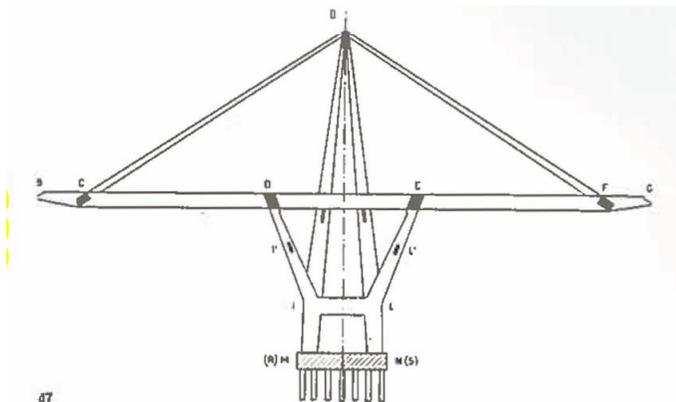
Fig. 2 – The balanced system (L'Industria Italiana del Cemento, 1967) [2]

In the following, a description of the adopted model with respect to the original design tables of the balanced system is provided. It consists of: (i) a reinforced concrete trestle composed by four H-shaped frames connected by cross girders (Fig. 4); (ii) An A-shaped tower, completely independent

The main girder works as a continuous beam on four supports. The trestle provides the first supports on the central portion of the system, while stay-cables passing over the top of the A-shaped tower provide additional supports at both extremities.

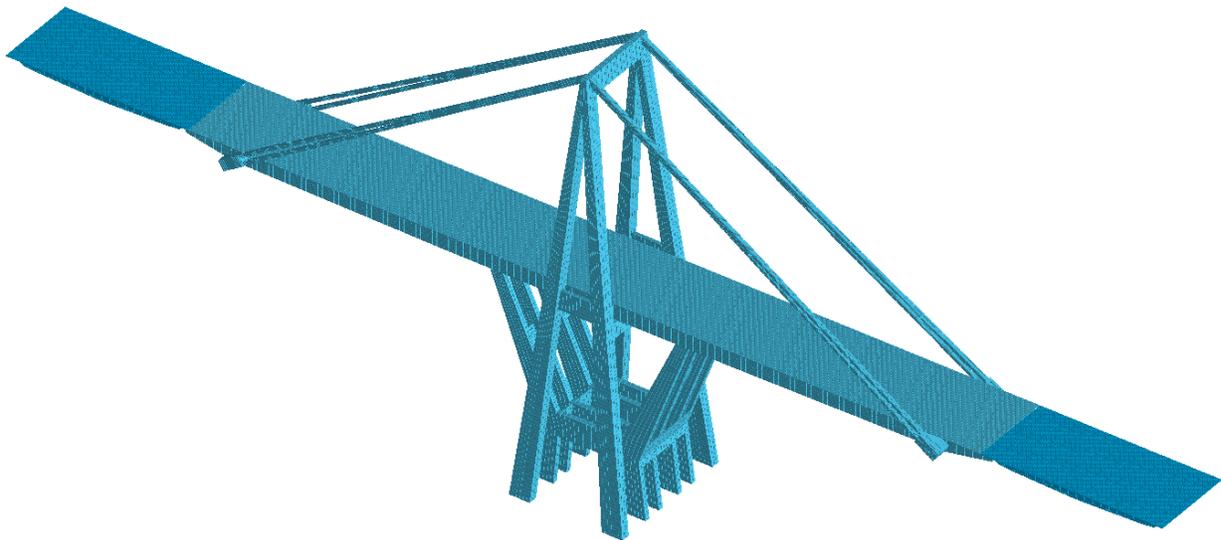
Fig. 3 – Image of the AEM model of the balanced system

In the present research, stays' strands were modelled as nonlinear springs in their actual positions on the cross section of the stays' within the encased concrete, connecting face-by-face adjacent solid concrete elements. The whole model consists of 900000 degrees of freedom. Additional details pertaining to the AEM model employed herein, is provided in the ensuing section of this article.

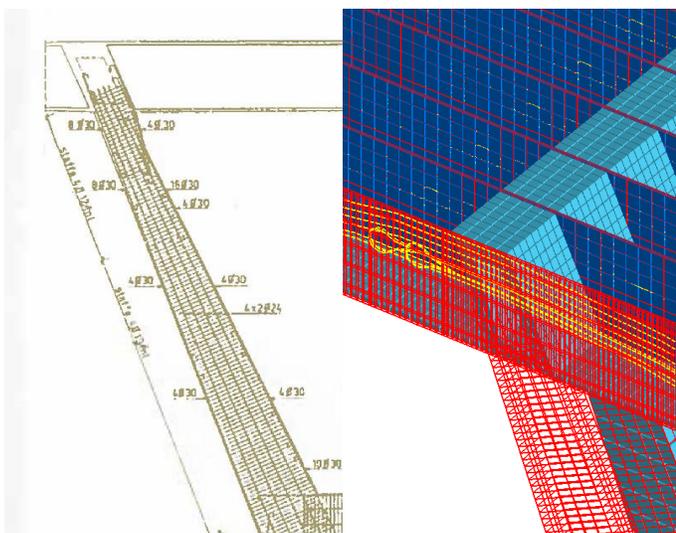
Fig. 4 – RC trestle reinforcements detail. Comparison between as-built drawings (L'Industria Italiana del Cemento, 1967) [2] and the AEM model

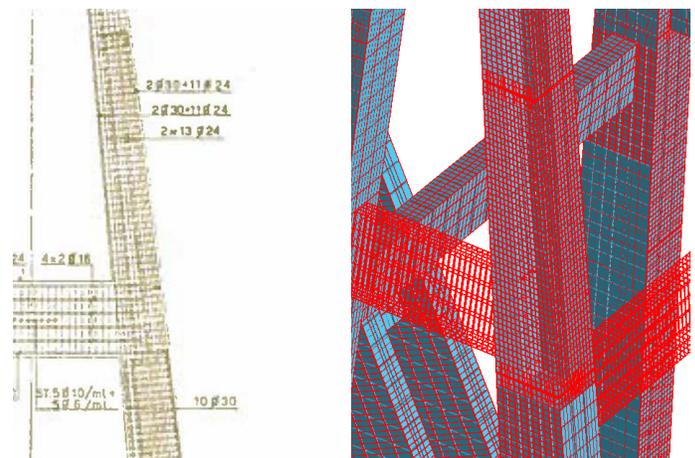
Fig. 5 – RC A-shaped tower reinforcements detail. Comparison between as-built drawings (L'Industria Italiana del Cemento, 1967) [2] and the AEM model

from the trestle, made up of four inclined columns with variable hollow sections (Fig. 5 and Fig. 6); and (iii) A continuous box girder of prestressed concrete with six longitudinal ribs. Prestressed cables were placed in the ribs at the intersection between the transverse beams and the trestle (e.g. Fig. 7). Additional prestressing cables were placed at the bottom of the deck.

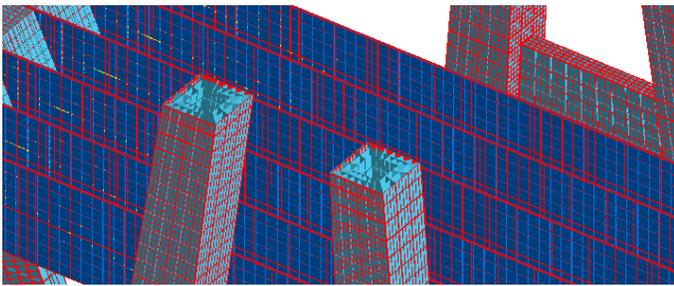
Fig. 6 – Hollow sections of tower's RC columns

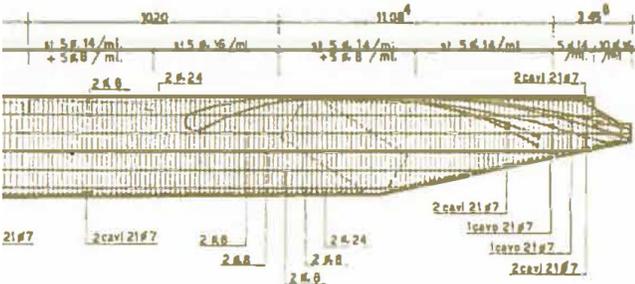
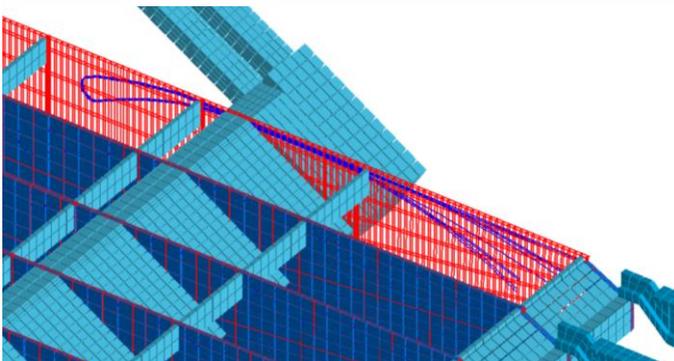
Fig. 7 – Deck's detail: prestressed cables at the connection with the stays. Comparison between as-built drawings (L'Industria Italiana del Cemento, 1967) [2] and the AEM model

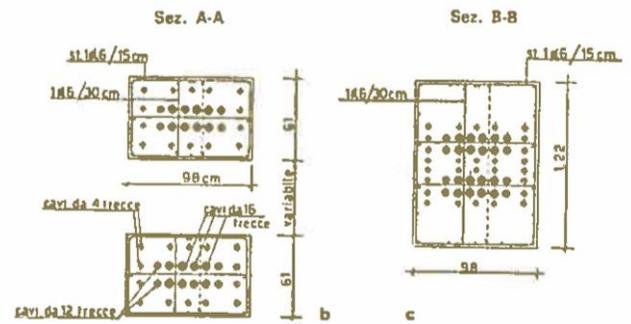
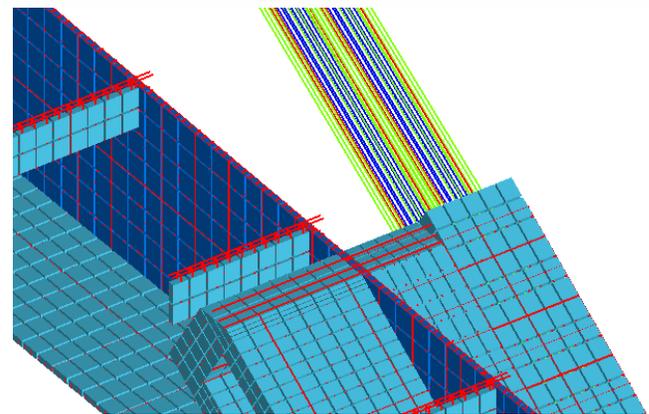
Fig. 8 – Stay-cables: primary (blue and red) and secondary (green) tendons in the AEM model. Comparison with as-built drawings (L'Industria Italiana del Cemento, 1967) [2] and the AEM model

The stays had variable cross-sections: at the deck connection they were split in two 98x61 cm rectangles to spread the effect of the concentrated force.

At the top of the A-shaped tower around the saddle, the cable was composed of a single 98x122 cm rectangle (Fig. 8). The cross-sectional area and the number of strands within each cross section remained the same.

Cables A, the inner cables, were the first to be installed and were composed of 8 units of 12 strands each, and 16 units of 16 strands each (352 total

strands). Cables B were composed of 28 units of 4 strands each (112 total strands). All the strands had half inch (1/2") diameters.

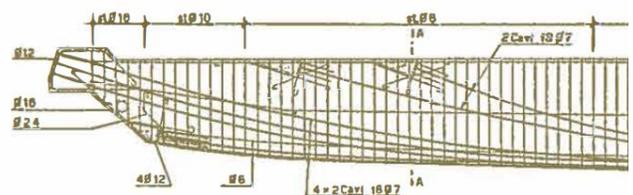
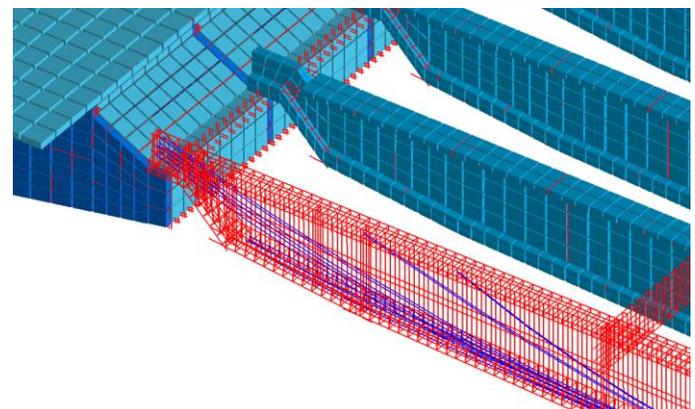
Fig. 9 – Gerber girders. Comparison between as-built drawings (L'Industria Italiana del Cemento, 1967) [2] and the AEM model

Gerber beams were installed to connect the adjacent piers (Fig. 9). A bearing materials was employed at the interface between the box girder and the Gerber beams in order to allow sliding along the horizontal axes [17]. Sensitivity analyses identified the suitable mesh size and analysis time step parameters. In doing so, both parameters were decreased during the analysis until convergence in the deck's displacement and cable's catenary shape were reached. Then, a collapses scenario was assumed to determine a suitable time step for collapse behavior. Analysis with time step higher than 0.001 showed unrealistic collapse behavior. Finally, 0.001 s time step and approximately 150000 solid elements were employed for the analyses. This led to a total computation time of almost 48 hours. Each solid element had 8 nodes, 6 degrees-of-freedom (3 translations and 3 rotations), and five springs per elemental face. A 6 core 3.50 GHz processor with 64Gb RAM and SSD drive was employed in the aforementioned computations.

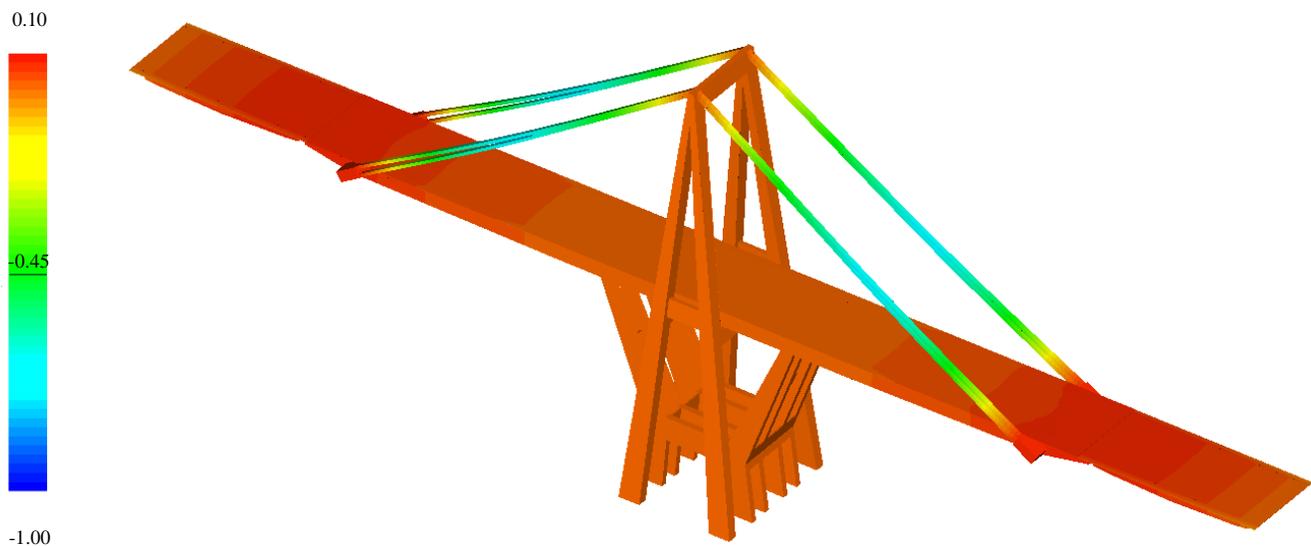
Fig. 10 – AEM model: vertical displacements due to the dead load after post-tensioning of prestressing cables [m]

Time-dependent phenomena, as well as construction defects were not considered in the analysis scheme described herein. The vertical displacements based on the above-mentioned analysis schemes are shown in Fig. 10.

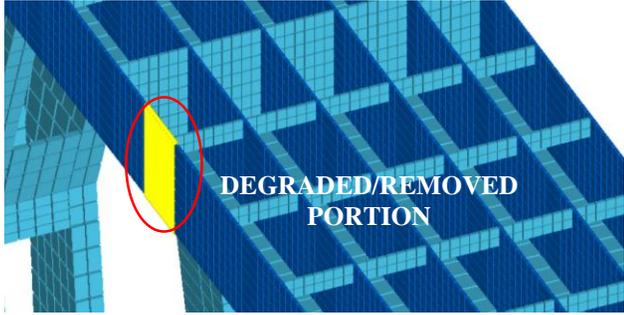
3 RIBS	<i>No-collapse: the structure is able to redistribute the loads between the other elements</i>
		4 RIBS	<i>Collapse</i>
TRESTLE

Table 2 summarizes the local incremental section removal assumptions employed in this study. For the deck and the trestle, removal corresponded to the transvers section reduction of both steel reinforcements and concrete. For stays, damage corresponded to the transvers section reduction of steel reinforcements only. The proposed damage analysis approach was implemented through incremental reduction of the properties of the spring elements that connect the rigid elements of the model.

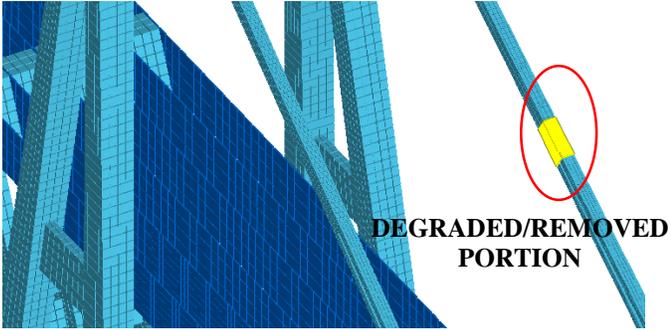
1 STAY	<i>Collapse</i>

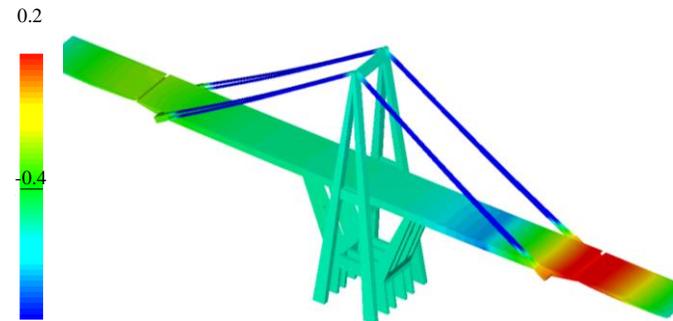
Fig. 11 – Vertical displacement with section removal at three deck’s ribs [m]

The collapse of the balanced system did not occur, even following the reduction in the global capacities of three deck ribs. The bridge was still able to redistribute the loads, even when the deck deflected by about 1 m (Fig. 11). The bridge collapsed when four deck ribs reached their maximum removal limits (Fig. 12).

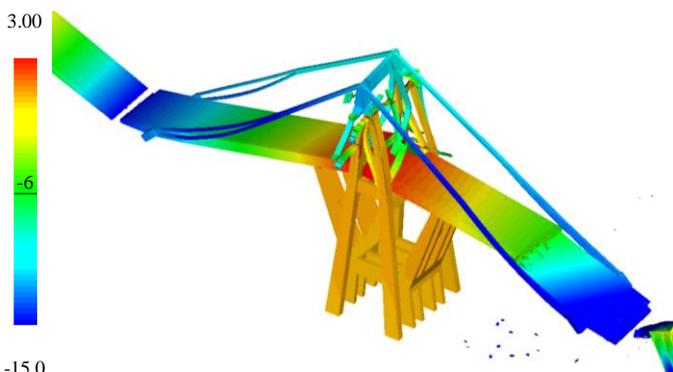
Fig. 12 – Vertical displacement with section removal at four deck’s ribs [m]

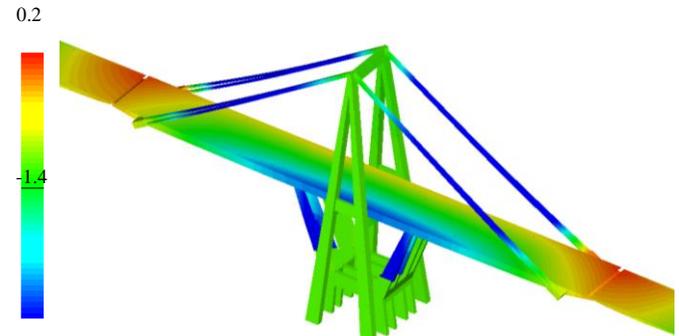
Fig. 13 – Vertical displacement with section removal at four trestle’s sections [m]

Similarly, even full section loss of four out of eight trestle columns did not lead to collapse of the bridge, considering the large vertical displacements as shown in Fig. 13. The collapse occurred when the fifth trestle section was fully removed (Fig. 14).

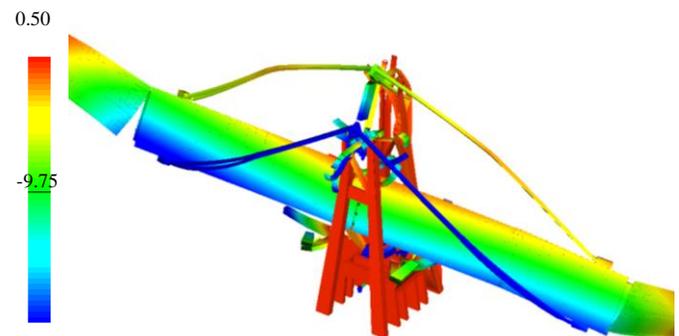
Fig. 14 – Vertical displacement with section removal at five trestle’s sections [m]

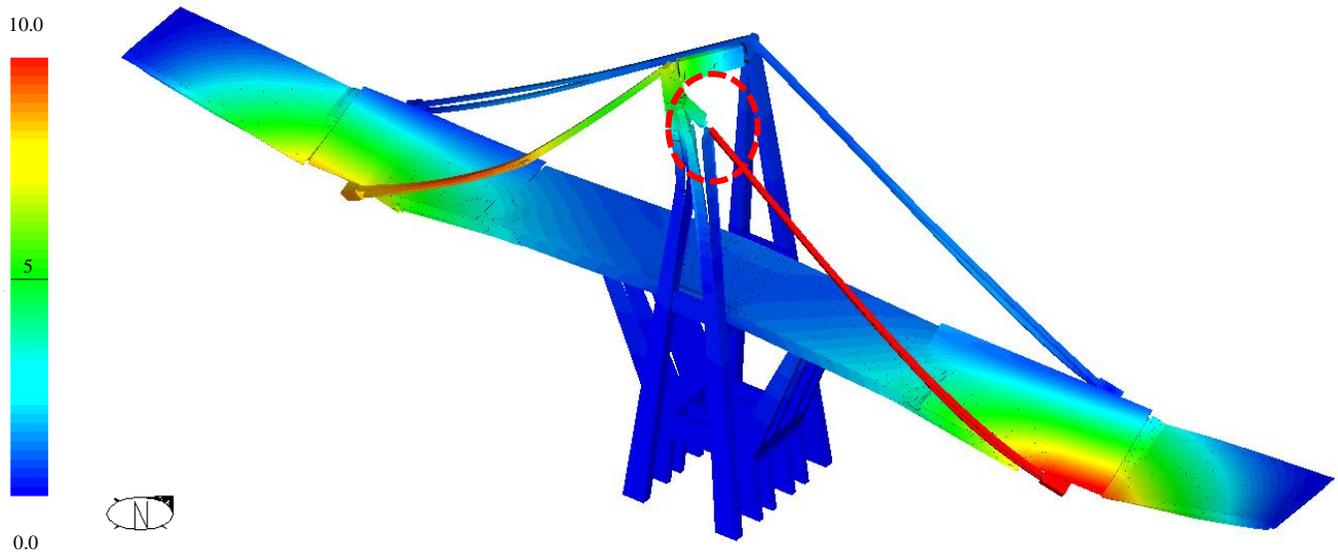
Fig. 17 – Vertical displacement with localized section loss to the South-East stay (red circle, dashed line) [m].

The outcomes of the analyses in the previous section of this article allowed for the identification of the component and the section that may have triggered the progressive collapse. The numerical simulations described in this section are focused on the comparison with the available documents, such as the video footage released by the authorities [9]. In particular, the failure of the South-East stay was reproduced, by gradually degrading the strands at the connection between the stay and the saddle at the top of the A-shaped tower (Fig. 17). In total around 60 % of the cross section of the strands was removed for simulating the strength degradation. The simulations were compared, frame by frame, with the images derived from the collapse footage to allow an improved interpretation of the mechanism (Fig. 18).

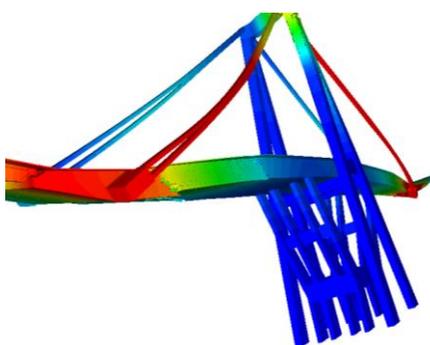
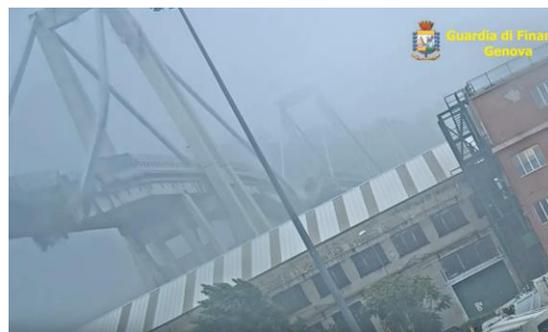
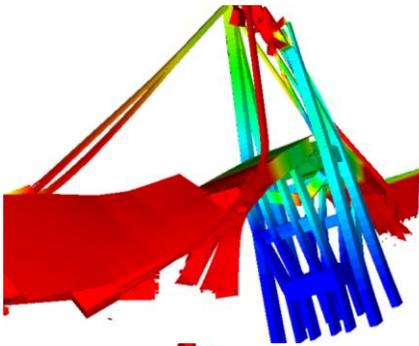
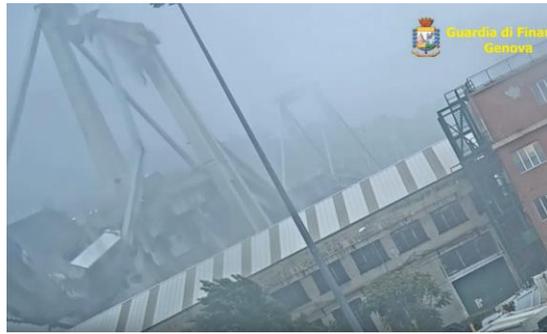
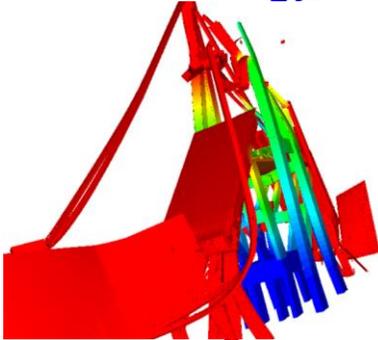
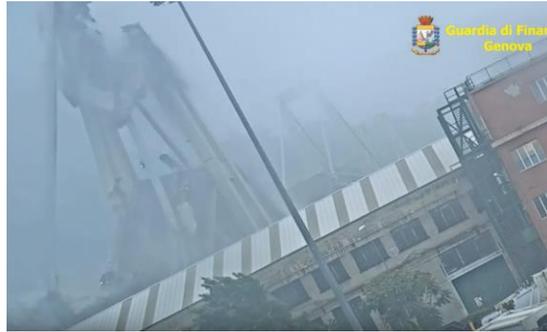
The first step at the 1-second time instant in Fig. shows the collapsing bridge deck that has lost its support at the South-East stay. The bridge starts to collapse, and the end of the deck at the east side undergoes relevant displacements in vertical direction. The southwest stay breaks the tower, and at the same time, the deck breaks in two points.

At the 2-second time instant, the deck twists around the longitudinal axis because of the pull from the standing support at the north side stay. By the 3-second time instant, the deck has already broken into a “V” shape. The south saddle at the top of the A-shaped tower has also collapsed during this time interval. It is also worth noticing that the western portion of the deck sticks vertically into the ground.

However, a discrepancy can be observed in the video footage from the 5 second time instant onwards, when the downstream (South) part of the tower is still standing up until the 9-second time instant, but in the model it collapses much earlier.

Correspondence between the computational model and the footage at the 3-second time instant can be also observed by the rotation of the western section of the deck with respect to the transvers axis of the bridge. In

Fig. 18 – Side by side comparison of the collapse mechanism of the bridge. Analysis results (left), actual collapse images (right) [9].

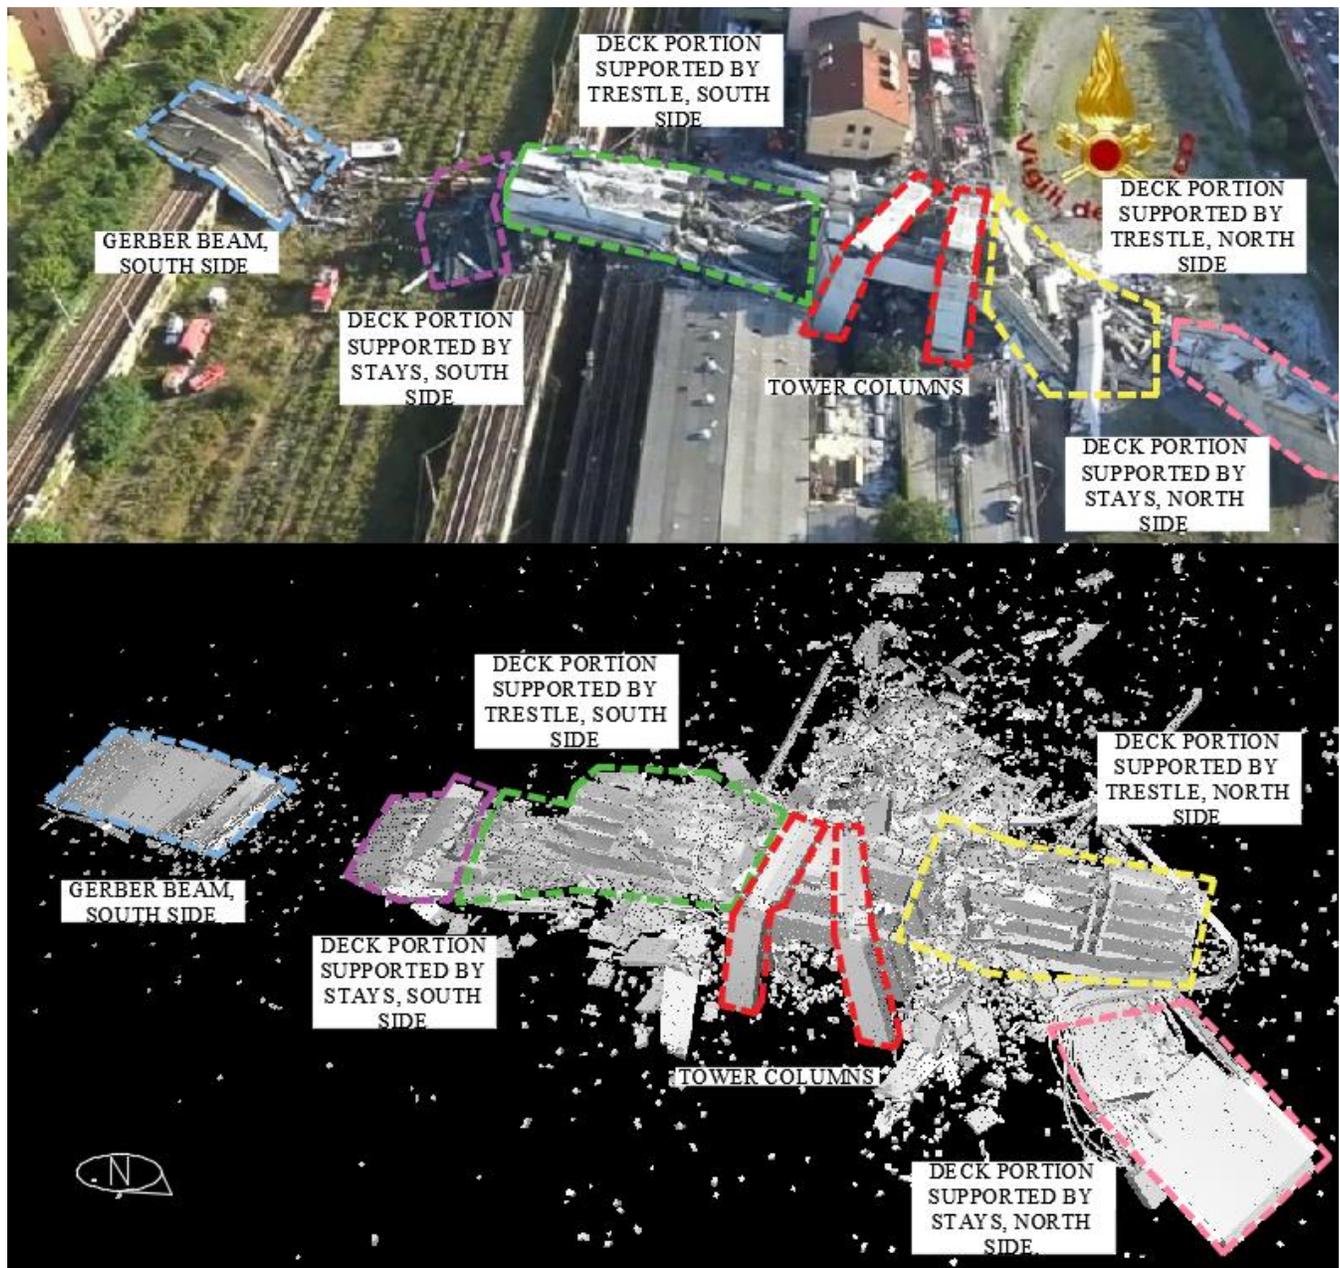
Fig. 19 – Debris heap from a picture of the Italian Fire Brigade Corps (above) [8] and same view of the collapsed shape of the AEM model (below)

Fig. shows the post collapse shape and distribution of the debris by the computational model and the real distribution of the debris. The comparison shows satisfactory agreement between the simulated and actual debris shapes. Slight differences between the two are related to the rigid model adopted for the soil. It does not allow for the penetration of any debris into the ground. Moreover, some site details, such as the railway and the buildings were not modelled and, therefore, they can’t interact with the debris distribution.
