UAV AND CLOSE-RANGE PHOTOGRAMMETRY TO SUPPORT GEO-MECHANICAL ANALYSIS IN SAFETY ROAD MANAGEMENT: THE “VALLONE D’ELVA” ROAD

KEYWORDS: Landslide Hazard, Geomechanics Analysis, Photogrammetry, Multiscale Approach, DTMs, Orthophotos.

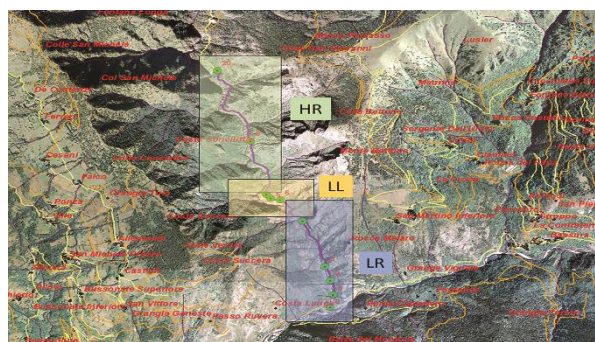
Figure 1. Representative areas of surveys

In order to cover all ten kilometres of the road, the survey was divided in three different areas, namely "High part of Road (HR)", "Low part of Road (LR)" and "Large Landslide (LL)", respectively, as shown in Figure 1.

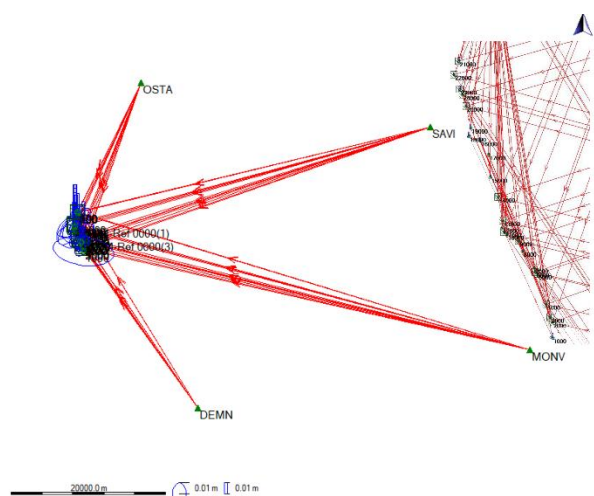
Figure 2. CORS constellations in Elva area.

guarantee a rigorous approach in terms of accuracy and precision ($\sigma_{\max} = 3$ mm in the vertical direction). The vertices coordinates have been measured through a geodetic GNSS receiver in static mode and, in a second phase, the network was calculated using the permanent stations of the national network. The coordinates have been estimated considering a multi-base solution (through the Leica Geo Office® software v.8.4) with stations of CORSs (*Continuous Operating Reference Stations*) (Snay & Soler, 2011) network by Piedmont district like reported in Figure 2.

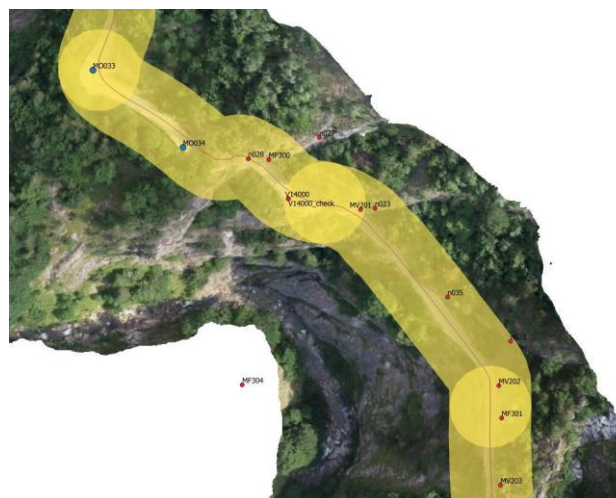
Figure 3. Shape and distribution of measured topographic points.

Subsequently, some photogrammetric control points have been acquired on markers, both on horizontal street surface and on vertical rock façades, with a few centimetres ($\sigma_{\max} = 3$ cm) coordinates precision using a fixed-phase ambiguity for all points. Moreover, 54 vertical markers and 120 natural target points have been measured using TS (*Leica Image Station*) located on the reference vertices. In the end, the data have been processed and adjusted in order to obtain the final coordinates: the RMSE (*Root Mean Square Error*) was less than 1 cm. These horizontal and vertical markers have been classified as GCPs (*Ground Control Points*) and CPs (*Check Points*) used to georeference the subsequent 3D post-processing data. It is important to note that both of them were mainly materialized along the road axis (within an area of 15 meters from its axis on both side), except some natural points, as evidenced by their distributions shown in the Table 1. This testifies the linear extent of our investigation area along the 10 km of Vallone d'Elva road development, like show in Figure 3.

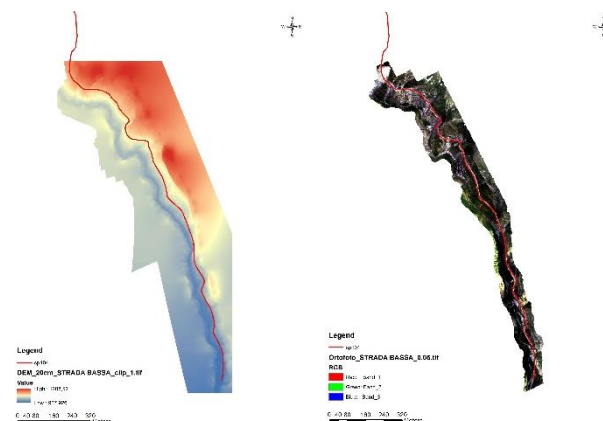
Figure 4. LR example of DSM and orthophoto.

The final steps had regarded the generation of the DSMs and the relative orthophotos in WGS84 – UTM 32N coordinates system starting by the relative meshes (detailed in Table 8), as shown in Figure 4.

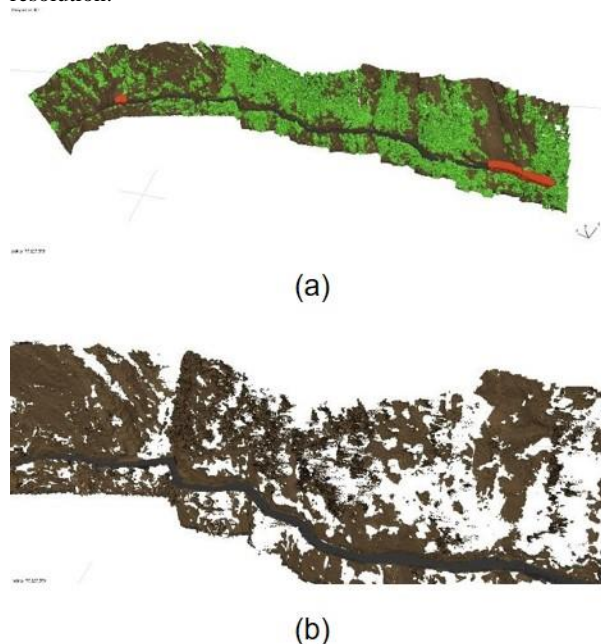
Figure 5. a) Semi-automatic classification in AMS; b) Critical issues found cause of complex and steep geography. Red, green, brown and black points represent building, vegetation, ground and road respectively.

Indeed, the use of such high-detail clouds in complex environments with slopes and irregularities, makes it necessary to experiment “ad-hoc” workflow to detected ground points and other features, such as trees and buildings (Spanò et al., 2018). In this case, to obtain a DTM (*Digital Terrain Model*) a semi-automatic classification approaches with AMS has been tested. The results of classification were quite satisfactory: 75% of the vegetation points were correctly detected, while were wrongly classified ground about 11 %, and the rest was unclassified; besides, 85% of rock wall were correctly detected as ground, while 9% were wrongly classified like buildings in “quasi” vertical parts. In the following Figure 5 an example and the critical issues found, are reported.

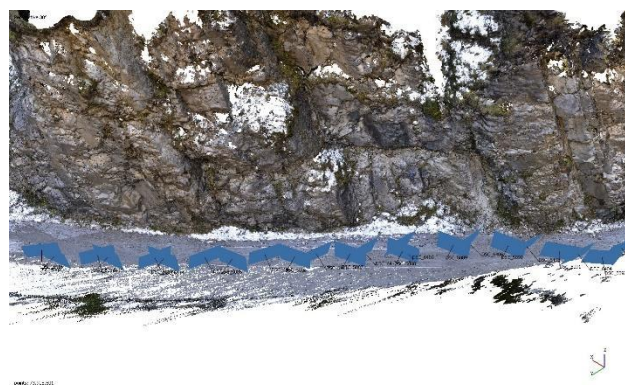
Figure 6. Terrestrial photogrammetric images pattern.

The terrestrial photogrammetric process has been made by SfM approach within the multiscale process: in fact, the rockwall flanks have been reconstructed in a large scale (1:200) along the 10 km of Vallone d'Elva road. The acquired images have been took using a particular pattern (Figure 6): parallel to the rockwall

flank and with 45° on the left and on the right along the road with a possible maximum distance from the flanks to optimize the resolution.

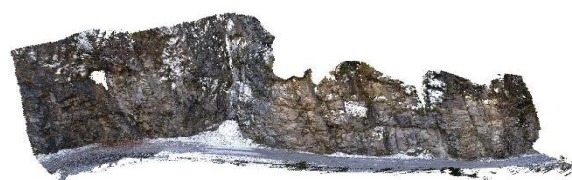
Figure 7. Example of "vertical" terrestrial dense point cloud.

An *ad hoc* procedure allowed us to compute 16 high resolution dense point clouds (setting-up "high" details level during the alignment and building phases), in order to perform many 3D surfaces (named meshes), also with "high" details level, as show an example in Figure 7 and Figure 8 respectively.

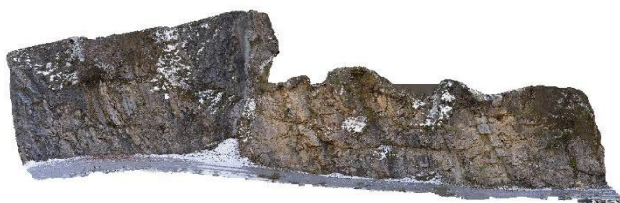
Figure 9. Example of "vertical orthophotos".

Finally, the vertical orthophotos have been created starting from the respective meshes, with a millimetric resolution (mean about 4 mm each), how is reported in Figure 9.

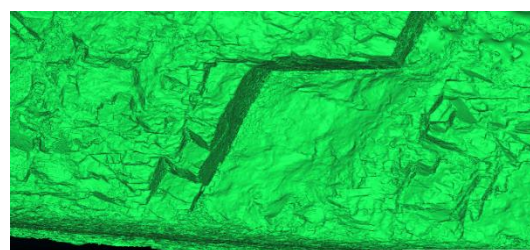
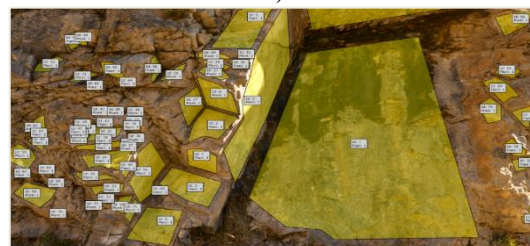
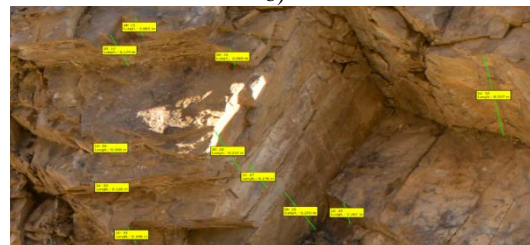
Figure 11. Geometrical features of discontinuities collected by Rockscan software: a) Model; b) discontinuity planes; c) spacing.

The DTMs, the oriented digital images and the camera calibrations parameters have been used in Rockscan software (Ferrero et al., 2019) specifically developed for measuring plane orientation and spacing (Figure 11). In this way more than 2560 planes orientation data and 1000 spacing measure have been collected allowing the authors to carry out kinematic analysis to evaluate how the stability degree of the rock mass change along the road. For each slope a stereographic projection of the collected plane has allowed the identification of the set of discontinuities and the orientation of their main plane; the spacing measure has allowed the definition of the shape and volume of the detachable blocks and their kinematic condition (any movement, rock fall, planar slide or wedge slide). In the attached file (Figure 12), the results obtained for one of the 20 rock slope analysed is reported.
