# UAV AND CLOSE-RANGE PHOTOGRAMMETRY TO SUPPORT GEO-MECHANICAL ANALYSIS IN SAFETY ROAD MANAGEMENT: THE “VALLONE D’ELVA” ROAD

E. Pontoglio <sup>1,1\*</sup>, E. Colucci <sup>1</sup>, A. Lingua <sup>1</sup>, P. Maschio <sup>1</sup>, M.R. Migliazza <sup>2</sup>, C. Scavia <sup>2</sup>,

<sup>1</sup> Department of Environmental, Land and Infrastructure Engineering (DIATI) - Politecnico di Torino C.so Duca degli Abruzzi 24, 10129, Torino (Italy) (emanuele.pontoglio, elisabetta.colucci, andrea.lingua, paolo.maschio)@polito.it

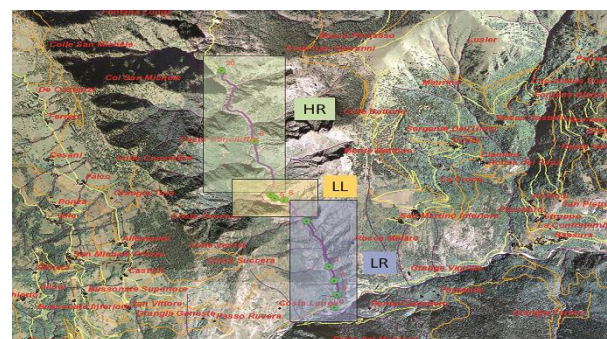
Figure 1. Representative areas of surveys

In order to cover all ten kilometres of the road, the survey was divided in three different areas, namely "High part of Road (HR)", "Low part of Road (LR)" and "Large Landslide (LL)", respectively, as shown in Figure 1.

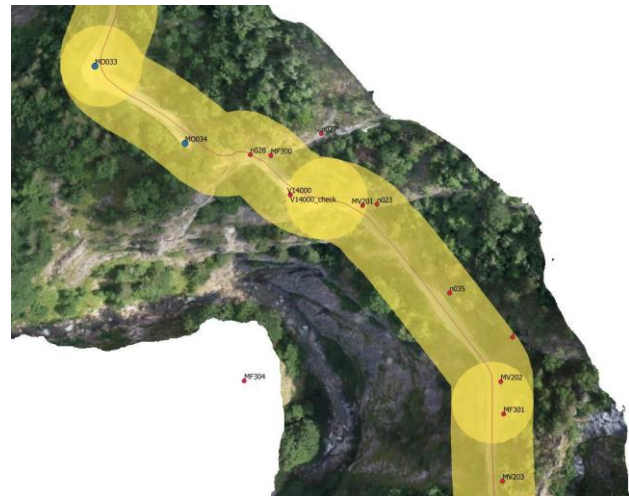
Figure 3. Shape and distribution of measured topographic points.

Subsequently, some photogrammetric control points have been acquired on markers, both on horizontal street surface and on vertical rock façades, with a few centimetres ( $\sigma_{\max} = 3$  cm) coordinates precision using a fixed-phase ambiguity for all points. Moreover, 54 vertical markers and 120 natural target points have been measured using TS (*Leica Image Station*) located on the reference vertices. In the end, the data have been processed and adjusted in order to obtain the final coordinates: the RMSE (*Root Mean Square Error*) was less than 1 cm. These horizontal and vertical markers have been classified as GCPs (*Ground Control Points*) and CPs (*Check Points*) used to georeference the subsequent 3D post-processing data. It is important to note that both of them were mainly materialized along the road axis (within an area of 15 meters from its axis on both side), except some natural points, as evidenced by their distributions shown in the Table 1. This testifies the linear extent of our investigation area along the 10 km of Vallone d’Elva road development, like show in Figure 3.

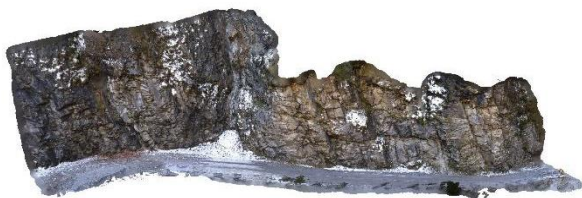
Figure 8. Example of "vertical" terrestrial mesh.

An *ad hoc* procedure allowed us to compute 16 high resolution dense point clouds (setting-up "high" details level during the alignment and building phases), in order to perform many 3D surfaces (named meshes), also with "high" details level, as show an example in Figure 7 and Figure 8 respectively.

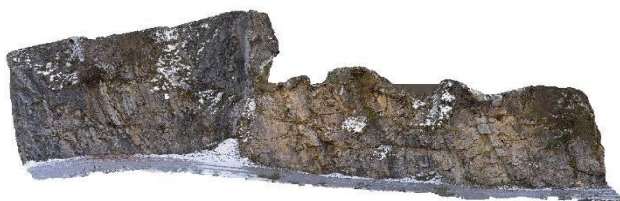
Figure 9. Example of "vertical orthophotos".

Finally, the vertical orthophotos have been created starting from the respective meshes, with a millimetric resolution (mean about 4 mm each), how is reported in Figure 9.

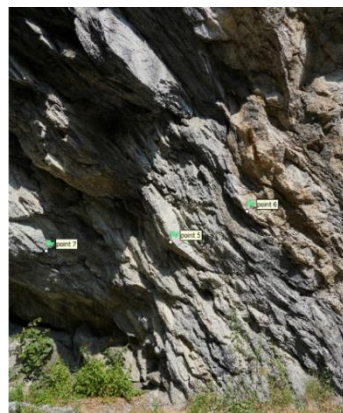
Figure 10. Examples of natural markers used for georeferencing the specific DTMs.

With this aim the DTMs have built rock surfaces with limited dimensions: about 30-40 m length and 15 m high; the most of the surveyed rock masses did not include any GCPs or CPs reported in paragraph 2.1; for this reason, each DTM have been georeferenced by defining several natural points (markers in Figure 10) on the digital images and by getting their coordinates directly from the general DSM of the entire road.

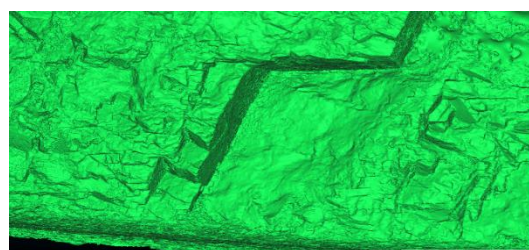
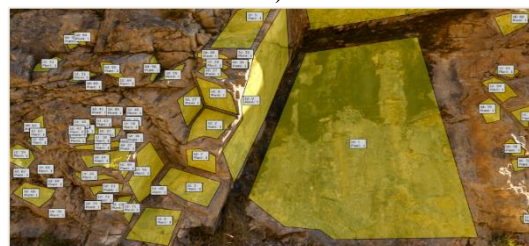
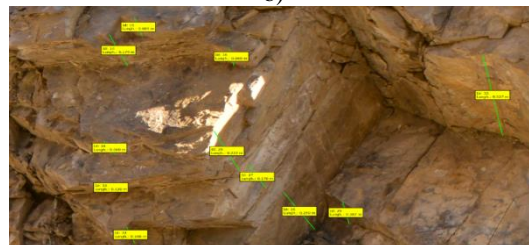
Figure 11. Geometrical features of discontinuities collected by Rockscan software: a) Model; b) discontinuity planes; c) spacing.

The DTMs, the oriented digital images and the camera calibrations parameters have been used in Rockscan software (Ferrero et al., 2019) specifically developed for measuring plane orientation and spacing (Figure 11). In this way more than 2560 planes orientation data and 1000 spacing measure have been collected allowing the authors to carry out kinematic analysis to evaluate how the stability degree of the rock mass change along the road. For each slope a stereographic projection of the collected plane has allowed the identification of the set of discontinuities and the orientation of their main plane; the spacing measure has allowed the definition of the shape and volume of the detachable blocks and their kinematic condition (any movement, rock fall, planar slide or wedge slide). In the attached file (Figure 12), the results obtained for one of the 20 rock slope analysed is reported.
