# UAV AND CLOSE-RANGE PHOTOGRAMMETRY TO SUPPORT GEO-MECHANICAL ANALYSIS IN SAFETY ROAD MANAGEMENT: THE “VALLONE D’ELVA” ROAD

E. Pontoglio <sup>1,1\*</sup>, E. Colucci <sup>1</sup>, A. Lingua <sup>1</sup>, P. Maschio <sup>1</sup>, M.R. Migliazza <sup>2</sup>, C. Scavia <sup>2</sup>,

**KEYWORDS:** Landslide Hazard, Geomechanics Analysis, Photogrammetry, Multiscale Approach, DTMs, Orthophotos.

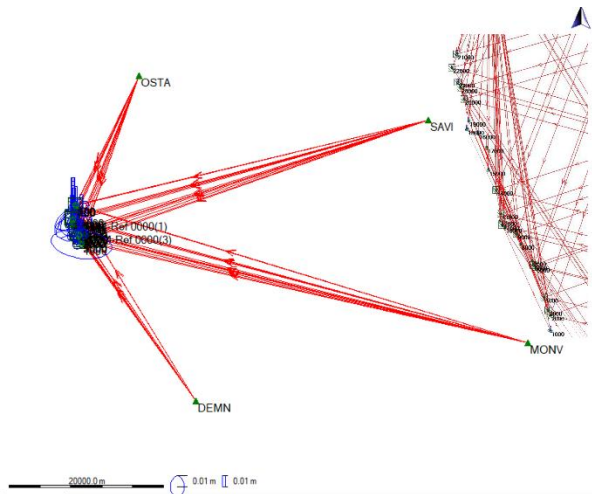
Figure 2. CORS constellations in Elva area.

guarantee a rigorous approach in terms of accuracy and precision ( $\sigma_{max}= 3 \text{ mm}$  in the vertical direction). The vertices coordinates have been measured through a geodetic GNSS receiver in static mode and, in a second phase, the network was calculated using the permanent stations of the national network. The coordinates have been estimated considering a multi-base solution (through the Leica Geo Office® software v.8.4) with stations of CORSs (*Continuous Operating Reference Stations*) (Snay & Soler, 2011) network by Piedmont district like reported in Figure 2.

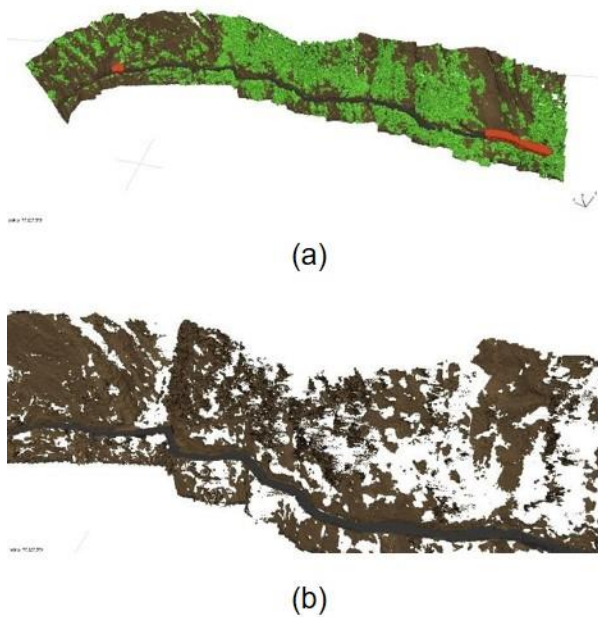
Figure 5. a) Semi-automatic classification in AMS; b) Critical issues found cause of complex and steep geography. Red, green, brown and black points represent building, vegetation, ground and road respectively.

Indeed, the use of such high-detail clouds in complex environments with slopes and irregularities, makes it necessary to experiment “ad-hoc” workflow to detected ground points and other features, such as trees and buildings (Spanò et al., 2018). In this case, to obtain a DTM (*Digital Terrain Model*) a semi-automatic classification approaches with AMS has been tested. The results of classification were quite satisfactory: 75% of the vegetation points were correctly detected, while were wrongly classified ground about 11 %, and the rest was unclassified; besides, 85% of rock wall were correctly detected as ground, while 9% were wrongly classified like buildings in “quasi” vertical parts. In the following Figure 5 an example and the critical issues found, are reported.

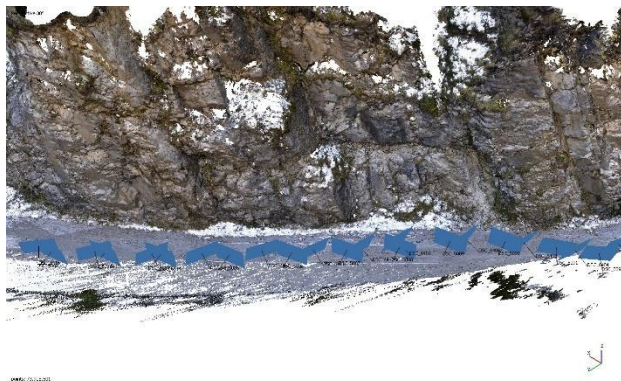
Figure 6. Terrestrial photogrammetric images pattern.

The terrestrial photogrammetric process has been made by SfM approach within the multiscale process: in fact, the rockwall flanks have been reconstructed in a large scale (1:200) along the 10 km of Vallone d’Elva road. The acquired images have been took using a particular pattern (Figure 6): parallel to the rockwall

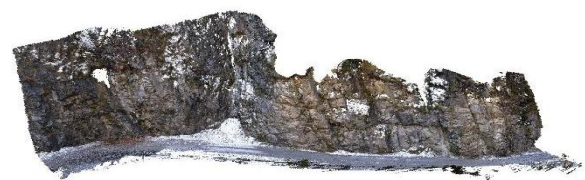
Figure 7. Example of "vertical" terrestrial dense point cloud.

An *ad hoc* procedure allowed us to compute 16 high resolution dense point clouds (setting-up "high" details level during the alignment and building phases), in order to perform many 3D surfaces (named meshes), also with "high" details level, as show an example in Figure 7 and Figure 8 respectively.

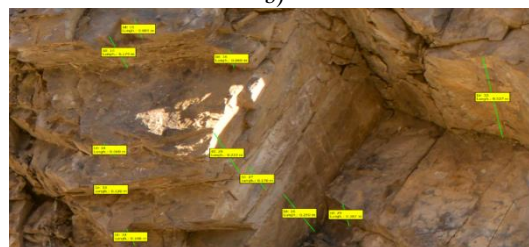
Figure 11. Geometrical features of discontinuities collected by Rockscan software: a) Model; b) discontinuity planes; c) spacing.

The DTMs, the oriented digital images and the camera calibrations parameters have been used in Rockscan software (Ferrero et al., 2019) specifically developed for measuring plane orientation and spacing (Figure 11). In this way more than 2560 planes orientation data and 1000 spacing measure have been collected allowing the authors to carry out kinematic analysis to evaluate how the stability degree of the rock mass change along the road. For each slope a stereographic projection of the collected plane has allowed the identification of the set of discontinuities and the orientation of their main plane; the spacing measure has allowed the definition of the shape and volume of the detachable blocks and their kinematic condition (any movement, rock fall, planar slide or wedge slide). In the attached file (Figure 12), the results obtained for one of the 20 rock slope analysed is reported.
