# UAV AND CLOSE-RANGE PHOTOGRAMMETRY TO SUPPORT GEO-MECHANICAL ANALYSIS IN SAFETY ROAD MANAGEMENT: THE “VALLONE D’ELVA” ROAD

## Commission II, WG II/10

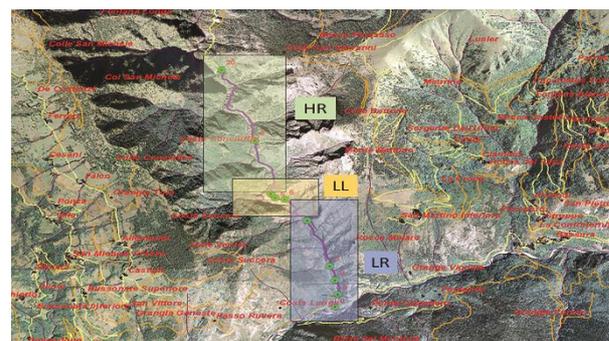
Figure 1. Representative areas of surveys

In order to cover all ten kilometres of the road, the survey was divided in three different areas, namely "High part of Road (HR)", "Low part of Road (LR)" and "Large Landslide (LL)", respectively, as shown in Figure 1.

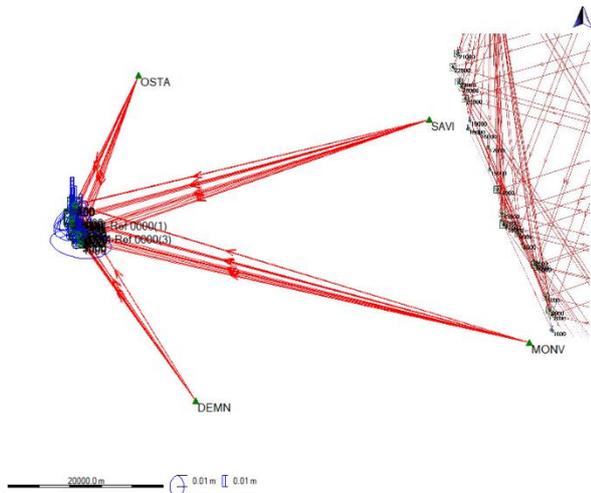
Figure 2. CORS constellations in Elva area.

guarantee a rigorous approach in terms of accuracy and precision ( $\sigma_{\max} = 3$  mm in the vertical direction). The vertices coordinates have been measured through a geodetic GNSS receiver in static mode and, in a second phase, the network was calculated using the permanent stations of the national network. The coordinates have been estimated considering a multi-base solution (through the Leica Geo Office® software v.8.4) with stations of CORSs (*Continuous Operating Reference Stations*) (Snay & Soler, 2011) network by Piedmont district like reported in Figure 2.

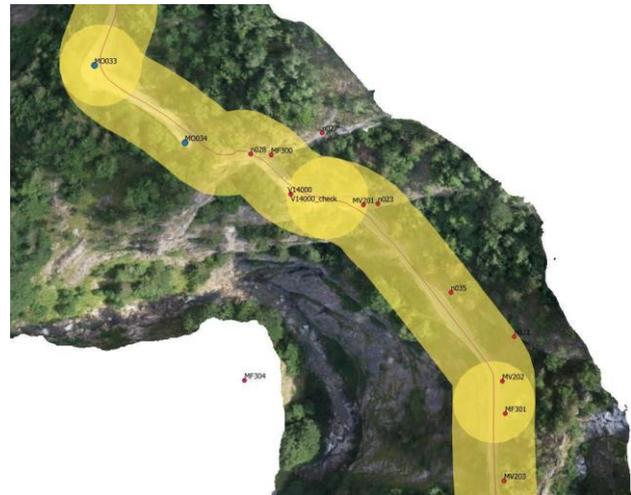
Figure 3. Shape and distribution of measured topographic points.

Subsequently, some photogrammetric control points have been acquired on markers, both on horizontal street surface and on vertical rock façades, with a few centimetres ( $\sigma_{\max} = 3$  cm) coordinates precision using a fixed-phase ambiguity for all points. Moreover, 54 vertical markers and 120 natural target points have been measured using TS (*Leica Image Station*) located on the reference vertices. In the end, the data have been processed and adjusted in order to obtain the final coordinates: the RMSE (*Root Mean Square Error*) was less than 1 cm. These horizontal and vertical markers have been classified as GCPs (*Ground Control Points*) and CPs (*Check Points*) used to georeference the subsequent 3D post-processing data. It is important to note that both of them were mainly materialized along the road axis (within an area of 15 meters from its axis on both side), except some natural points, as evidenced by their distributions shown in the Table 1. This testifies the linear extent of our investigation area along the 10 km of Vallone d’Elva road development, like show in Figure 3.

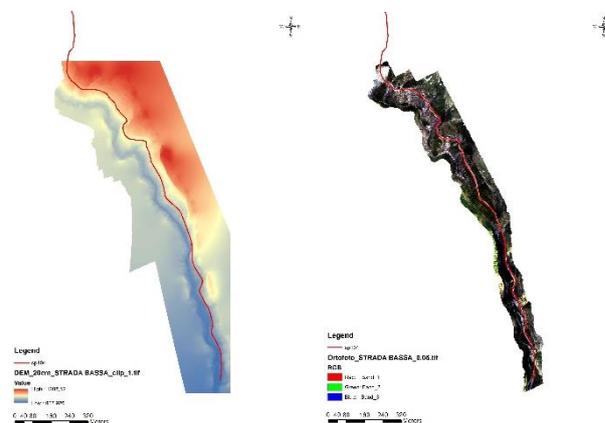
Figure 4. LR example of DSM and orthophoto.

The final steps had regarded the generation of the DSMs and the relative orthophotos in WGS84 – UTM 32N coordinates system starting by the relative meshes (detailed in Table 8), as shown in Figure 4.

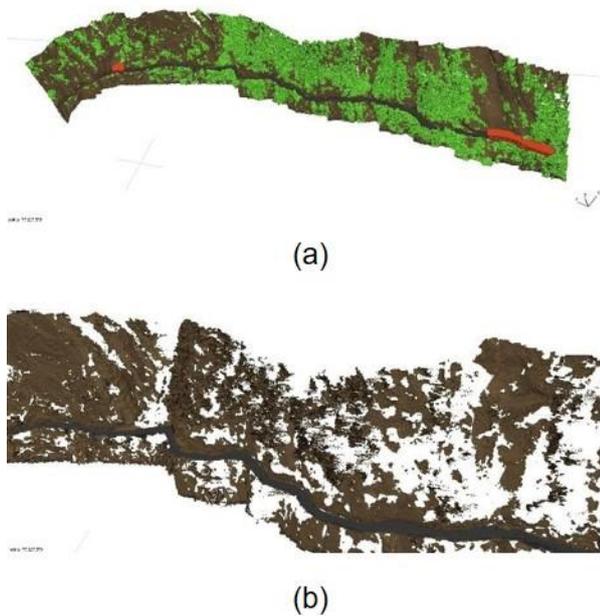
Indeed, the use of such high-detail clouds in complex environments with slopes and irregularities, makes it necessary to experiment “ad-hoc” workflow to detected ground points and other features, such as trees and buildings (Spanò et al., 2018). In this case, to obtain a DTM (*Digital Terrain Model*) a semi-automatic classification approaches with AMS has been tested. The results of classification were quite satisfactory: 75% of the vegetation points were correctly detected, while were wrongly classified ground about 11 %, and the rest was unclassified; besides, 85% of rock wall were correctly detected as ground, while 9% were wrongly classified like buildings in “quasi” vertical parts. In the following Figure 5 an example and the critical issues found, are reported.

Figure 5. a) Semi-automatic classification in AMS; b) Critical issues found cause of complex and steep geography. Red, green, brown and black points represent building, vegetation, ground and road respectively.

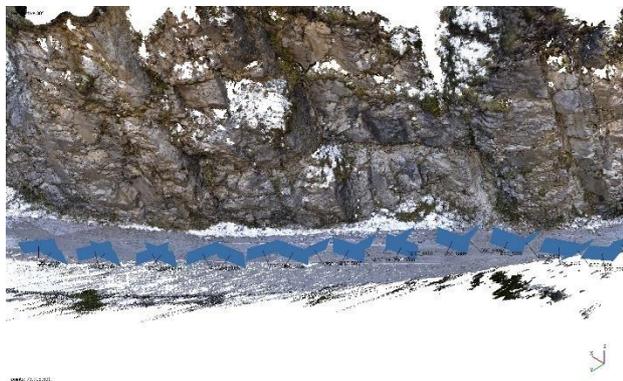
Figure 6. Terrestrial photogrammetric images pattern.

The terrestrial photogrammetric process has been made by SfM approach within the multiscale process: in fact, the rockwall flanks have been reconstructed in a large scale (1:200) along the 10 km of Vallone d’Elva road. The acquired images have been took using a particular pattern (Figure 6): parallel to the rockwall

flank and with 45° on the left and on the right along the road with a possible maximum distance from the flanks to optimize the resolution.

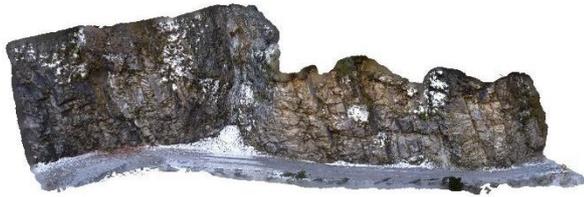
Figure 8. Example of "vertical" terrestrial mesh.

An *ad hoc* procedure allowed us to compute 16 high resolution dense point clouds (setting-up "high" details level during the alignment and building phases), in order to perform many 3D surfaces (named meshes), also with "high" details level, as show an example in Figure 7 and Figure 8 respectively.

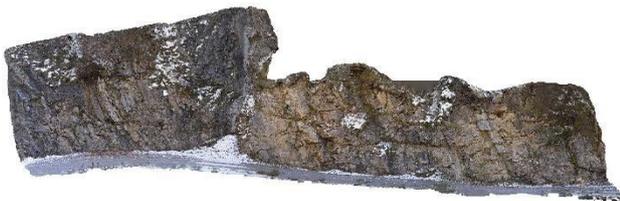
Figure 9. Example of "vertical orthophotos".

Finally, the vertical orthophotos have been created starting from the respective meshes, with a millimetric resolution (mean about 4 mm each), how is reported in Figure 9.

This innovative product has been used to employ the traditional UAV and terrestrial photogrammetric processes for a better understanding and definition of the landscape environment about this specific case study. Moreover, associated with the geomechanical surveys and the related data processing (see next paragraph), they allowed a more detailed investigation about many geomechanical features (such as sliding mechanisms, rock-such as sliding mechanisms, rock-wall fracture analysis, etc.) of the investigated rock masses.

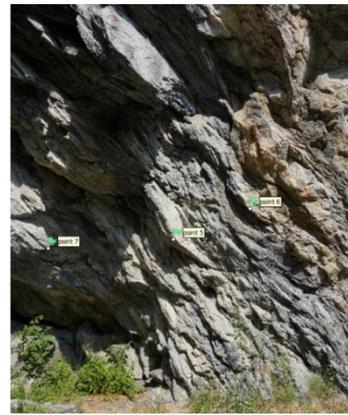
With this aim the DTMs have built rock surfaces with limited dimensions: about 30-40 m length and 15 m high; the most of the surveyed rock masses did not include any GCPs or CPs reported in paragraph 2.1; for this reason, each DTM have been georeferenced by defining several natural points (markers in Figure 10) on the digital images and by getting their coordinates directly from the general DSM of the entire road.

Figure 10. Examples of natural markers used for georeferencing the specific DTMs.

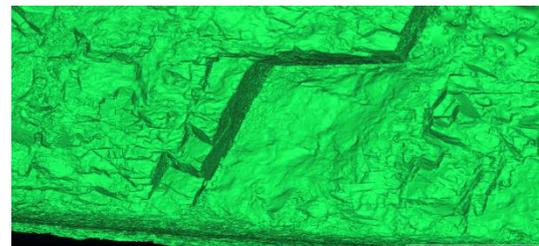
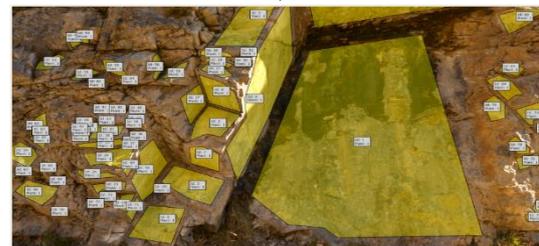
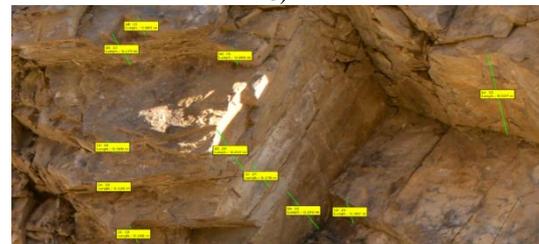
Figure 11. Geometrical features of discontinuities collected by Rockscan software: a) Model; b) discontinuity planes; c) spacing.

The DTMs, the oriented digital images and the camera calibrations parameters have been used in Rockscan software (Ferrero et al., 2019) specifically developed for measuring plane orientation and spacing (Figure 11). In this way more than 2560 planes orientation data and 1000 spacing measure have been collected allowing the authors to carry out kinematic analysis to evaluate how the stability degree of the rock mass change along the road. For each slope a stereographic projection of the collected plane has allowed the identification of the set of discontinuities and the orientation of their main plane; the spacing measure has allowed the definition of the shape and volume of the detachable blocks and their kinematic condition (any movement, rock fall, planar slide or wedge slide). In the attached file (Figure 12), the results obtained for one of the 20 rock slope analysed is reported.

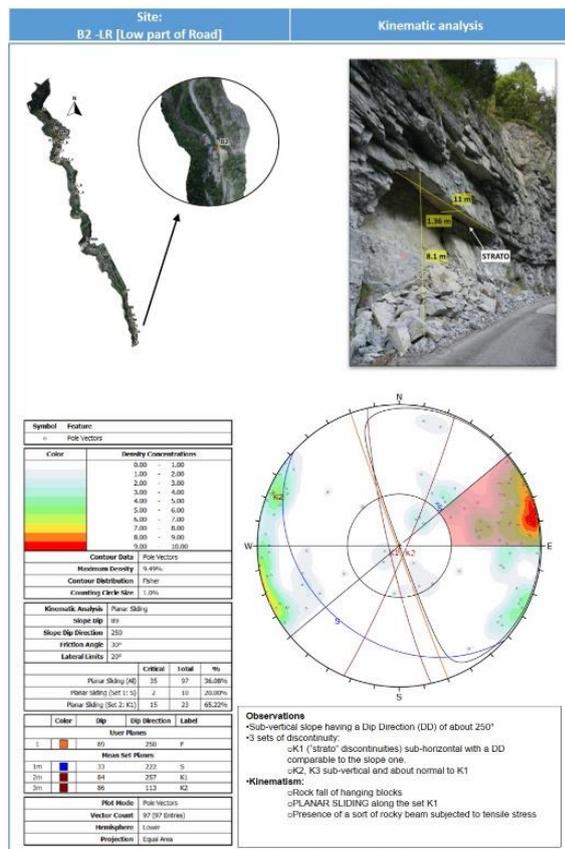
Figure 12. Example of stereographic projection of the collected plan for discontinuities sets identification.
