Acoustic Emission Monitoring of the Turin Cathedral Bell Tower: Foreshock and Aftershock Discrimination

Amedeo Manuello Bertetto ^{1,*}, Davide Masera ² and Alberto Carpinteri ¹¹ Department of Structural, Geotechnical and Building Engineering, Politecnico di Torino – Corso Duca degli Abruzzi, 24, 10129 Torino, Italy; alberto.carpinteri@polito.it² Masera Engineering Group s.r.l, 10129 Torino, Italy; davide.masera@polito.it

Abstract: Historical churches, tall ancient masonry buildings, and bell towers are structures subjected to high risks due to their age, elevation, and small base-area-to-height ratio. In this paper, the results of an innovative monitoring technique for structural integrity assessment applied to a historical bell tower are reported. The emblematic case study of the monitoring of the Turin Cathedral bell tower (northwest Italy) is herein presented. First of all, the damage evolution in a portion of the structure localized in the lower levels of the tall masonry building is described by the evaluation of the cumulative number of acoustic emissions (AEs) and by different parameters able to predict the time dependence of the damage development, in addition to the 3D

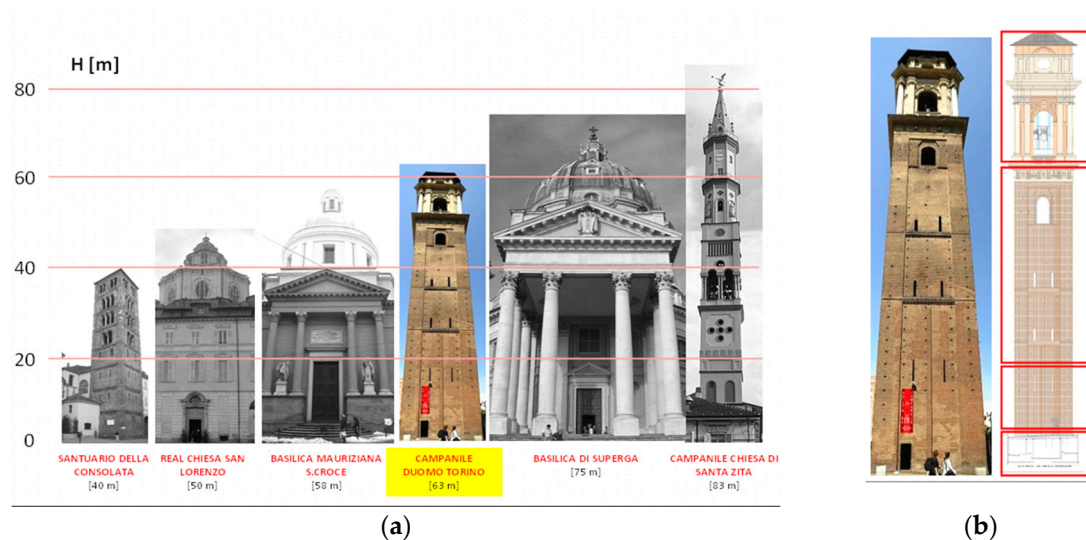
Figure 2. Tall masonry building in Turin and parts constituting the bell tower. (a) The bell tower is the third tallest masonry building in the city (63 m); (b) The tower is subdivided into different parts—the stem and the bell cell are constituted by different materials and were erected in different times and by different building techniques.

The bell tower is today the third tallest masonry building in the City, (63 m) (see Figure 2a). As mentioned, the structure, finished around 1470, was built next to the paleochristian complex of the so-called three churches, the communicating buildings of San Salvatore, Santa Maria, and San Giovanni Battista. Successively, the structure was incorporated into the building of San Giovanni. About 20 years later, the churches were destroyed, and in their place, the city's cathedral was built. The brilliant architect Meo del Caprina designed the cathedral, and the original tower became the bell tower, connected to the church by an underground gallery that is now part of the Diocesan Museum (Figure 1a). The tower was restored for the first time in 1620, and a century after, the design of Filippo Juvarra was completed for the top cell and the roof. When the Palazzo Vecchio was demolished in the 19th century, the bell tower remained isolated and ignored until 1986, when contemporary restorations were started by the architects Maurizio and Giuseppe Momo. The tower, therefore, consists of two distinct parts: the 15th-century tower, with a squared plan erected on the site of the early

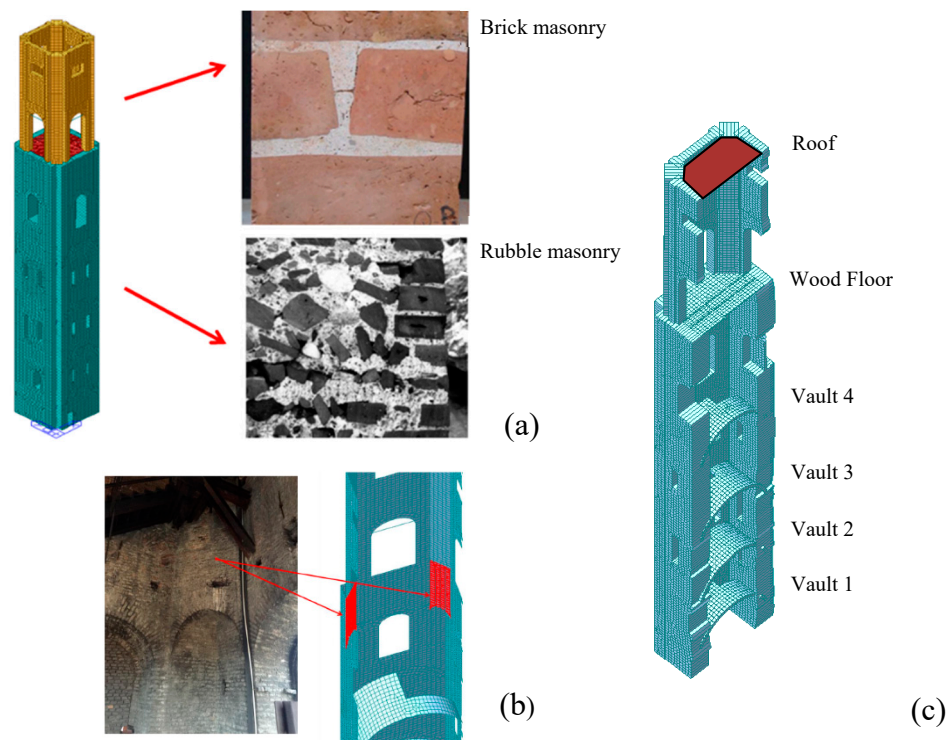
Figure 3. The FEM: (a) The bell tower is made with different materials and different building techniques (sack masonry). (b) Chains have also been inserted within the model in correspondence with the “key heads” observable from the outside. The loads of the various elements were assessed by multiplying their thickness by the specific weight of the materials. The different dead loads were associated to the different levels and structural elements. (c) Axonometric cross-section of the tower.

Starting from the results of the survey, FEM was implemented with the aid of Midas FX software (CSP Fea Engineering, Padova, Italy), a three-dimensional geometric modeler completed by the FEM modulus. Through the CAD (computer-aided drafting) reproduction, the geometric model of the tower was initially defined, from which, thanks to the software's auto-meshing function, the FEM model was obtained. In Figure 3, the model obtained is shown.

In addition, thin elements have been inserted (chain) (see Figure 3b), which act as connections between the two different parts of the tower—the stem and the cell. In this way, the loads of the bell cell are gradually transferred on the fifteenth-century part of the tower. Chains have also been inserted in the model in correspondence with the “key heads” observable from the outside; the external ‘keys’ and the inserted chains can be seen in Figure 3b. It can be observed that some chains do not circumscribe the tower; this is due to the fact that they have only been inserted in correspondence with the externally visible “keys.” This operation is therefore in favor of safety, since the chains are certainly less in number than those actually present in the structure.

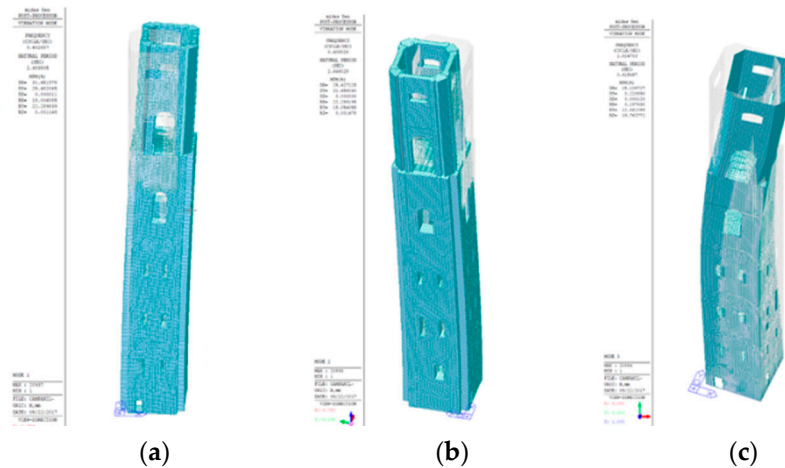
Figure 6. Representation of the modal analysis: (a,b) The two modes of the tower in the y and the x directions, represented by flexural modalities, (c) The third mode showing a torsional modality.

In order to further validate the numerical model, the results of the modal analysis are shown in Figure 6, and the first three vibrating modes were investigated and reported. It can be observed that the first and second modes are flexional, characterized mainly by displacements in x and y directions, while the third is torsional. In Tables 4 and 5, the results of eigenvalue analysis and the masses participating in the individual modes were reported. In the last table, the values of the predominant masses of the

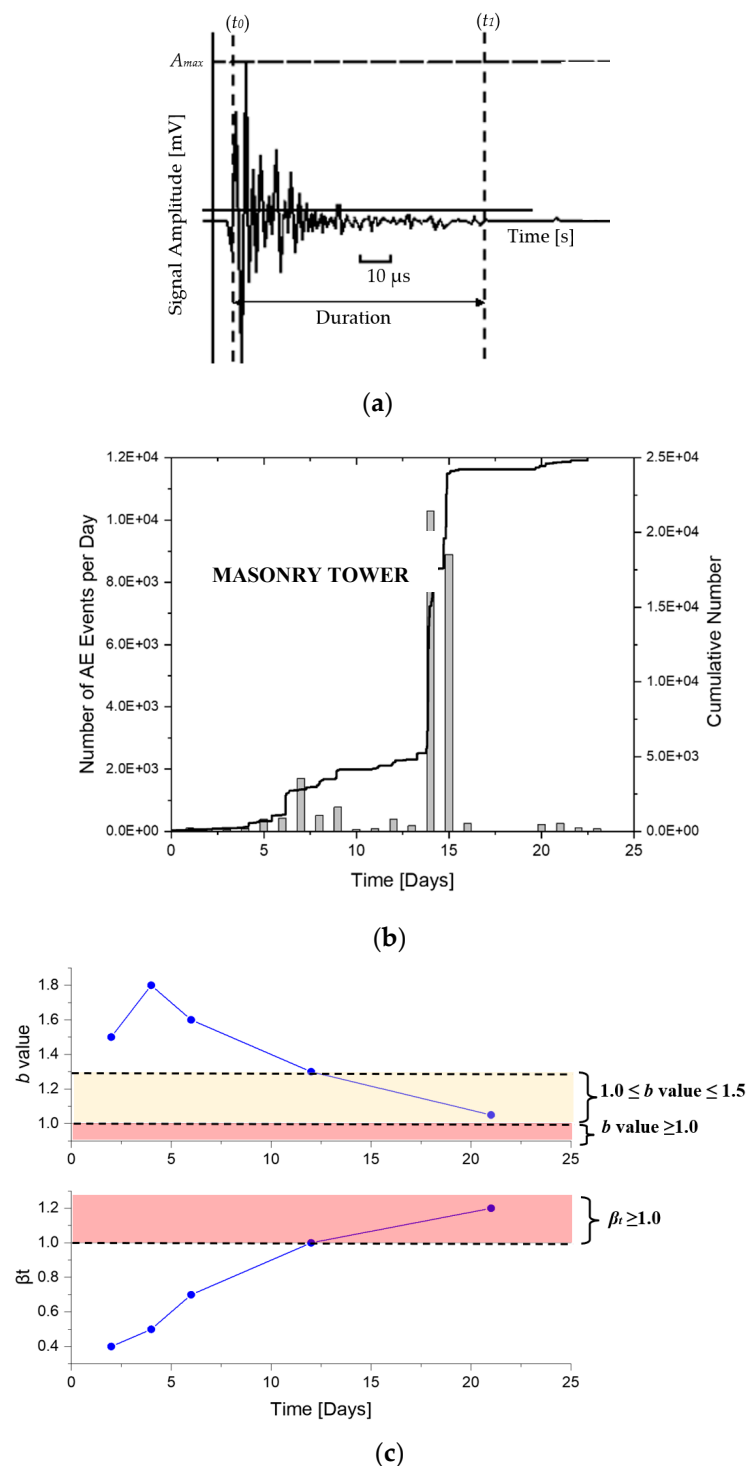
Figure 7. AE signal and AE results of the tower: (a) Typical received signal in the time domain during the acoustic emission (AE) monitoring. The AE equipment used in the present paper allow to set the appropriate threshold value due to the monitored structure and the environmental conditions. (b) Cumulative number of AE and AE count per day during the monitoring time. (c) b -value diagram representing the evolution of the damage, β_t trend evolution during time.

The analysis of the b -value has been widely used for the application of AE analysis. In particular, during the last few decades, very important results were achieved for concrete structures using b -value and improved b -value by Shiotani et al. [27,28]. In present paper, in order to carry out an accurate study, the disturbances of the environment and the noise filters of the instrumentation have been optimized. In particular, a filtering on amplitude signal levels and frequency values is adopted for the AE time series. The b -value trend was obtained working on time windows containing at least 100 AE. Signals with repetitive frequency values or too far from the typical range proper of the frequency of the damage source generation in these types of materials have been discarded. In particular, it is interesting to note that the b -value showed a decreasing trend that is compatible with the growth of macro-cracks localized in the south side of the tower between the second and the third level, in correspondence of the portion of the monitored structure. After 12 monitoring days, the b -value trend entered the $1.5 < b\text{-value} > 1.0$ phase, corresponding to a critical condition (Figure 7c).

In this phase, the localized point started to be found by the triangulation procedure as stated in the following. After 21 monitoring days, the trend approached the local collapse condition $1.0 < b\text{-value}$ (Figure 7c). This phase was correlated with the intensification of the localized point of the damage sources (Figure 8), in correspondence of the evolution of active cracks (Figure 8a,b). Furthermore, as reported in Figure 7c, the growth of the β_t toward values higher than 1.0 in correspondence with the decrease in the b -value highlighted the instability of the crack growth process. As mentioned before, the localization procedure was employed to evaluate the source damage position and the diffusion of the cracking pattern. Localization is one of the most used analysis in AE monitoring. The AE localization technique has been widely applied in laboratory and in situ tests, as well as, has been performed with different methods in order to improve the results accuracy [29–41]. In this second stage (low b -value and higher β_t) in fact, the formation of micro-cracks in a 3D space is analyzed, and the triangulation technique was applied to signals recorded by at least five sensors falling into time intervals sufficiently small (50 μs). Thus, with this procedure, it is possible to define both the position of the micro-cracks in

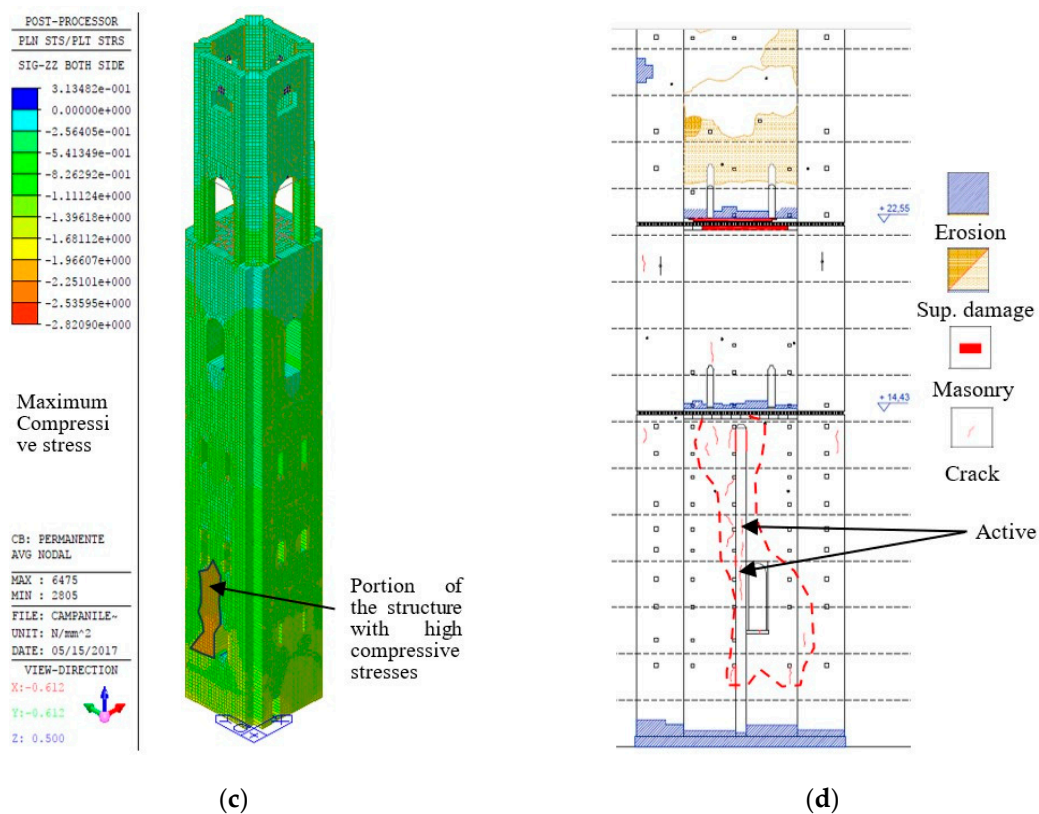
Figure 8. AE localization results. In (a), the portion of the masonry structure where the AE sensors were positioned. The localized points have been indicated with black points, for a total of 62 AE sources (b). Three circles are reported in correspondence to the center of AE source clusters. Two levels of cluster are reported with circle radius proportional to the number of AE source inside the areas. (c) The results of the numerical analysis reported the portion of the structure with higher compressive stress. (d) The same area is reported considering the crack position the erosion areas and the damaged surfaces.

the distance between S_i and source S , in Cartesian coordinates, and assuming the material to be homogenous, the path of the signal is given by $|S - S_i| = v(t_i - t_0')$. If the same event is observed from another sensor S_j at time t_j : $|S - S_j| - |S - S_i| = v(t_i - t_0')$. Assuming the arrival times of the signals and the positions of the two sensors to be known, the last is an equation with four unknowns— x , y , z , and v . Hence, the problem of the localization of S is determined if it is possible to write a sufficient number of equations of that type, i.e., when the same AE event is identified by at least five sensors. If this did not occur, it would be necessary to adopt simplifying assumptions to reduce the degrees of freedom of the problem, such as, for instance, imposing the speed of transmission of the signals or having the AE source lie on predetermined plane. For the analysis carried out in the present research, three-dimensional localizations with at least five sensors were performed. In particular, Figure 8a and Table 6 indicate the position where the sensors were applied, (Figure 8b) the result of the localization with the source points projected on the surface of the facade, (Figure 8c) the relationship with the main results of the numerical model, and (Figure 8d) the detection of damage together with the crack pattern on the same portion of the structure. The localization procedure is based on the principles recently reported by the same authors concerning the signal accuracy [20]. Finally, according to the steps described in the previous section, the sources of AE events were localized. The localized points have been indicated with black points, for a total of 62 AE sources. In the figure, three circles are reported in correspondence to the center of the AE source clusters. Two levels of cluster are reported with circle radii proportional to the number of AE source inside the areas (see Figure 8b). In Figure 8d, the map of surface erosions, masonry gaps, surface damage, and cracks was reported. The AE localization allowed us to identify the portions of the masonry where active and growing cracks were concentrated (Figure 8b). These areas are also those where the highest values in compressive stresses were observed through the numerical model during the static calculus (Figure 8c).

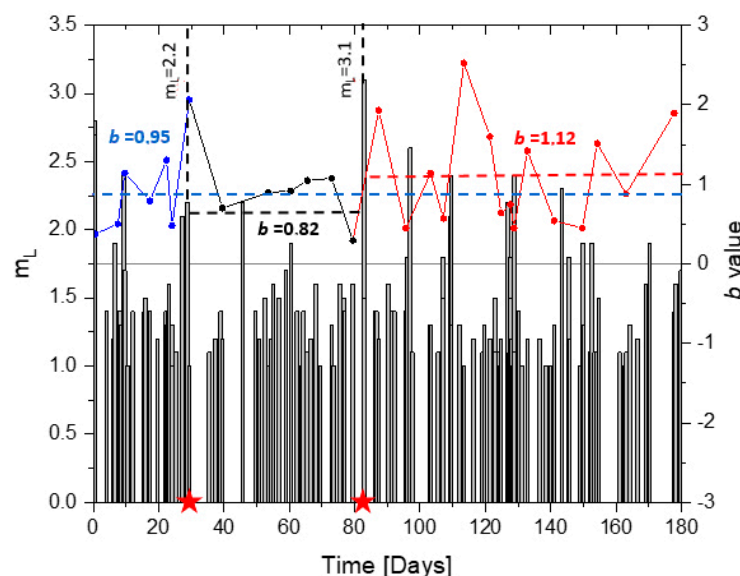
Figure 12. The average b -values before the “anticipator” event (12 April 2018) is equal to 0.95. After this, an evident reduction in the average value equal to 15% is observed (average b -value = 0.82). The main event occurred about 50 days after (5 June 2018). After the m_L : 3.1, no event with greater magnitude were registered for three months.

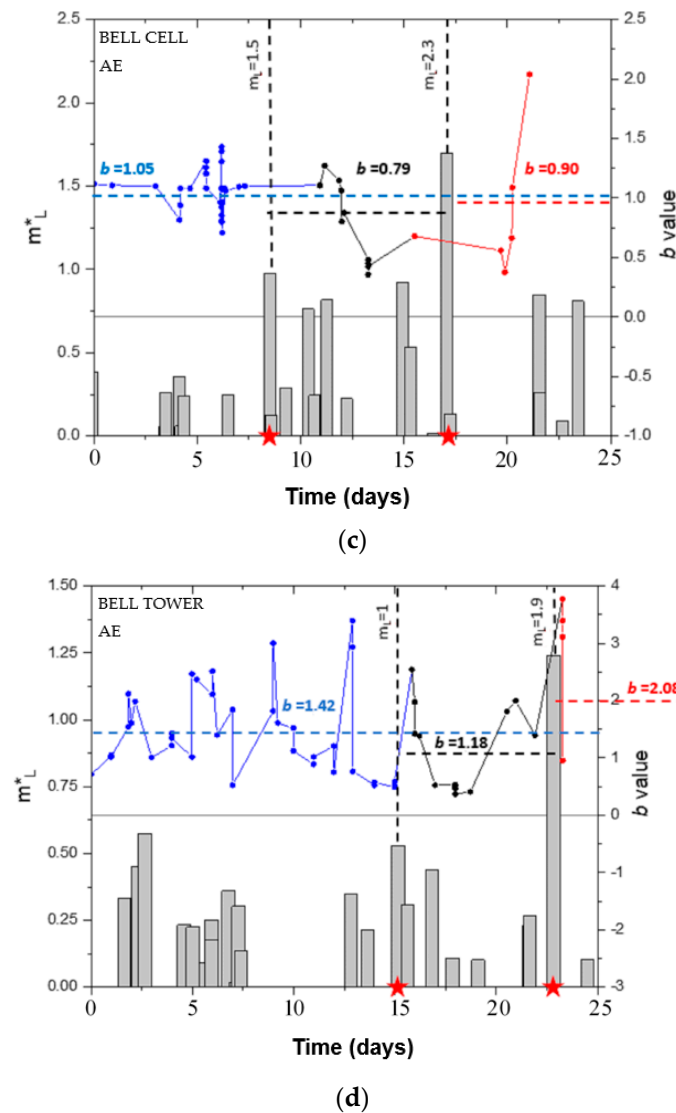
Figure 13. The seismic time series are represented together with the variations of the AE average b -values detected on the structures of the tower: (a,b) b -value time series considering the seismic activity along 40-day time windows. In both the two cases the average b -values demonstrated an evident reduction in correspondence of foreshocks periods between the anticipating and the main event. (c,d) At the same time, the b -value time series have been computed for AE data and correlated to the seismic activity for a period of 25 days contained in the previous larger time intervals.

where m_L^* is the reduced local magnitude; m_L is the actual local magnitude and d is the distance, measured in km, between the epicenter and the Bell Tower of the Turin Cathedral. In Figure 13 the two seismic time series were represented together with the variations of the average b -values.

These variations trends resulted particularly evident for both the two considered periods (10 May 2018–30 June 2018 and 1 August 2019–25 September 2019). For each period, two couples of events were recognized, each of them formed by one anticipant and one main event (the anticipant and the main events are distinguished by stars on the x -axis of the graph). The average values of the b -value before the anticipating events are 1.34 and 2.01 for the two periods, respectively (see Figure 13a,b). The reduced local magnitudes for the two anticipants are $m_L^* = 1.5$ (1 June 2018, Inverso Pinasca, 44°57' N 7°13' E, near Turin); and $m_L^* = 1.0$ (24 August 2019, Torre Pellice, 44°49' N 7°14' E). After these two events two phases, the first of about seven days and the second of about eight days with average b -values of 0.58 and 1.85 were observed for the two time windows. After these intervals, the expected seismic main events $m_L^* = 2.3$ and $m_L^* = 1.9$ took place (Figure 13a,b). These two events were both anticipated by the previously mentioned series where the average b -values encountered reductions of 56% and 8%. After the occurrence of the two events recognized as main events, the b -values trends returned to grow significantly—the average b -values were 1.22 for the first time window
