Acoustic Emission Monitoring of the Turin Cathedral Bell Tower: Foreshock and Aftershock  
Discrimination

# Acoustic Emission Monitoring of the Turin Cathedral Bell Tower: Foreshock and Aftershock Discrimination

**Abstract:** Historical churches, tall ancient masonry buildings, and bell towers are structures subjected to high risks due to their age, elevation, and small base-area-to-height ratio. In this paper, the results of an innovative monitoring technique for structural integrity assessment applied to a historical bell tower are reported. The emblematic case study of the monitoring of the Turin Cathedral bell tower (northwest Italy) is herein presented. First of all, the damage evolution in a portion of the structure localized in the lower levels of the tall masonry building is described by the evaluation of the cumulative number of acoustic emissions (AEs) and by different parameters able to predict the time dependence of the damage development, in addition to the 3D localization of the AE sources. The *b*-value analysis shows a decreasing trend down to values compatible with the growth of localized micro and macro-cracks in the portion of the structure close to the base of

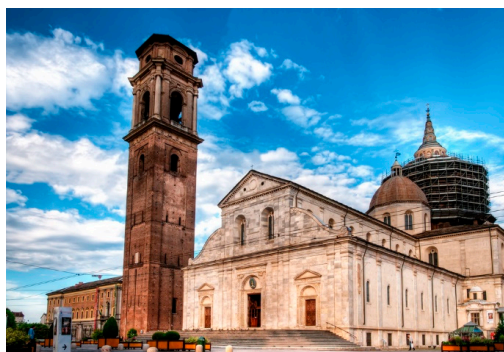
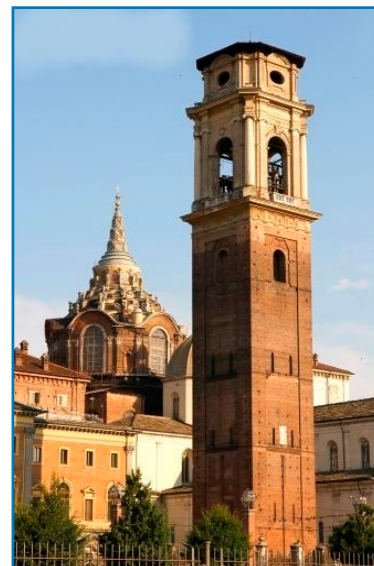
**Figure 1.** Architectural complex of the Cathedral with the bell tower in the front and the dome erected by G. Guarini: (a) on the backside; (b) view of the isolated bell tower from the other side

The bell tower was initially built in the second half of the 15th century between 1468 and 1470 [11,12]. Recently restored, the tower is inserted, today, in the Diocesan Museum of the Sabaudian city (see Figure 1). The masonry tower was erected completely by the will of bishop Giovanni di Compey (Figure 1a). Between 1720 and 1722, the court architect Filippo Juvarra worked on the crowning and the dome, the tower assumed its current appearance—a brick construction that ends with a baroque bell tower made by stone decorations [11,12] (see Figures 1b and 2).

Christian churches, still marked at the top by the opening of the ancient bell cell; and the 18th-century crowning—the unfinished realization of Filippo Juvarra’s project (Figure 2b). The ancient part is a square plan of about 10 meters ( $9.70 \times 9.70$ ) on each side with perimeter walls of a constant thickness (2 m) up to the Juvarrian crown, where, in correspondence to the bell cell, the square is connected to an octagon. The restorations of the 1980s were followed up in 2013 by the architects Maurizio and Chiara Momo. In the last few years, the bell tower was subjected to the last external restoration works that completely returned the tower to the city in all its magnificence (Figure 1b).

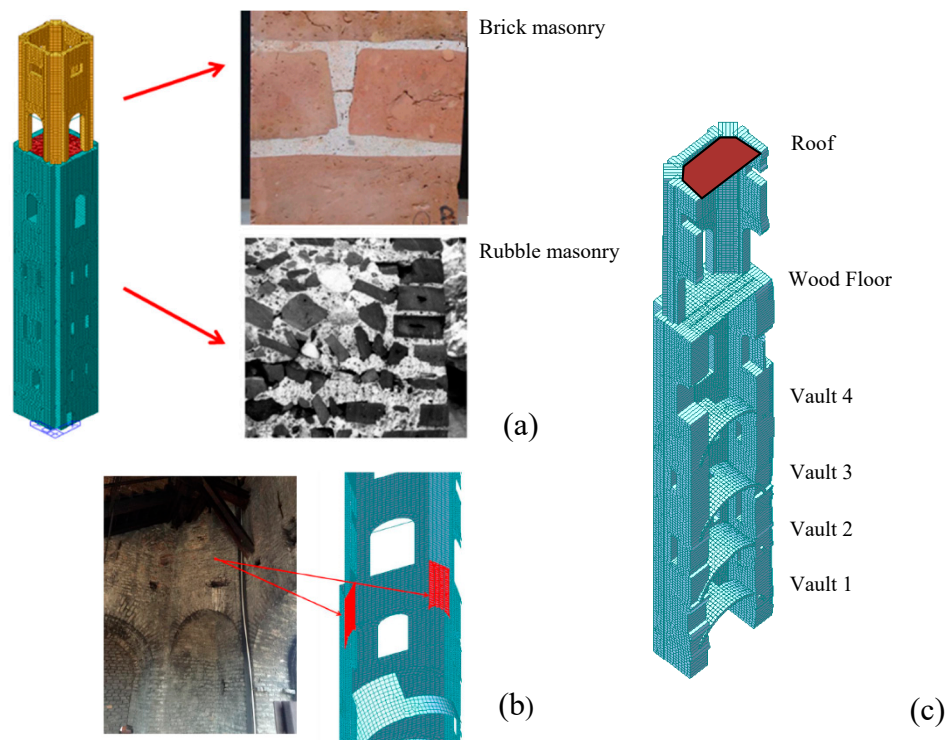
**Figure 3.** The FEM: (a) The bell tower is made with different materials and different building techniques (sack masonry). (b) Chains have also been inserted within the model in correspondence with the “key heads” observable from the outside. The loads of the various elements were assessed by multiplying their thickness by the specific weight of the materials. The different dead loads were associated to the different levels and structural elements. (c) Axonometric cross-section of the tower.

Starting from the results of the survey, FEM was implemented with the aid of Midas FX software (CSP Fea Engineering, Padova, Italy), a three-dimensional geometric modeler completed by the FEM modulus. Through the CAD (computer-aided drafting) reproduction, the geometric model of the tower was initially defined, from which, thanks to the software's auto-meshing function, the FEM model was obtained. In Figure 3, the model obtained is shown.

In addition, thin elements have been inserted (chain) (see Figure 3b), which act as connections between the two different parts of the tower—the stem and the cell. In this way, the loads of the bell cell are gradually transferred on the fifteenth-century part of the tower. Chains have also been inserted in the model in correspondence with the “key heads” observable from the outside; the external ‘keys’ and the inserted chains can be seen in Figure 3b. It can be observed that some chains do not circumscribe the tower; this is due to the fact that they have only been inserted in correspondence with the externally visible “keys.” This operation is therefore in favor of safety, since the chains are certainly less in number than those actually present in the structure.

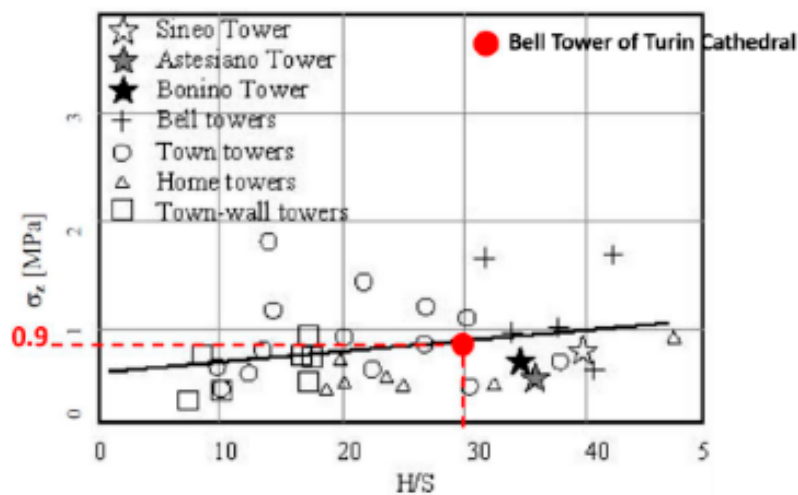
**Figure 4.** Compressive stress  $\sigma$  for different ancient tall masonry towers in Italy [22]. The maximum stress is reported as a function of the ratio between the height and the maximum depth of the bearing wall of the structure.

In term of comparison to the real scenario, and in order to validate the results of the implemented model, the value of the maximum compressive stress obtained by the simulations at the base of the tower was compared to the values reported in the literature for similar Italian ancient masonry towers, characterized by similar base vs. height ratio, constructive techniques and elastic properties of the constituting materials [22]. In particular, in Figure 4, the stress value obtained at the base of the tower by the simulations (0.95 MPa) were put in the graph where the compressive stress at ground level of similar monuments were reported. The value obtained are perfectly in agreement with the others and can be considered well validated.

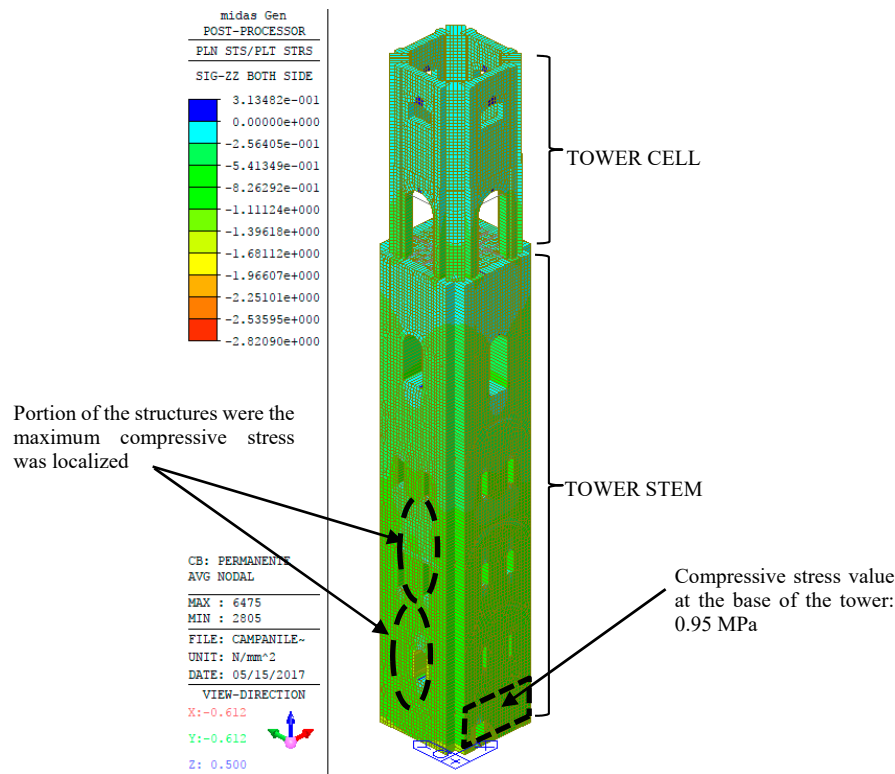
**Figure 5.** Portion of the structures were the maximum compressive stress was localized. The compressive stress value at the base of the tower is 0.95 MPa.

The results of the static analysis are reported in Figure 5. The value of the compressive stress, as reported previously, was equal to 0.95 MPa at the base of the tower. On the other hand, in a localized portion of the structure, related to the opening disposition, the compressive stress reached higher values up to 1.4 MPa. These values were observed particularly on the south façade of the tower, between the second and the third level.

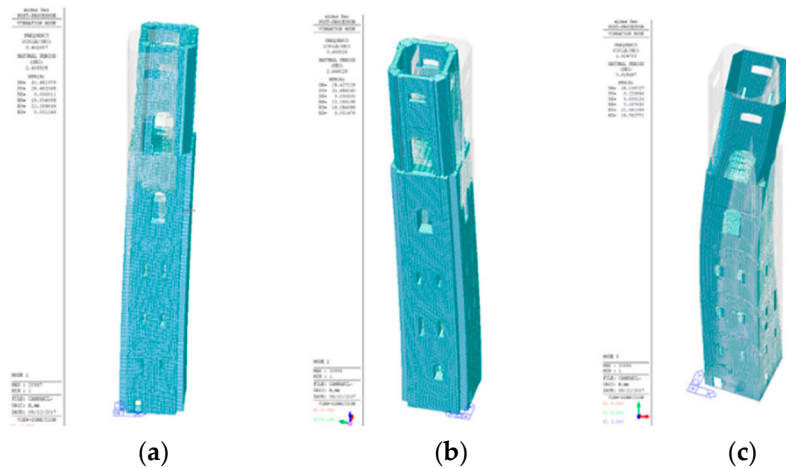
**Figure 6.** Representation of the modal analysis: (a,b) The two modes of the tower in the y and the x directions, represented by flexural modalities, (c) The third mode showing a torsional modality.

In order to further validate the numerical model, the results of the modal analysis are shown in Figure 6, and the first three vibrating modes were investigated and reported. It can be observed that the first and second modes are flexional, characterized mainly by displacements in x and y directions, while the third is torsional. In Tables 4 and 5, the results of eigenvalue analysis and the masses participating in the individual modes were reported. In the last table, the values of the predominant masses of the

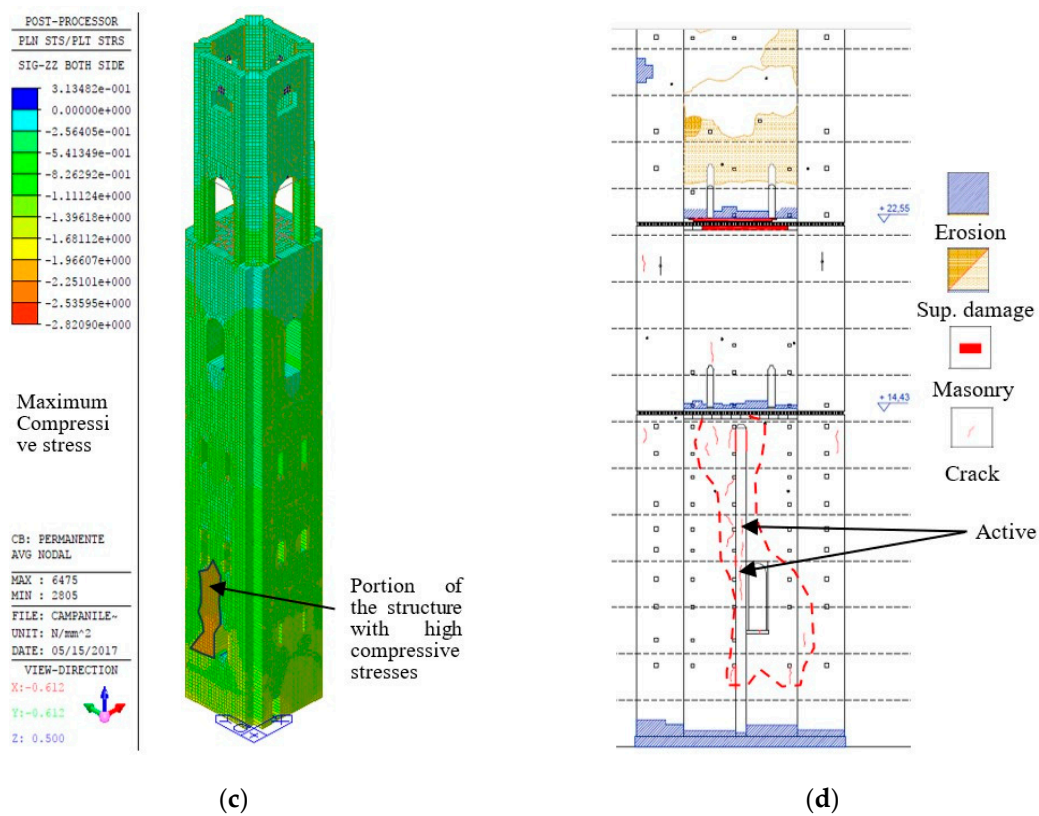
**Figure 8.** AE localization results. In (a), the portion of the masonry structure where the AE sensors were positioned. The localized points have been indicated with black points, for a total of 62 AE sources (b). Three circles are reported in correspondence to the center of AE source clusters. Two levels of cluster are reported with circle radius proportional to the number of AE source inside the areas. (c) The results of the numerical analysis reported the portion of the structure with higher compressive stress. (d) The same area is reported considering the crack position the erosion areas and the damaged surfaces.

the distance between  $S_i$  and source  $S$ , in Cartesian coordinates, and assuming the material to be homogenous, the path of the signal is given by  $|S - S_i| = v(t_i - t_0)$ . If the same event is observed from another sensor  $S_j$  at time  $t_j$ :  $|S - S_j| - |S - S_i| = v(t_i - t_0)$ . Assuming the arrival times of the signals and the positions of the two sensors to be known, the last is an equation with four unknowns— $x$ ,  $y$ ,  $z$ , and  $v$ . Hence, the problem of the localization of  $S$  is determined if it is possible to write a sufficient number of equations of that type, i.e., when the same AE event is identified by at least five sensors. If this did not occur, it would be necessary to adopt simplifying assumptions to reduce the degrees of freedom of the problem, such as, for instance, imposing the speed of transmission of the signals or having the AE source lie on predetermined plane. For the analysis carried out in the present research, three-dimensional localizations with at least five sensors were performed. In particular, Figure 8a and Table 6 indicate the position where the sensors were applied, (Figure 8b) the result of the localization with the source points projected on the surface of the facade, (Figure 8c) the relationship with the main results of the numerical model, and (Figure 8d) the detection of damage together with the crack pattern on the same portion of the structure. The localization procedure is based on the principles recently reported by the same authors concerning the signal accuracy [20]. Finally, according to the steps described in the previous section, the sources of AE events were localized. The localized points have been indicated with black points, for a total of 62 AE sources. In the figure, three circles are reported in correspondence to the center of the AE source clusters. Two levels of cluster are reported with circle radii proportional to the number of AE source inside the areas (see Figure 8b). In Figure 8d, the map of surface erosions, masonry gaps, surface damage, and cracks was reported. The AE localization allowed us to identify the portions of the masonry where active and growing cracks were concentrated (Figure 8b). These areas are also those where the highest values in compressive stresses were observed through the numerical model during the static calculus (Figure 8c).

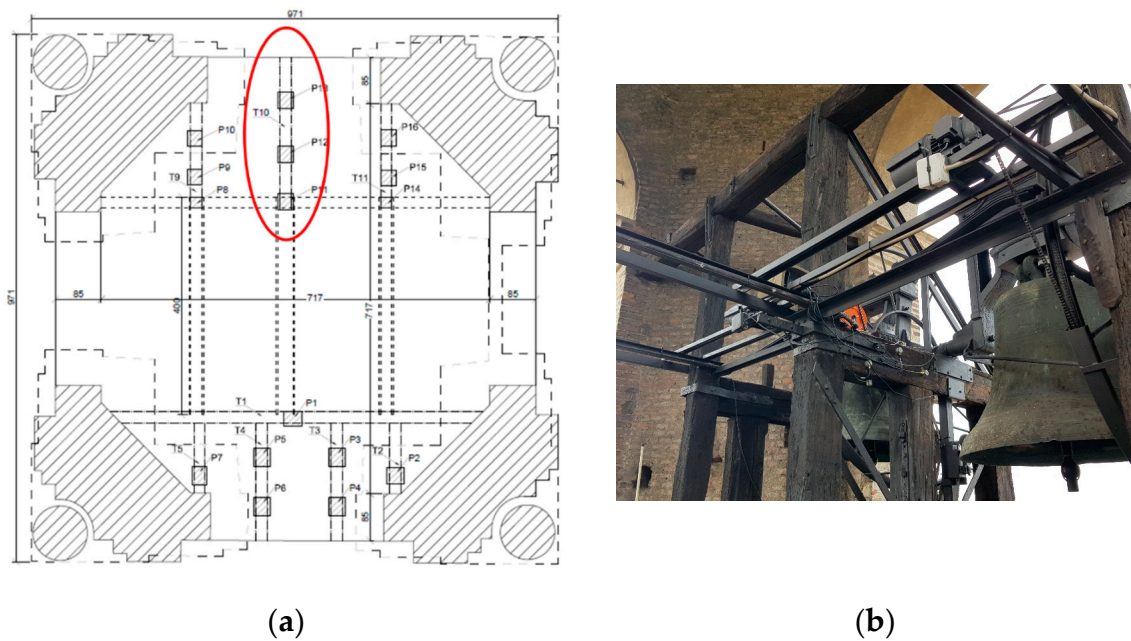
**Figure 9.** Timber structure positioned inside the bell cell at the top of the tower: (a) Plan of the cell where the timber frame layout is reported. The monitored portion is localized. (b) AE sensors disposition on the wood frame.

The second part of the Bell Tower subjected to the AE monitoring is the timber structure sustaining the bells, positioned inside the bell cell at the top of the tower (see Figure 9). In this case, the wooden structure supporting the bells was monitored with an eight-channel acoustic emission data acquisition system to evaluate the evolution of the cracking pattern evolution over the monitoring time (see Table 7 for the sensor positioning). The sensors were positioned in the wood frame sustaining the heaviest bells, as shown in Figure 8. The structure was monitored for a period of time equal to one month; in particular, the monitoring was carried out from 8 August to 8 September 2019.

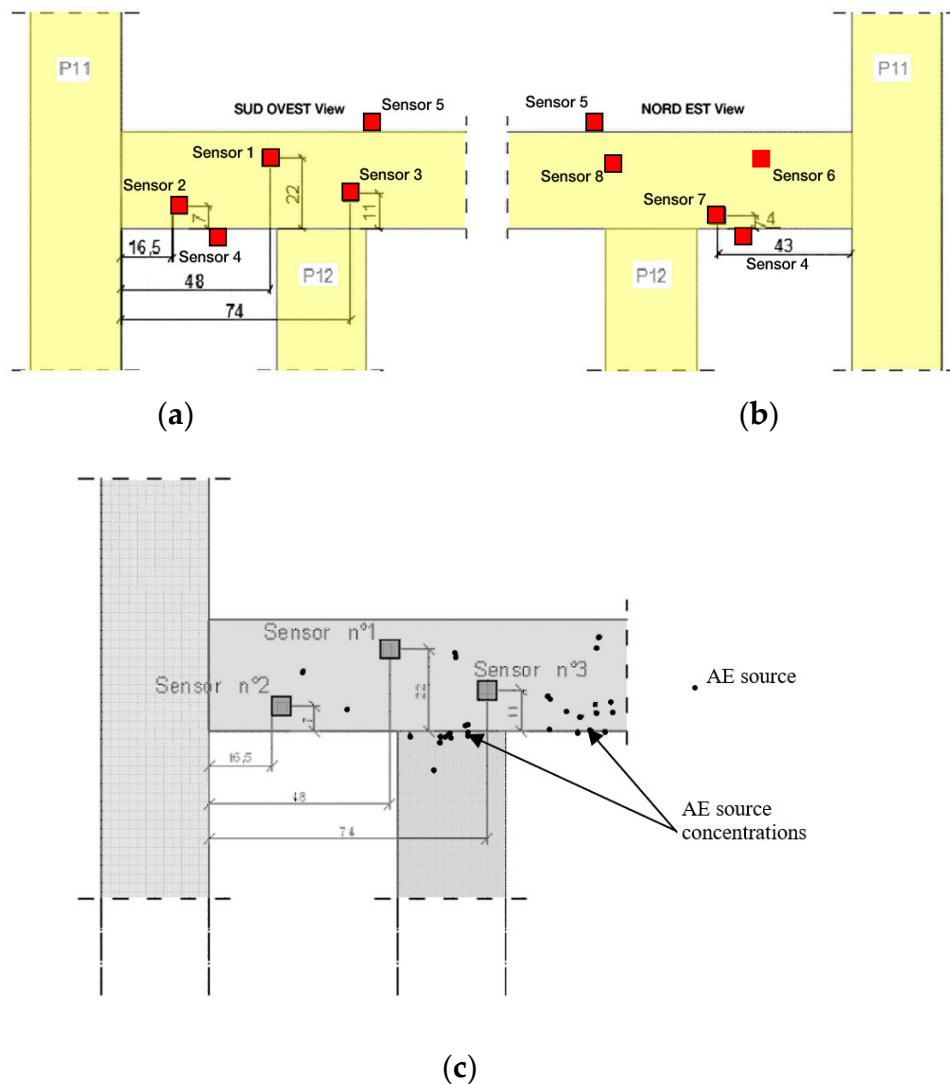
**Figure 11.** AE localization results. In figure (a) and (b), the portion of the wooden frame where the AE sensors were positioned is showed, (c) The localized points have been indicated with black points, for a total of 24 AE sources.

Finally, the sources of AE events were localized. The position of the sensors and the localized sources are shown in Figure 11a,b. The localized points have been indicated with black points, for a total of 24 AE sources. In this Figure, two circles are reported in correspondence to the barycenter of AE source clusters. Two levels of cluster are reported with circle radii proportional to the number of AE source inside the areas. The results of the AE localization, together with the  $b$ -value trend, made it possible to identify the column-beam joint and the portion of the beam close to the pin of the big bell as a portion of the wood frame affected by crack formation and damage growth.

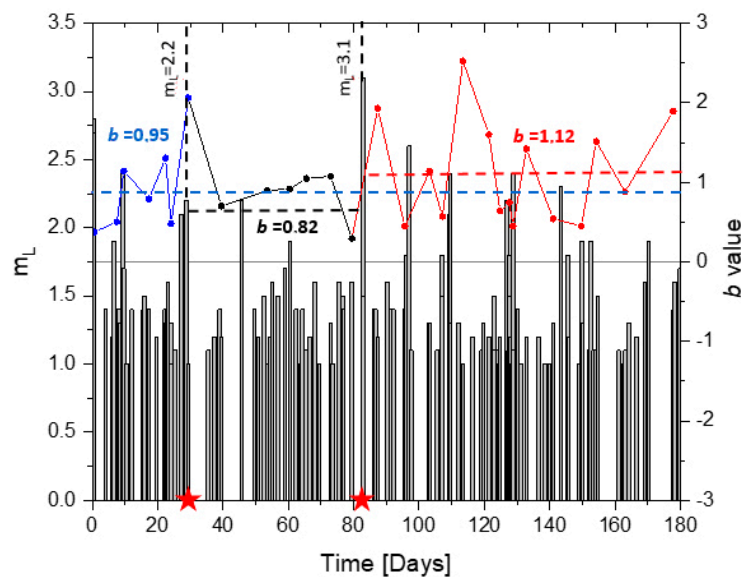
**Figure 12.** The average  $b$ -values before the “anticipator” event (12 April 2018) is equal to 0.95. After this, an evident reduction in the average value equal to 15% is observed (average  $b$ -value = 0.82). The main event occurred about 50 days after (5 June 2018). After the  $m_L$ : 3.1, no event with greater magnitude were registered for three months.

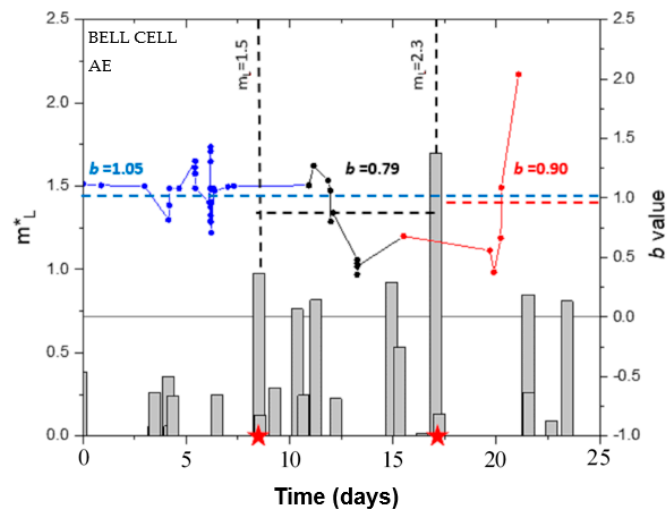
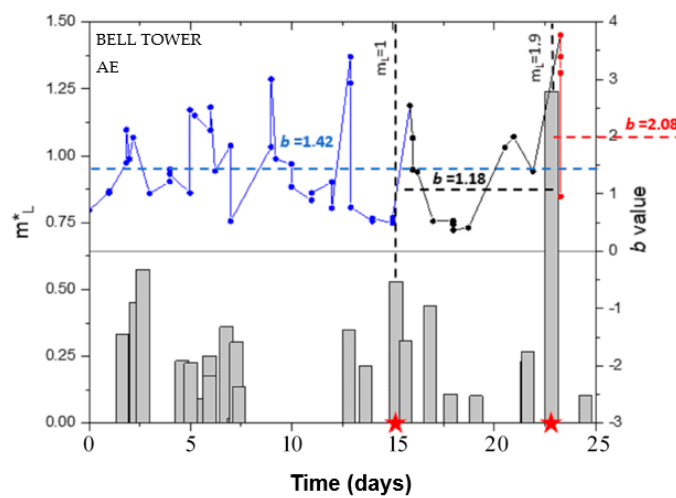
**Figure 13.** The seismic time series are represented together with the variations of the AE average  $b$ -values detected on the structures of the tower: (a,b)  $b$ -value time series considering the seismic activity along 40-day time windows. In both the two cases the average  $b$ -values demonstrated an evident reduction in correspondence of foreshocks periods between the anticipating and the main event. (c,d) At the same time, the  $b$ -value time series have been computed for AE data and correlated to the seismic activity for a period of 25 days contained in the previous larger time intervals.

where  $m_L^*$  is the reduced local magnitude;  $m_L$  is the actual local magnitude and  $d$  is the distance, measured in km, between the epicenter and the Bell Tower of the Turin Cathedral. In Figure 13 the two seismic time series were represented together with the variations of the average  $b$ -values.
