Stabilitätsbewertung eines schornsteins aus mauerwerk durch schwingungsmessungen

Structural stability assessment of a masonry chimney by vibration measurements

F. Telch⁽¹⁾, G. Lacidogna⁽¹⁾, O. Rösch⁽²⁾

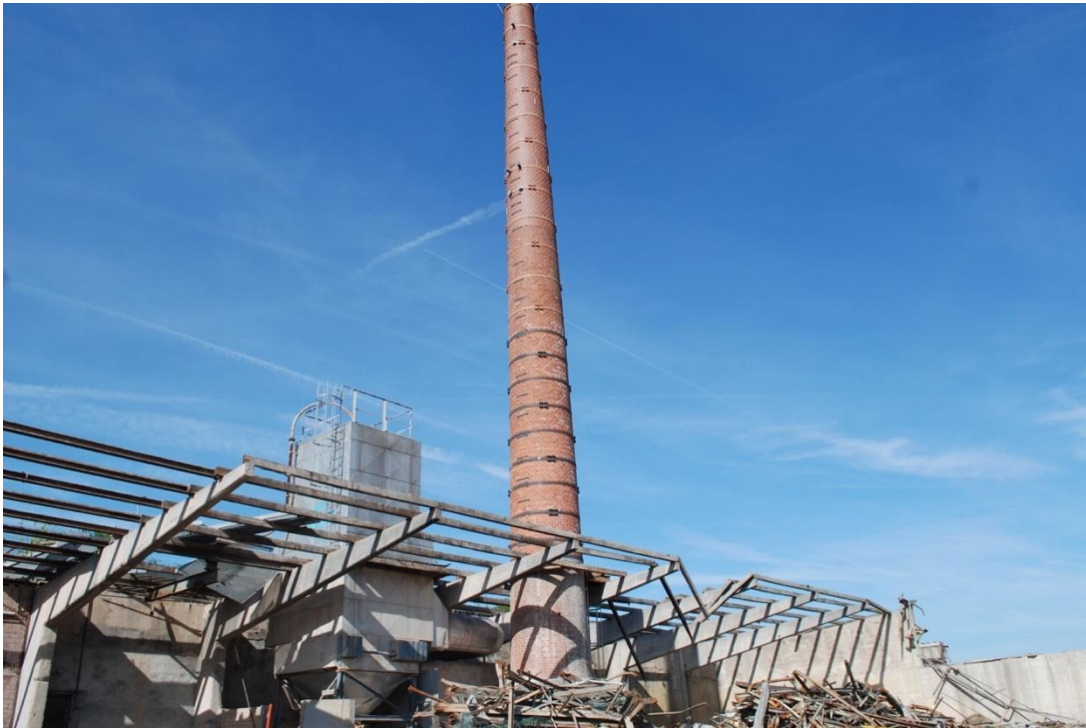
Fig. 2: The chimney

According to implementation plans [8], the 54-year-old masonry chimney protrudes 30 meters from the ground. Its diameter is 2.56 m at the bottom and 1.36 m at the top. The wall has four thickness jumps over its height. Between the jumps the thickness remains constant, it is equal to 50 cm at the bottom, and only 18 cm at the top. Table 1 shows the sections with the individual wall thicknesses.

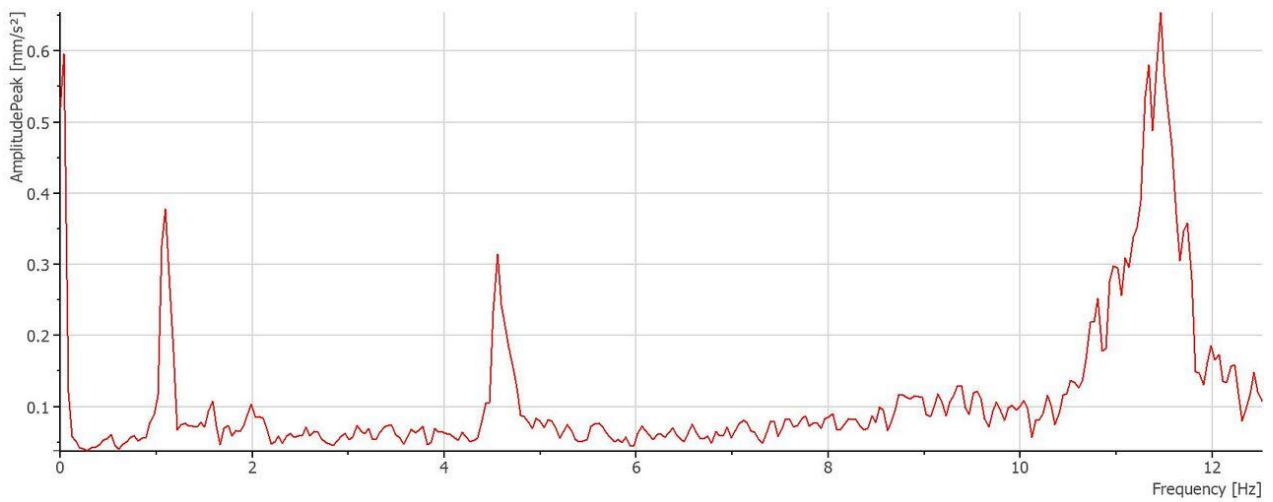
The amplitude spectrum is shown in Fig. 5. From here one can see that the natural frequencies are approximately: 1.10 Hz, 4.55 Hz and 11.46 Hz.

Fig. 5: Amplitude spectrum of the vibration measurement

If the first natural frequency is $f_0 = 1.10$ Hz and the degree of damping is set equal to $\zeta_0 = 0.02$, the constant of the time τ_0 can be derived from Eq. 1 as follows:

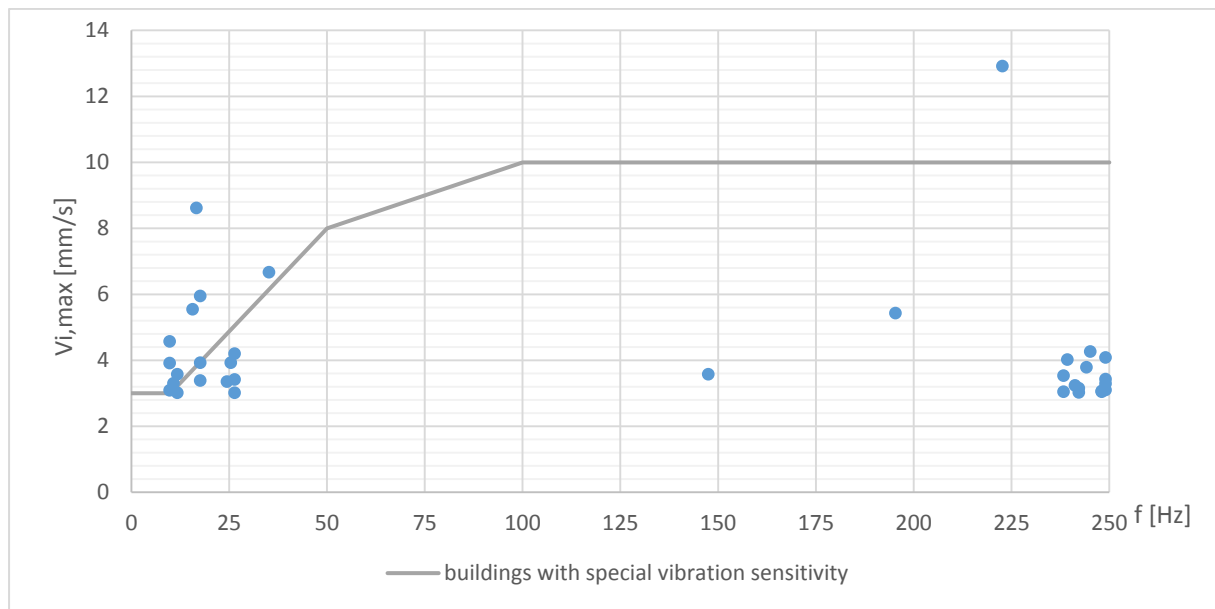
In Fig. 7 all results are shown graphically for better understanding. Basically, one can see a clear division into two large groups: the first one between 9 and 28 Hz and the second one between 230 and 250 Hz. It can be concluded that the excitement come from two different sources. The first group is due to falling masses.

Fig. 7: Graphic representation of the events

In addition, it can be seen in Fig. 7 that three points do not fall into these two cases: on May 30, at 07:57 am, May 23 at 09:37 am, and July 18 at 08:03 am, but it was not possible to detect the source which was the cause.

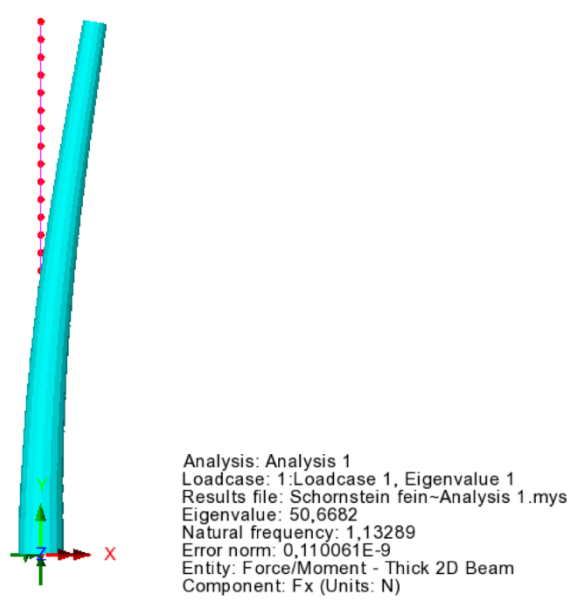
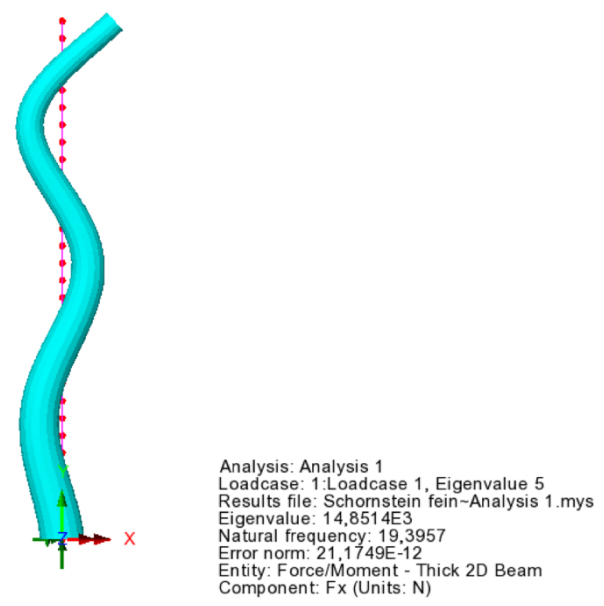
The stone strength was estimated with the Schmidt-Hammer. The Schmidt-Hammer is a rebound hammer, an instrument for non-destructive material testing, which measures the compressive strength point by point. It has been found that the bricks have a relatively high compressive strength of over 10 N/mm^2 . The mortar is most likely a cement mortar with equally high strength. As mentioned, there is no secure information about the used materials. For this reason, a conservative masonry strength of $f_k = 4.8 \text{ N/mm}^2$ was estimated. Based on the compressive strength, the modulus of elasticity was determined: $E = 4.8 \times 1100 = 5280 \text{ N/mm}^2$. Using a density of $\rho = 1800 \text{ kg/m}^3$, the first four natural frequencies listed in Table 3 with the associated modal masses can be obtained. The modal shapes and frequencies are represented in Fig. 9.

Fig. 9.1: First natural frequency

Fig. 9.2: Second natural frequency

Fig. 9.3: Third natural frequency

Fig. 9.4: Fourth natural frequency

Fig. 9: Modal shapes and frequencies of the masonry chimney

As can be seen in Table 3, the calculated natural frequencies almost coincide with the measured ones, so that one can assume that the assumed material properties are correct. The total mass of the chimney for the given geometry is 81.388 kg.

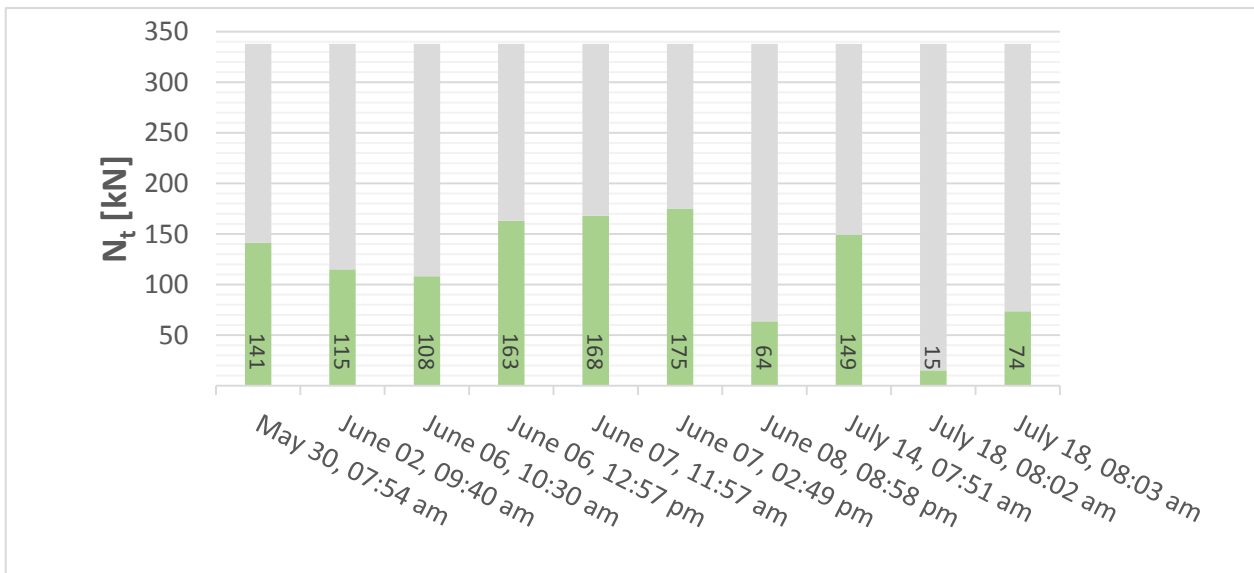
In Figs. 12 and 13, the compressive stress and the tensile forces are shown. As can be seen, the permissible compressive stress of 4.8 MPa and the existing permissible tensile force of 338 kN were never reached. It is noticeable that the higher the vibration velocity was measured, the lower the loads. On the other hand,

Fig. 13: Existing tensile force (green), missing tensile force to reach the permissible one (grey)
