Collecting Built Environment Information Using UAVs: Time and Applicability in Building Inspection Activities

Keywords: maintenance plan; preventive maintenance; buildings inspections; inspection costs; UAV

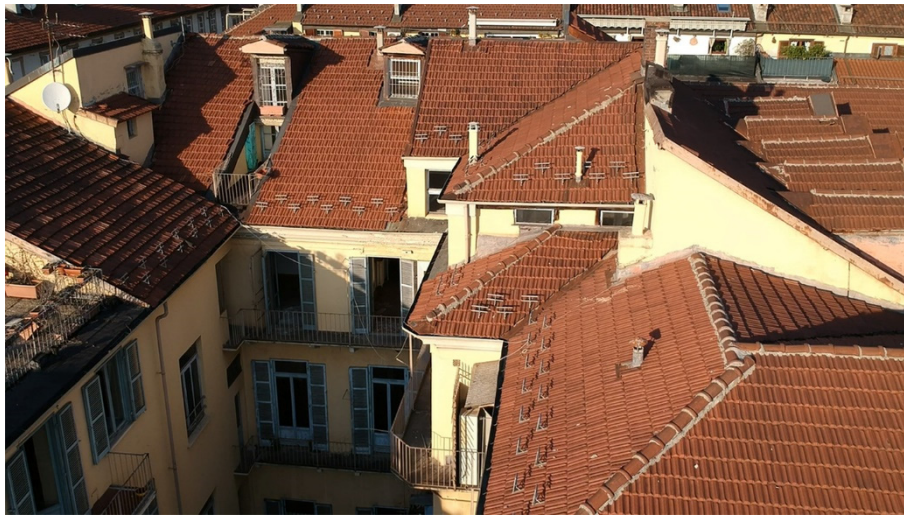
Figure 7. Picture that shows the facade of the inspected building. The frame was extrapolated from the video registered by the UAV's camera (source: real estate company archive).

The simulations assumed so far are derived from a survey that was carried out by a real estate company to detect the state of maintenance of a building in the outskirts of Turin (Figures 7 and 8). Using a drone, a series of photographs was collected that allowed the designers to understand the real state of the roof and of the facades. The survey was conducted before the renovation works by three workers (an architect, a surveyor and a worker) and it took about three hours on the field, also including the time to reach the area. The post-production time was about 50 min and it consisted only in the analysis of the photograms and of the video. As far as economic data are concerned, it was not possible to divide them by the global costs of the renovation design service. Nevertheless, these inspection data were very useful to determine the time of the options above hypothesized (Table 10).

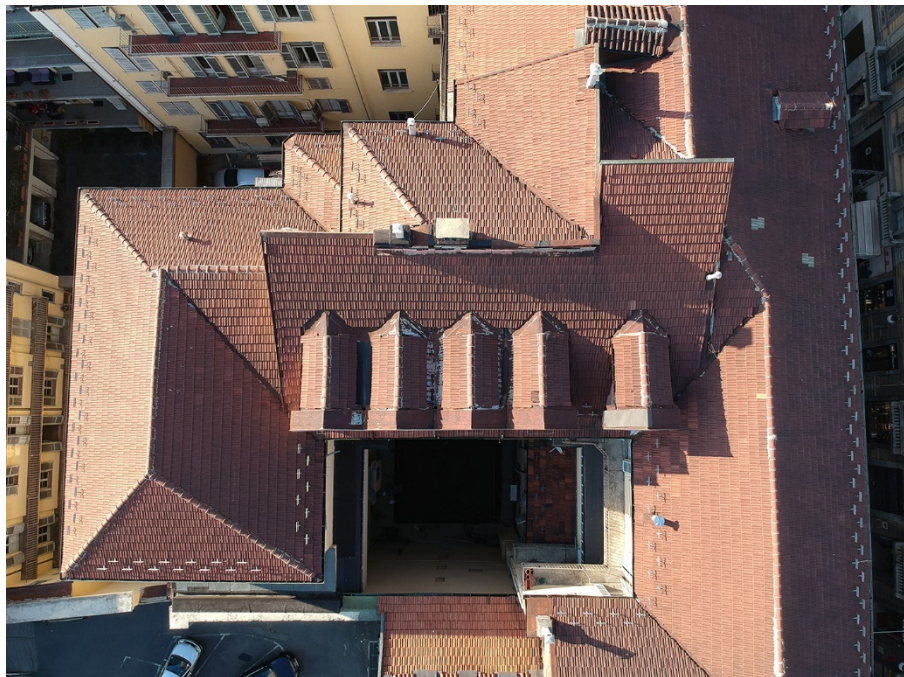
Figure 8. Picture that shows the roof system of the inspected building. The frame was taken with UAV's camera (source: real estate company archive).
