# Collecting Built Environment Information Using UAVs: Time and Applicability in Building Inspection Activities

**Abstract:** The Italian way of thinking about maintenance is too often one-sided. Indeed, it is considered not so much as a useful practice to prevent the occurrence of a fault (ex ante), but as an intervention to solve it (ex post). Analyzing the legislation relating to the construction sector, it can be seen that it does not clearly define the responsibilities, timescales and methods in which maintenance interventions must be planned and carried out. For this reason, this practice is still very weak compared, for example, to the industrial sector, where it is an established practice. Currently, the complexity of reading the maintenance plans drawn up by designers and the considerable costs associated with maintenance operations discourage owners and managers from even carrying out preliminary inspection operations. This research aims to stimulate these stakeholders to carry out inspection operations regularly, highlighting their costs and benefits. In particular, working on a case study in Piedmont, the costs of visual inspections carried out in the traditional way a

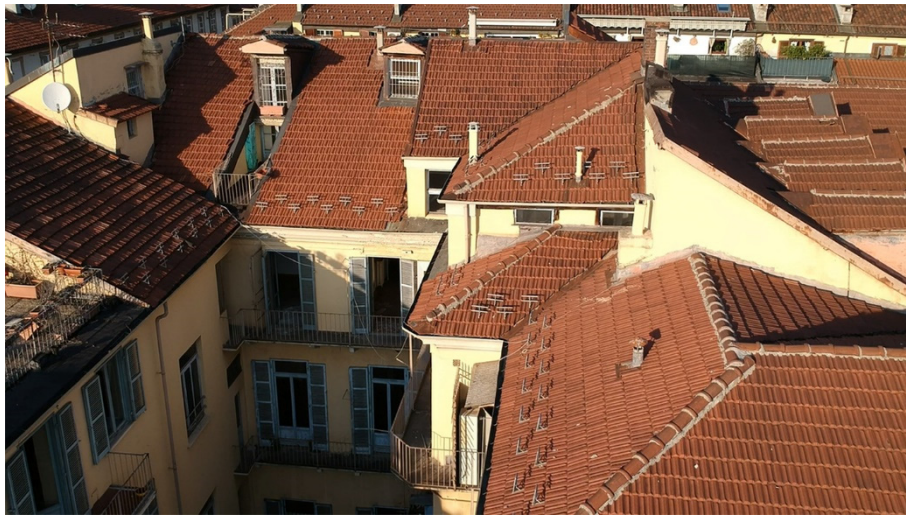
**Figure 7.** Picture that shows the facade of the inspected building. The frame was extrapolated from the video registered by the UAV's camera (source: real estate company archive).

The simulations assumed so far are derived from a survey that was carried out by a real estate company to detect the state of maintenance of a building in the outskirts of Turin (Figures 7 and 8). Using a drone, a series of photographs was collected that allowed the designers to understand the real state of the roof and of the facades. The survey was conducted before the renovation works by three workers (an architect, a surveyor and a worker) and it took about three hours on the field, also including the time to reach the area. The post-production time was about 50 min and it consisted only in the analysis of the photograms and of the video. As far as economic data are concerned, it was not possible to divide them by the global costs of the renovation design service. Nevertheless, these inspection data were very useful to determine the time of the options above hypothesized (Table 10).

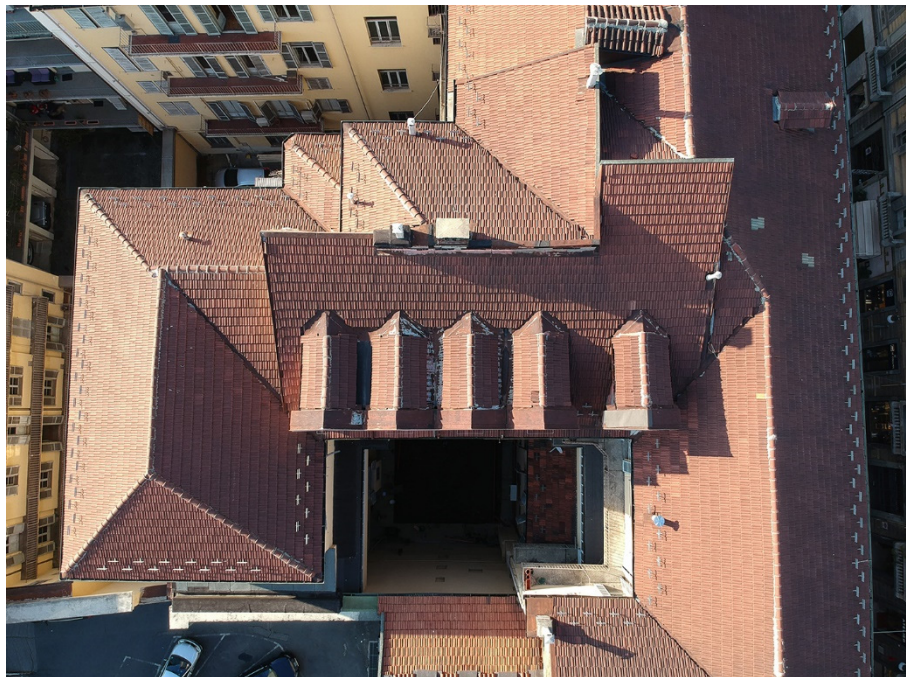
**Figure 8.** Picture that shows the roof system of the inspected building. The frame was taken with UAV's camera (source: real estate company archive).
