MA-XRF measurement for corrosion assessment on bronze artefacts

Abstract – In this study, an innovative portable macro X-Ray Fluorescence (MA-XRF) scanner prototype has been employed in order to gain information on composition and distribution of corrosion products artificially grown on Cu-based coupons. First results have shown the importance of using artificially corroded reference samples before any assessment on archaeological artefacts. Moreover, the prototype used demonstrated to be a powerful tool for understanding complex corrosion processes which might occur on Cu-based alloys. The scanner was able to detect light elements as S and Cl, essential for studying the distribution of specific corrosion compounds. Using imaging techniques, it was possible to observe a gradient in Cu elemental maps intensity caused by the overlapping of a thicker corrosion product layer.

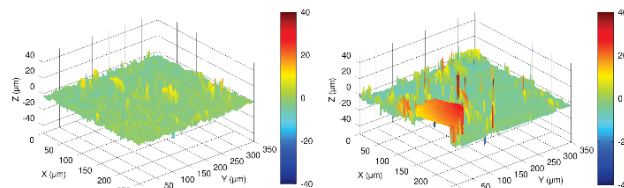
Fig. 2 shows, as an example, the confocal microscope images acquired on some of the copper reference samples. The *CW sample* presents a quite smooth surface structure with a standard deviation of about 2.7 μm ; the *sulphate sample* instead presents a more heterogeneous morphology with surface roughness values of about 6.1 μm .

Fig. 2. Confocal microscope images of the CW (left) and sulphate (right) corroded layers.

The roughness can be one of the major geometrical variables that affect the scanner performance, therefore a comparison of roughness and the sum map can show the presence of a geometrical factor that can create a sort of distortion on the scanner response. If the statistics are enough, one can hypothesize using an elemental map image as a mask to account for any roughness contribution to the final images.

The corrosion product layer thickness can vary greatly, and it depends on the nature of the products present and the alloy. As an approximation, its thickness can vary from 40 to 138 μm in the case of tin bronzes and from 14 to 146 μm in the case of quaternary bronzes [20]. Therefore, it is unlikely that, in this case, roughness would cause any significant distortion in the elemental distribution maps.
