ARCHITECTURAL HERITAGE AT RISK: THE CASE OF THE MAGNANO HAMLET (PIEDMONT, ITALY)

F. Fratini¹ *, M. Mattone², S. Rescic¹

KEY WORDS: Architectural heritage, Risk, Preservation, Compatibility, Identity, Re-use

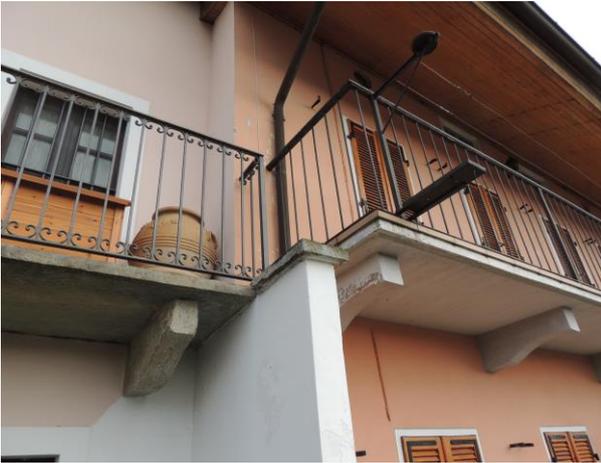
2.2.1 Adaptation of the historical built: Over time, some of the buildings of the hamlet have undergone interventions aimed at ensuring their re-use for residential purposes. They provided for the restoration of missing parts and the reshaping of the buildings in relation to aesthetic tastes and functional needs of the owners. Specific conservation requirements of the cultural heritage have not been sufficiently taken into account and interventions compromising its integrity and inherent values have been carried out. They led to a significant transformation of the buildings which often lost their specific features. The only recognised value was the use value, which led to the adaptation of the built to changing conditions in order to make it able to suit the new needs. The insertion of balconies with reinforced concrete structure (Figure 7); the insertion of stone slab coverings along the baseboards and of ceramic tiles on the external floors (Figure 8); the addition of wooden battens in the overhang of the roof (Figure 9); the replacement of windows and the application of finishing plasters testify to the lack of attention towards the architectural heritage which is altered without paying sufficient attention to its historical-cultural as well as formal characteristics. Integrations and replacements are carried out by compromising the preservation of the architectural artefacts both at the typological and construction level and causing the irremediable loss of their identity.

Figure 7. Building E - Balcony with reinforced concrete structure (credits Fabio Fratini).

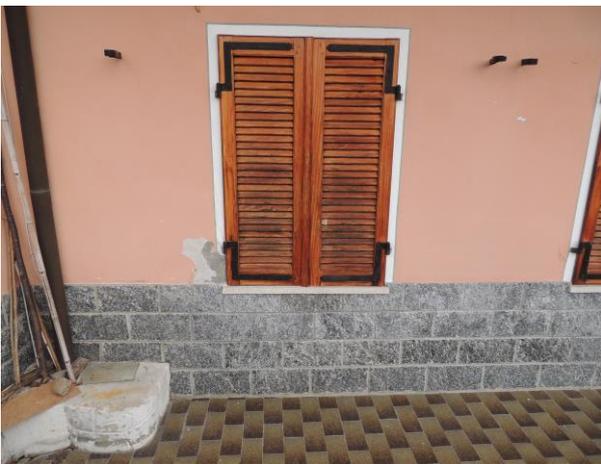
Figure 8. Building E - Baseboard in stone slabs and an external flooring in ceramic tiles, replacement of the windows and application of a new finishing layer (credits Fabio Fratini).

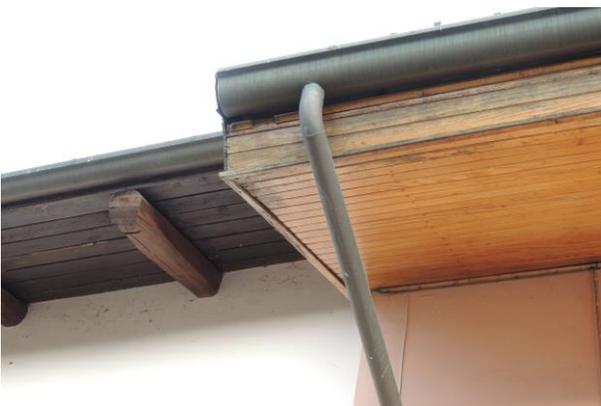
Figure 9. Building E - Wooden battens in the overhang of the roof (credits Fabio Fratini).

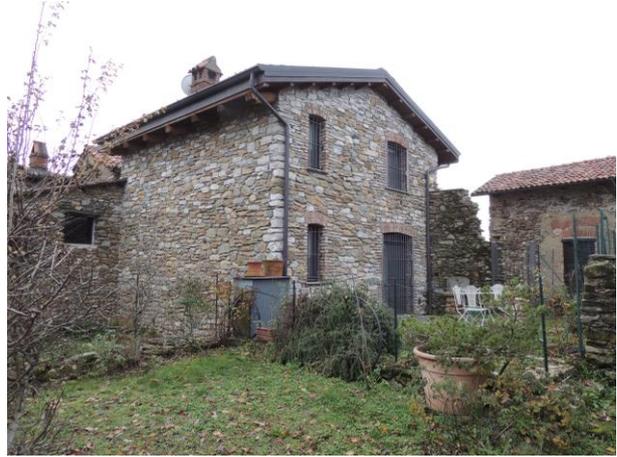
The same applies to restoration interventions that involve the reintegration of destroyed parts of the buildings such as walls, roofs, windows. Although the materials used are similar to the original ones, the treatment reserved for them is totally different. The methods of laying the stone and the bedding mortar change; the thickness of the roof is improved, presumably in relation to the desire to guarantee higher energy performances (Figure 10).

Figure 10. Building D - Reintegration of the upper part of the walls and of the roof (credits Manuela Mattone).

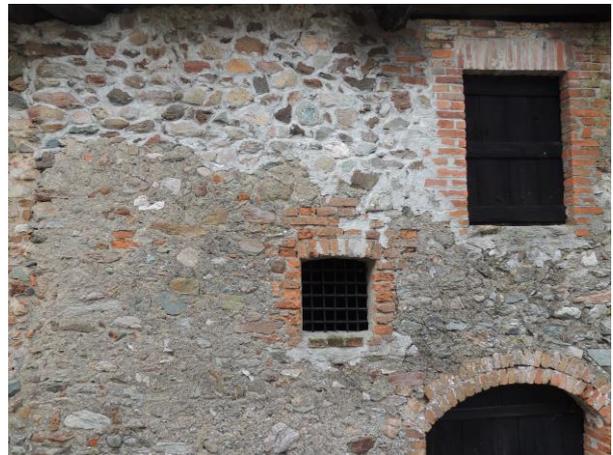
2.2.2 Incompatible materials and technique: Numerous inappropriate punctual interventions have also been done. Restoration of the walls has been often carried out using inadequate laying materials and methods. Particularly noteworthy is the widespread use of cement mortar not only for the bedding of bricks, but also for the reintegration of cracks and heavily eroded bricks (Figures 11 to 15).

Figure 11. Building B - Reintegration of the masonry adopting inappropriate materials (credits Fabio Fratini).

This intervention is incompatible not only from the mechanical point of view (elastic modulus of the whole), but also as regards the chemical (development of saline efflorescence) and physical compatibility (different behaviour towards water both in liquid and vapour form).

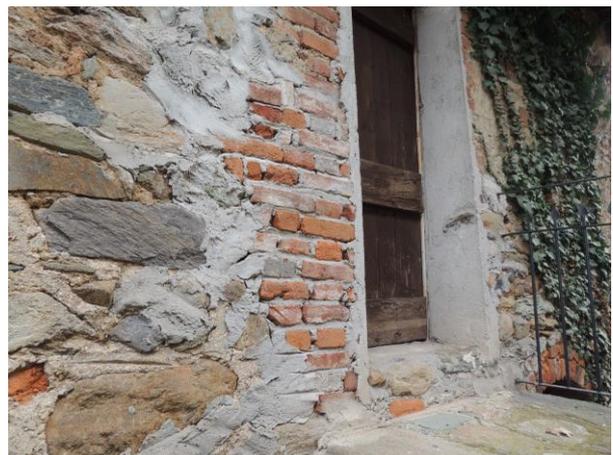
Figure 12. Building G - Improper intervention with cement mortar (credits Fabio Fratini).

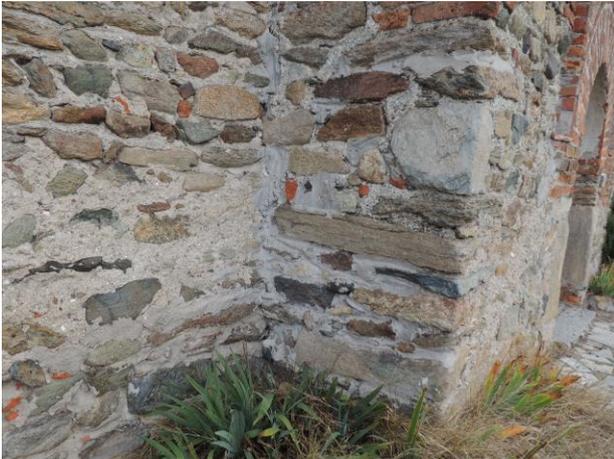
Figure 13. Building A - Grouting with cement mortar (credits Fabio Fratini).

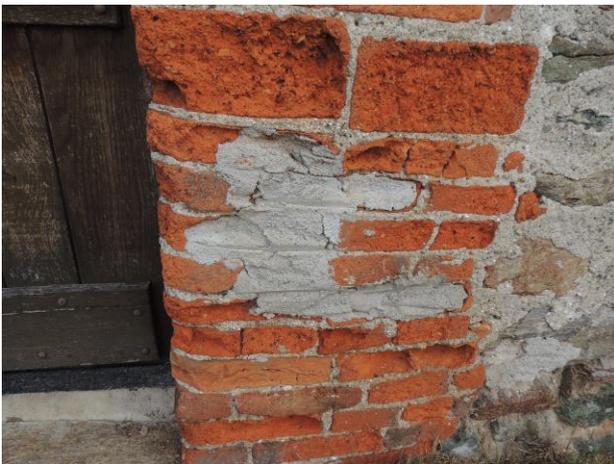
Figure 14. Building A - Reintegration of eroded bricks with cement mortar (credits Fabio Fratini).

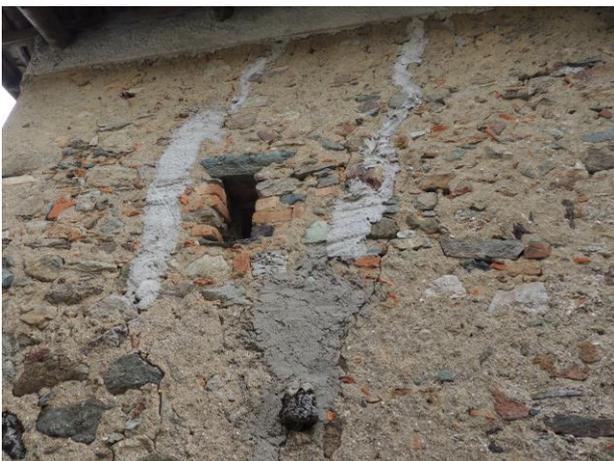
Figure 15. Building G - Filling of cracks with cement mortar (credits Fabio Fratini).

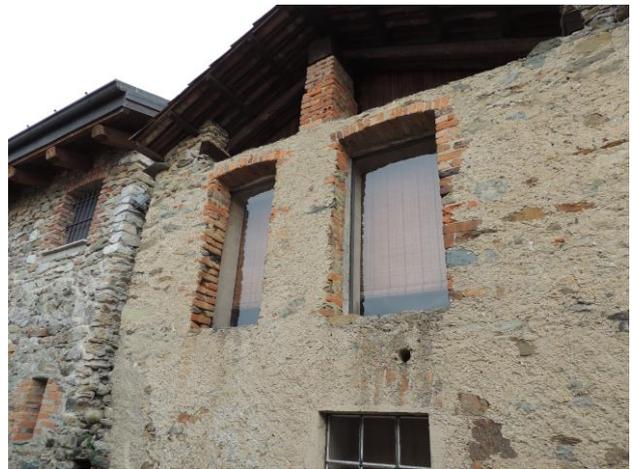
Interesting in this sense are the examples of Figures 16 and 17. In the first case, the intervention aimed at ensuring the re-use of the building was carried out without changing the characteristics of the masonry surface and of the roof, whose thickness was not altered.

In order to solve the problems due to the lack of light in the interior, windows were replaced adopting thin window frames (Figure 16).

Figure 16. Building F - Intervention preserving both the external masonry surfaces and the roof (credits Silvia Rescic).

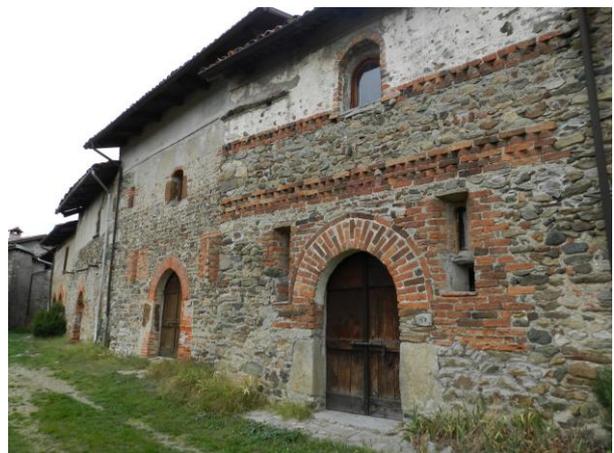
Preservation of the external wall surfaces and their stratifications, as well as of the finishing elements (such as the access portal) characterise also the intervention shown in Figure 17.

Figure 17. Building H - Preservation of the surface of the external wall and of the access portal (credits Silvia Rescic).
