TOWARDS A SUSTAINABLE AND CONTEXT-BASED APPROACH TO ANTI-SEISMIC
RETROFITTING TECHNIQUES FOR VERNACULAR ADOBE BUILDINGS IN COLOMBIA

International Conference on Vernacular Architecture in World Heritage Sites. Risks and New Technologies (Volume XLIV-M-1-2020)

F. De Filippi¹, R. Pennacchio^{1,*}, L. Restuccia², S. Torres¹

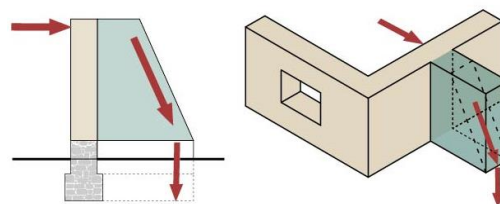
Figure 1. Buttresses seismic load transferring into foundation. Data from Minke (2001).

Perpendicular reinforcements reduce the bending moment in the middle of the walls, by transferring horizontal seismic loads diagonally to the foundations (Minke, 2001) (Figure 1). Horizontal and diagonal bending cracks and wall overturning are so avoided (Ojeda, 2002). Additionally, corner buttresses can increase walls vertical and horizontal load capacity in a 16% (Angulo et al., 2011).

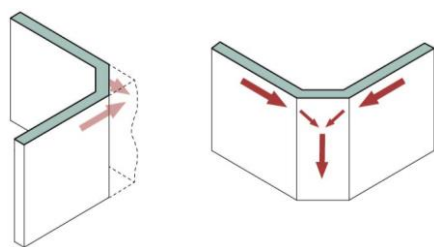
Figure 2. Rounded corners scheme. Figure from Minke, 2001.

Corner chamfering helps to reduce the shear and bending stress concentration on the junction of perpendicular walls (Figure 2) (Minke, 2001; Pennacchio, Nicchia, 2013). Even if this strategy can increase by 9% the gravitational and horizontal collapse load (Angulo et al., 2011), can only be applied during new buildings design phase, and cannot be taken into consideration for retrofit interventions.

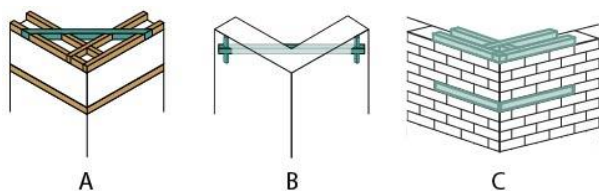
Figure 3. Corner braces options. Image redraw from Ortega et al. (2017).

Corner braces or corner keys reinforcements otherwise, help strengthening wall-to-wall junction as shown on Figure 3 (Angulo et al. 2011; Ortega et al., 2017).

Corner timber bracing reduce tensile cracks failures, by sharing shear stress among adjacent walls, while helping the masonry to keep its box-like behaviour, by strengthening corner junctions. Additionally, timber is able to assume the bending stress before adobes are carried to failure. Furthermore, even if the adobe masonry would crack in the corners, the braces reinforcement should keep the walls together. This type of reinforcement allows to modify the seismic response of the structure: it acquires a dissipative behaviour and therefore a greater ductility, linked to the post-peak capacity to absorb energy before breaking (Ortega et al., 2017), avoiding a sudden collapse of the corner. Angulo et al. (2011), found that, under vertical and horizontal loads, in case of corner braces fixed to the ring beam, the collapse load increase in 118% (Figure 3a), in 64% using diagonal tie braces (b), while, bracing beams parallel to the walls, showed a collapse load increase of 48% (c).

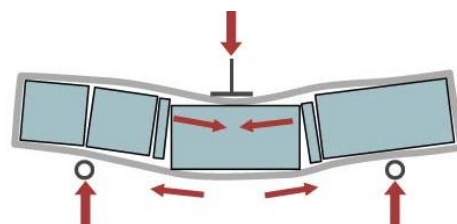
Figure 4. Adobe bricks kinematics and geogrid bending effect. Redrew from Invernizzi et al., 2017.

3.3.1 Plastic geogrids and synthetic ropes reinforcement: were studied for the first time in Latino America at 'Pontificia Universidad Catolica de Perú'. An interesting proposal, in this regard, is the use of a rope grid to reduce costs and make the technology accessible to poor population (Blondet et al., 2011). The behaviour of the wall compound, under horizontal non-axial loads, is schematized in Figure 4 (Invernizzi et al. 2017). Geogrid control flexural cracks caused by the maximum bending moment, thus reducing the associated failure mechanisms and, providing tensile strength to the adobe wall (Blondet et al., 2011). Considering a deflection increase of almost 750% for the geogrids reinforced walls under non-axial loads, Invernizzi et al. (2017) specified that the reinforcement is able to redistribute the stress, bracing the wall and keeping it together, as a single element. Moreover, shear capacity of geogrid reinforced elements is increased by 180% and shear deformation is 4 times larger than the unreinforced walls (Invernizzi et al. 2017). This suggests that failure mechanisms by shear cracking in walls and corners can be reduced by geogrid reinforcements.

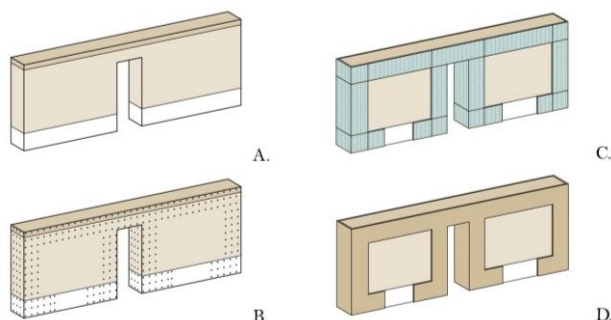
Figure 5. Rib lath reinforcement implementation. a) Adobe walls with ring beam and base course. b) Perforating wall for rib lath fixing. c) Localize rib lath d) Plastering rib lath. Redrew from Yamín et al. (2007) and Ruiz et al. (2012).

3.3.3 Rib-lath grids reinforcements: on top of the walls, on the corners and openings, create a ‘beams and columns’ additional pattern over both faces of the wall (Ruiz et al., 2012; Yamín et al., 2003). Figure 5 resumes the reinforcement implementation process; required materials are rib-laths, wire, and lime-sand mortar. The use of rib-lath reduce bending cracks in the middle of the wall and in the corners. According to Yamín et al. (2007), the reinforced walls, tested under non-axial loads, supported 43 kN without collapsing. Under earthquake shake table test, the reinforced adobe house model showed both enhanced ductility and energy dissipation of the structure (Yamín et al., 2007). Unexpectedly, the model suffered a sudden collapse (Yamin et al., 2003).
