Addressing the need for standardization of test methods for self-healing concrete: an inter-laboratory study on concrete with macrocapsules

Addressing the need for standardization of test methods for self-healing concrete: an inter-laboratory study on concrete with macrocapsules / Van Mullem, Tim; Anglani, Giovanni; Dudek, Marta; Vanoutrive, Hanne; Bumanis, Girts; Litina, Chrysoula; Kwiecie, Arkadiusz; Al-Tabbaa, Abir; Bajare, Diana; Stryzewska, Teresa; Caspeepe, Robby; Van Tittelboom, Kim; Tulliani, JEAN MARC CHRISTIAN; Gruyaert, Elke; Antonaci, Paola; De Belie, Nele. - In: SCIENCE AND TECHNOLOGY OF ADVANCED MATERIALS. - ISSN 1468-6996. - ELETTRONICO. - 21:1(2020), pp. 661-682.

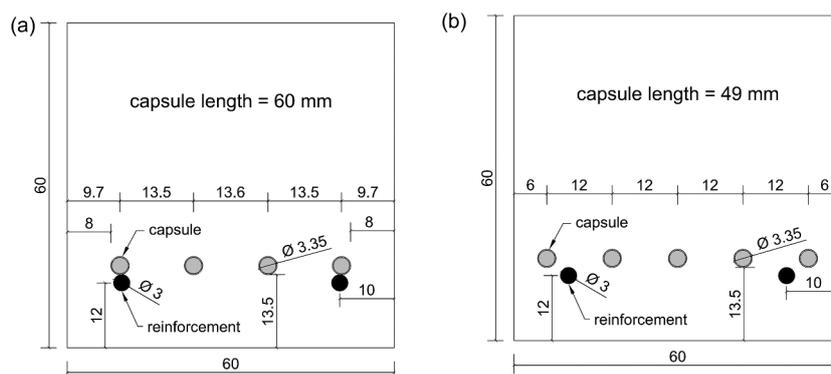
Figure 1. Cross-section of concrete specimens (a: layout with four capsules, b: layout with five capsules) (dimensions in mm).

agent to a slightly larger area of the crack in order to obtain perfect healing, see Figure 1 a. For the layout with five capsules, the requirement that the largest aggregates should be able to pass between the capsules and the side faces was not imposed as this would cause too much deviation from the identical circular outflow for the outermost capsules. Instead extra care was taken in filling and compacting these moulds. In both layouts, capsules were prepositioned in the moulds by gluing them on a nylon wire running just above the reinforcement, see Figure 2.

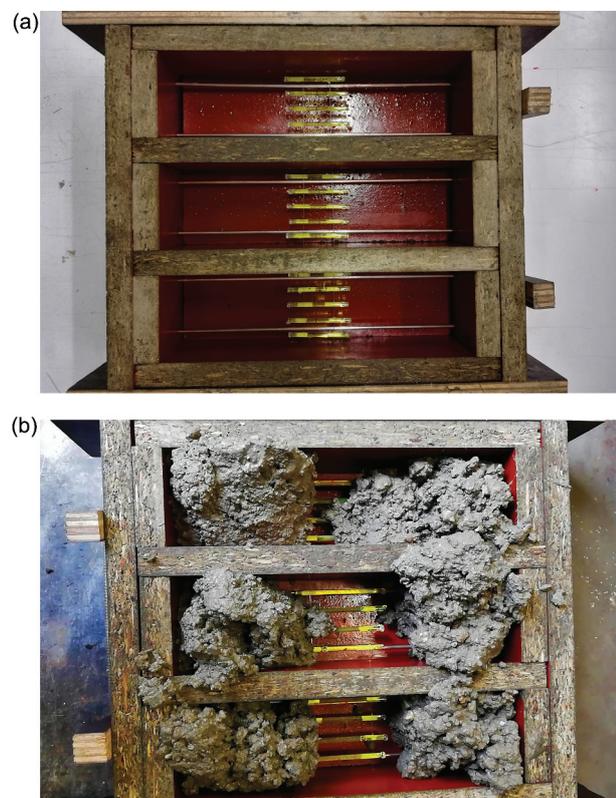
Figure 2. Moulds to make concrete specimens (60 × 60 × 220 mm³) with capsules (a: mould with five capsules; b: casting of specimens with four capsules).

All specimens were compacted on a vibration table. For the specimens with capsules, concrete was first placed next to the capsules, see Figure 2. The vibration table was then activated allowing the concrete to flow under and between the capsules, after which the rest of the concrete was added. The specimens were stored in a curing room (20°C and >95% relative humidity RH) and the day after casting they were demoulded. No compaction defects were visible for the specimens with five capsules, despite the limited distance between the outer capsules and the walls of the mould. The specimens were sealed in plastic foil in groups of three to prepare them for shipping. Up until the moment of shipping the specimens remained in a climate room at 20°C.

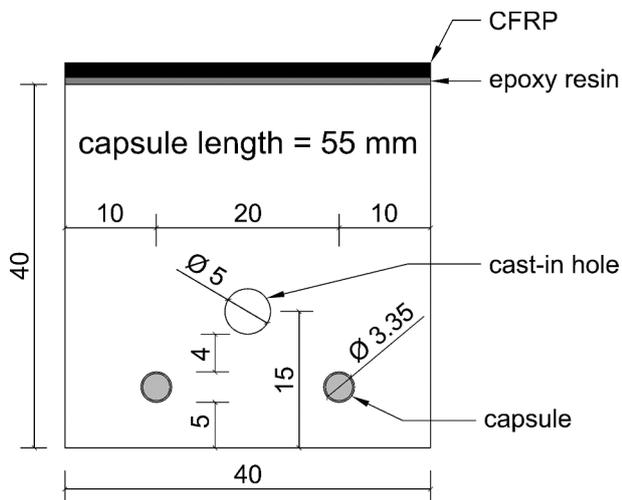
Figure 3. Cross-section of mortar specimens with capsules (dimensions in mm).

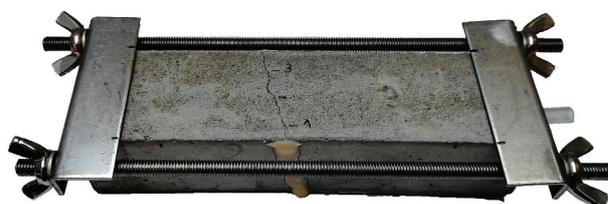
Figure 4. Screw jacks used for actively restraining the crack width of a mortar specimen.

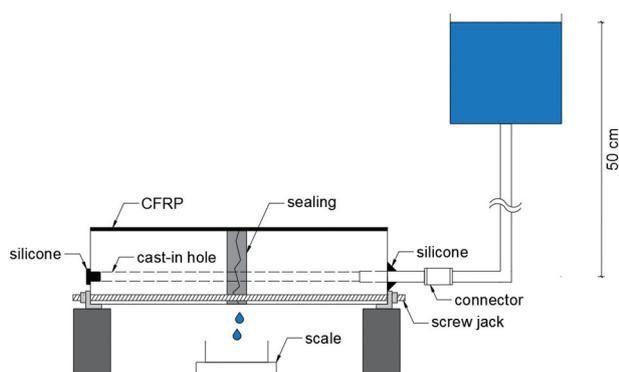
Figure 5. Water permeability measured by a constant head water flow test [33].

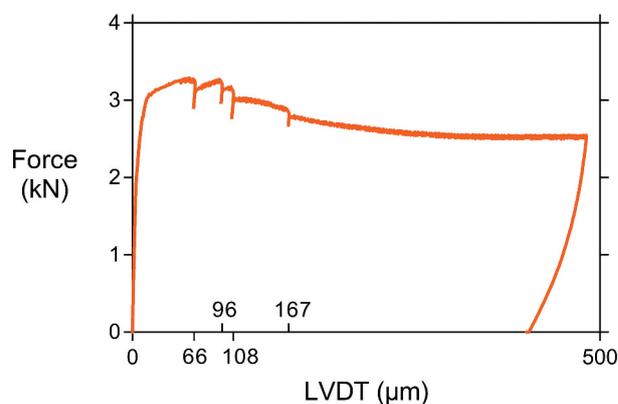
Figure 6. Load displacement graph of a CAPS specimen showing capsule rupture at 66, 96, 108, and 167 μ m.

From the data recorded during crack creation by three-point bending, controlled by using a displacement-controlled loading system, it was possible to plot load-displacement graphs. In the case of CAPS specimens, small drops in the load indicated the rupture of capsules. Figure 6 shows the load displacement graph of a representative concrete specimen with four capsules. In the represented case the four capsules broke at: 66, 96, 108 and 167 μ m of crack mouth opening. For some specimens, it was not possible to discern a discrete load drop for all of the contained capsules. The reason for this could be noise on the data or simultaneous breaking of multiple capsules. It has been reported for the type of capsules used in this study that the crack width at rupture at the location of the capsule is approximately 25 μ m [48]. This value was surpassed in all specimens; therefore, it can be assumed that all capsules inside of the concrete specimens ruptured.

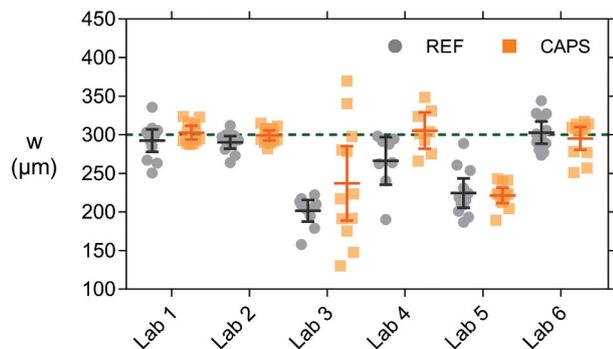
Figure 7. Crack width w of individual concrete specimens for which the mean of the series are indicated by horizontal lines and error bars give the 95% confidence interval on this mean. The horizontal dashed line indicates the target crack width of 300 μm .

After cracking, the crack width w at the bottom side of the concrete specimens was measured. Figure 7 shows the individual mean crack width of each specimen, as well as the mean of the series (horizontal lines) and the 95% confidence interval on this mean (error bars) for both REF and CAPS specimens. The horizontal-dashed line indicates the target crack width of 300 μ m. It is evident that there was quite some variation on the results, even though two minimal outliers (one of lab 3 REF and one of lab 4 REF) and two maximal outliers (two of lab 4 CAPS) were discarded from the dataset prior to plotting this graph and performing the subsequent statistical analysis. Table 5 shows the number of specimens for each lab after removing the outliers (lab 3 and lab 4 also lost some specimens while calibrating the cracking procedure). For each lab it was statistically analysed if the mean crack width of the REF, respectively CAPS specimens, was equal to the target crack width of 300 μ m (level of significance = 5.0%). Table 6 indicates that this

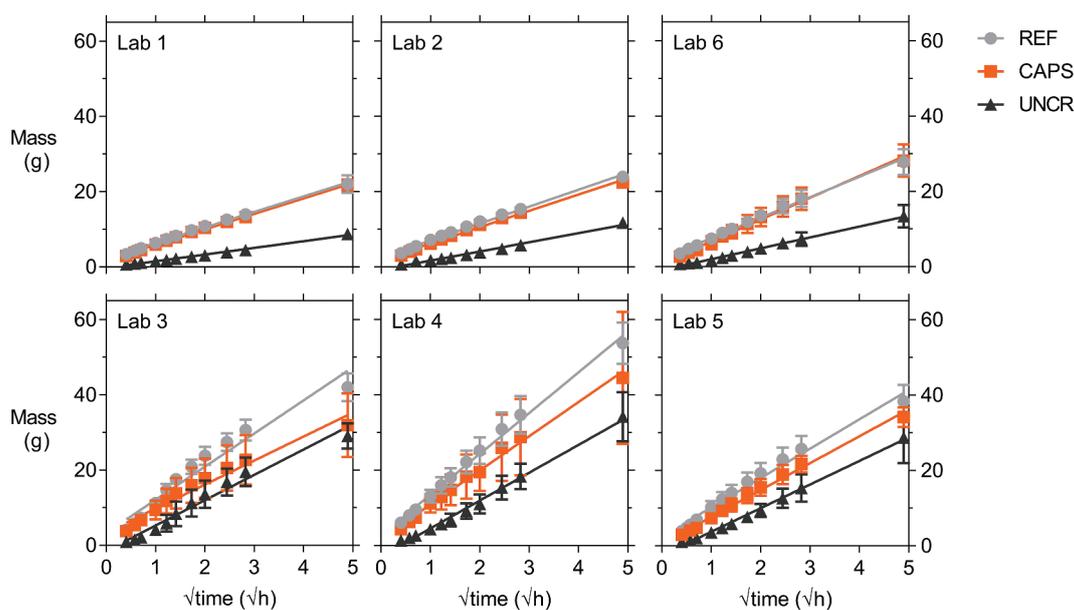
Figure 8. Cumulative mass gain versus the square root of time of REF, CAPS and UNCR specimens (waterproofed with aluminium tape) of all six labs with the linear regression line. Error bars indicate the standard deviation.

In order to calculate the sealing efficiency according to equation 1, the slope of the linear regression curve was determined both for waterproofing with aluminium tape and again for waterproofing with coating. It was noted that for nearly all cracked specimens the value after 24 hours of water contact fell below the regression curve, which was also the case when the specimens were waterproofed with aluminium tape (see Figure 8). In contrast, the uncracked

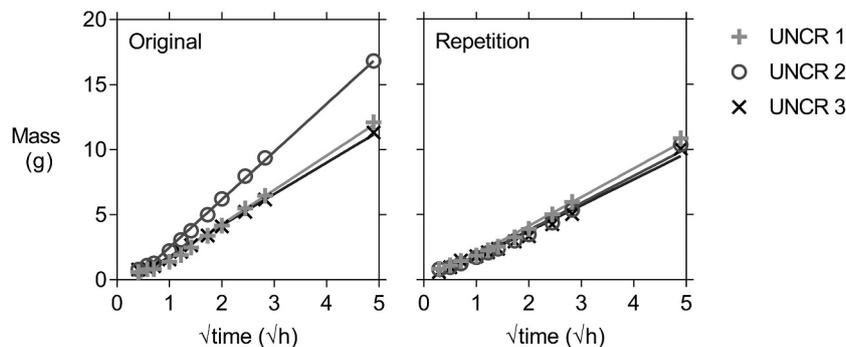
Figure 9. Comparison of the cumulative mass gain versus the square root of time for the uncracked specimens of lab 6 with the individual linear regression lines, showing a more uniform behaviour for the repeated waterproofing with aluminium tape compared to the original waterproofing with aluminium tape.

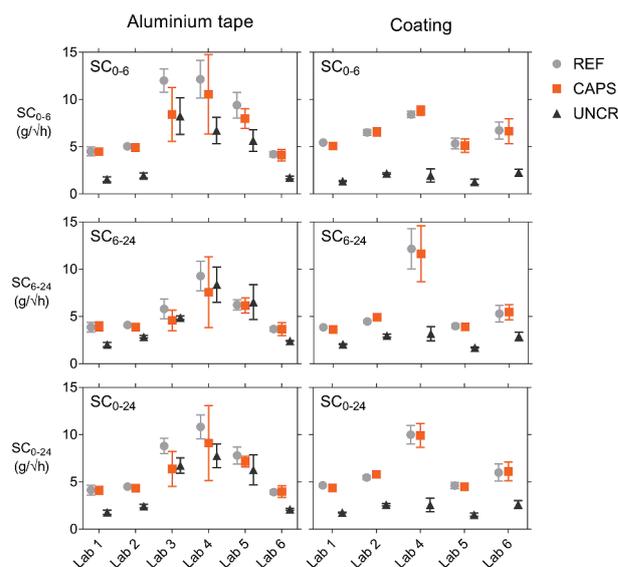
Figure 10. Sorption coefficients SC_{0-6} , SC_{6-24} and SC_{0-24} of REF, CAPS and UNCR specimens highlighting that an improved waterproofing quality results in more homogenous results. Error bars indicate the standard deviation.

Figure 10 gives a comparison of the three sorption coefficients, SC_{0-6} , SC_{6-24} and SC_{0-24} , in the case of waterproofing with aluminium tape and in the case of coating. The results with aluminium tape for lab 6 are the ones from the repeated test after removing and applying new aluminium tape. For the cracked specimens (REF and CAPS) with aluminium tape, it was clear that SC_{6-24} is lower than SC_{0-6} . As explained before, this was a result of the saturation of the concrete above the crack tip. All sets of specimens tested by the different labs exhibited this behaviour, but it was distinctly visible for labs 3, 4 and 5. On the other hand, the sorption coefficient of the second period SC_{6-24} of the uncracked specimens is higher than the one of the initial period SC_{0-6} , as can, for example be seen for the uncracked specimens of lab 5 with

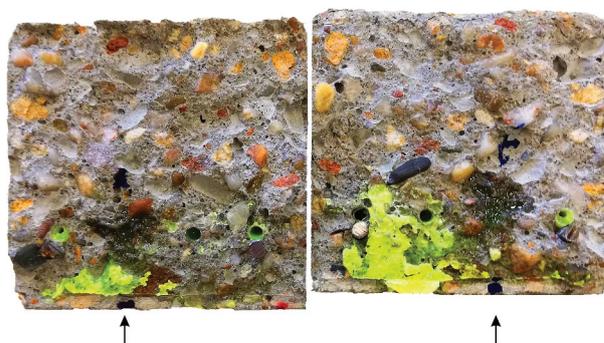
Figure 11. Crack surfaces (60 x 60 mm²) of one of the best performing CAPS specimen of lab 1. The hardened PU can be seen as fluorescent yellow. Arrows indicate the capsule from which fresh PU (visible as a dark stain) leaked on the surface when the specimen was broken. Image is highly saturated to improve visibility.

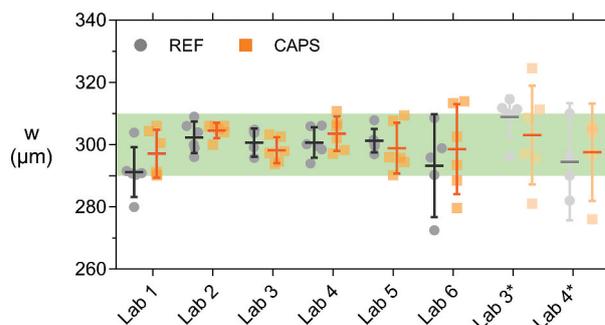
Figure 12. Crack width w of individual mortar specimens for which the mean of the series is indicated by a horizontal line and error bars give the 95% confidence interval on this mean. Most mortar specimens had a crack width w within the desired crack width range (shaded area).

After cracking the mortar specimens, they were restrained using screw jacks. The final mean crack width w measured by all labs after the active crack width restraining process is given in Figure 12. This figure shows the individual values, as well as the mean crack width of the series (horizontal lines) and the 95% confidence interval on this mean (error bars) for both REF and CAPS specimens. The green shaded band indicates the desired crack width range (290–310 μm). Lab 3 and lab 4 did a pre-test on a separately sent batch of specimens to familiarize themselves with the test technique, these are denoted by lab 3* and lab 4*. The crack width of many of these specimens fell outside of the intended range. Additionally, the screw jacks were not applying a significant pressure on the specimens, because the crack width of these specimens was rather limited after crack creation by three-point bending. In

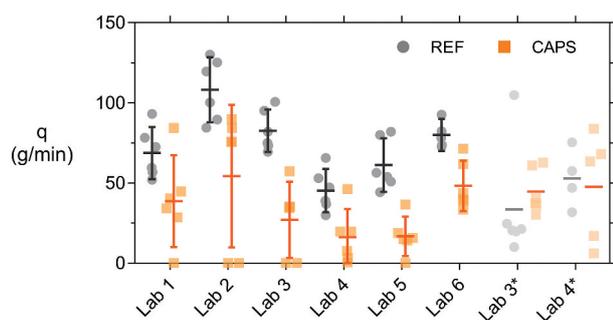
Figure 13. Individual flow rates q and the means of the different specimen batches indicated by horizontal lines. Error bars give the 95% confidence interval on the mean.

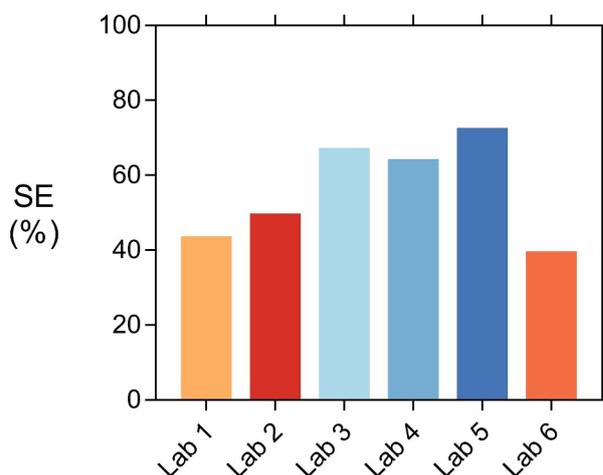
Figure 14. The sealing efficiency SE_{flow} , measured in the different labs.

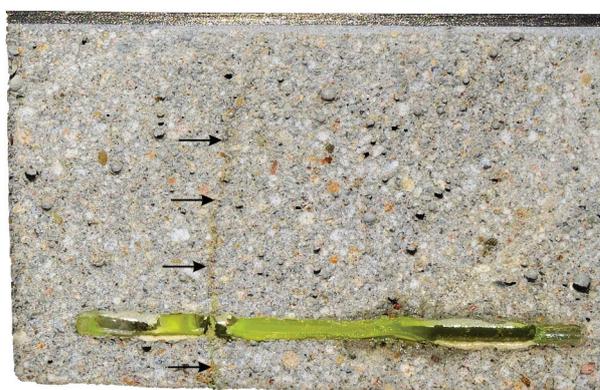
Figure 15. Mortar specimen with mortar removed from the side up to the location of a capsule (length approximately 55 mm) showing that most of the PU was retained in the capsule. Arrows indicate the location of the crack.

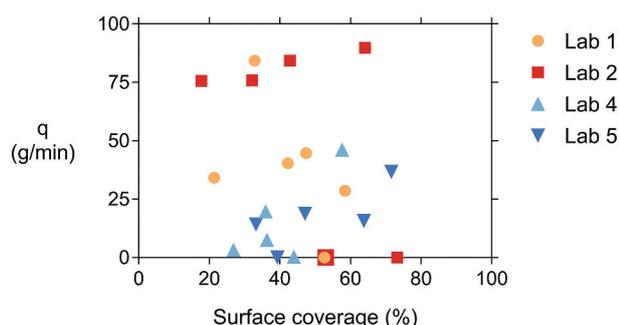
Figure 16. Water flow q versus the PU surface coverage for labs 1, 2, 4 and 5.

Figure 14. Figure 16 shows the water flow of the different specimens in function of their surface coverage. It is noted that it is impossible to obtain a perfect surface coverage since the area of the hole (used to induce the water in the permeability test) was taken into account in the total area. Anglani et al. [37] studied the same PU healing agent but encapsulated in one cementitious capsule with a larger diameter. These capsules had either an internal or an external epoxy coating to make them moisture-proof. They measured an average surface coverage of 36% for specimens with internally coated capsules and 47% for specimens with externally coated capsules. These values are comparable to the average surface coverage of the different labs, although it is noted that the variation is higher for the results reported here. The sealing efficiency measured by Anglani et al. [37], using the same permeability setup as is used in the current study, was equal to 79%, respectively 28%, for the specimens with an internally, respectively externally, coated capsule. Lab 1, 2, 4 and 5 obtained a sealing efficiency between 44% and 73% which falls in between these values.

From Figure 16 it could also be concluded that a high surface coverage does not directly translate into a good sealing efficiency. There seems to be no strong relationship between the surface coverage and the water flow. Indeed, the surface coverage only has an indirect influence on the water flow. Figure 17 shows a crack surface overlaid with its filtered segmented image determined using the Trainable Weka Segmentation plugin in ImageJ, see section 2.3.4. The surface coverage of this sample was one of the highest (71.6%), yet the zone below the hole was not completely covered with PU, leaving a path for the water to leak out of the specimen. To seal a crack, it is sufficient if the crack mouth is filled with healing agent, or in the studied specimens if the water-inducing hole is surrounded with healing agent. For many specimens it was noted that the PU spread regions from the individual capsules did not connect, and thus a barrier to withstand the water pressure could not be created.

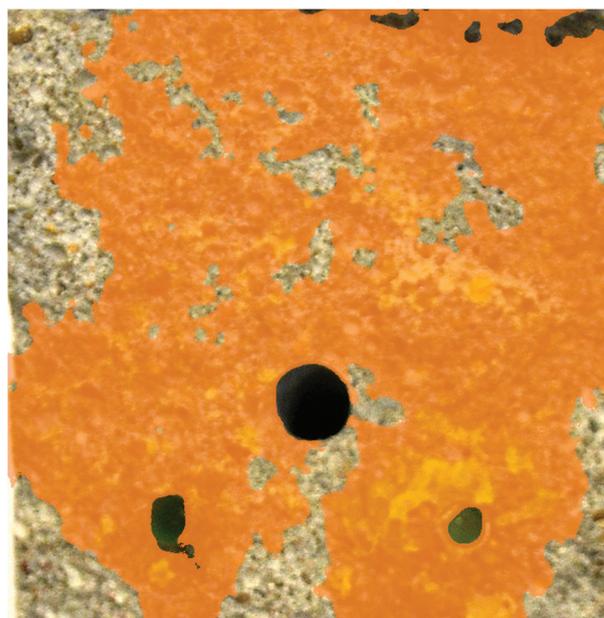
Figure 17. Crack surface ($40 \times 40 \text{ mm}^2$) of one of the specimens with the best PU surface coverage but still a significant flow due to an unconnected crack filling below the cast-in hole (through which water was induced during the permeability test). The crack mouth through which water leaked out of the specimen is oriented to the bottom, like in the water flow test.

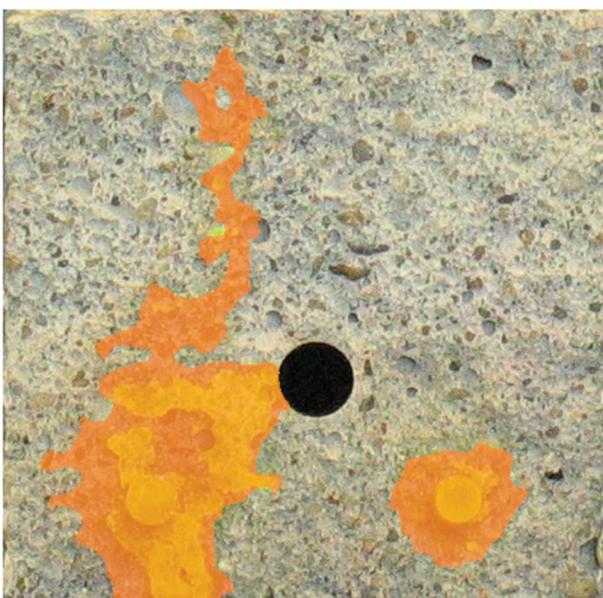
Figure 18. Crack surface ($40 \times 40 \text{ mm}^2$) of specimen with limited PU surface coverage. The crack mouth through which water leaked out of the specimen is oriented to the bottom, like in the water flow test.
