Addressing the need for standardization of test methods for self-healing concrete: an inter-laboratory study on concrete with macrocapsules

Tim Van Mullem , Giovanni Anglani , Marta Dudek , Hanne Vanoutrive , Girts Bumanis , Chrysoula Litina , Arkadiusz Kwiecień , Abir Al-Tabbaa , Diana Bajare , Teresa Stryzewska , Robby Caspeelee , Kim Van Tittelboom , Tulliani Jean-Marc , Elke Gruyaert , Paola Antonaci & Nele De Belie

Development and commercialization of self-healing concrete is hampered due to a lack of standardized test methods. Six inter-laboratory testing programs are being executed by the EU COST action SARCOS, each focusing on test methods for a specific self-healing technique. This paper reports on the comparison of tests for mortar and concrete specimens with polyurethane encapsulated in glass macrocapsules. First, the pre-cracking method was analysed: mortar specimens were cracked in a three-point bending test followed by an active crack width control technique to restrain the crack width up to a predefined value, while the concrete specimens were cracked in a three-point bending setup with a displacement-controlled loading system. Microscopic measurements showed that

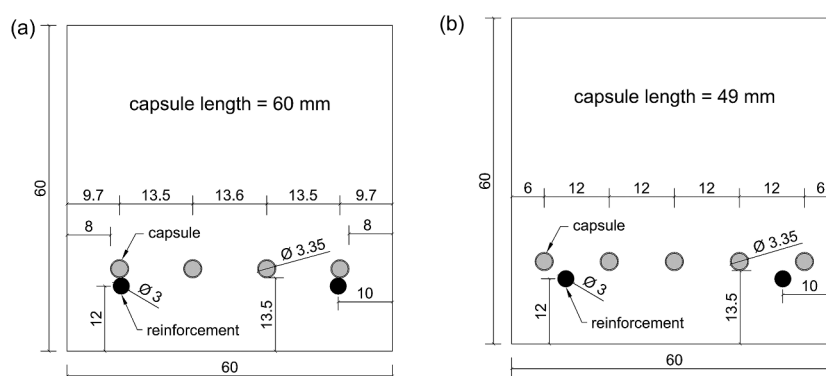
Figure 1. Cross-section of concrete specimens (a: layout with four capsules, b: layout with five capsules) (dimensions in mm).

agent to a slightly larger area of the crack in order to obtain perfect healing, see Figure 1 a. For the layout with five capsules, the requirement that the largest aggregates should be able to pass between the capsules and the side faces was not imposed as this would cause too much deviation from the identical circular outflow for the outermost capsules. Instead extra care was taken in filling and compacting these moulds. In both layouts, capsules were prepositioned in the moulds by gluing them on a nylon wire running just above the reinforcement, see Figure 2.

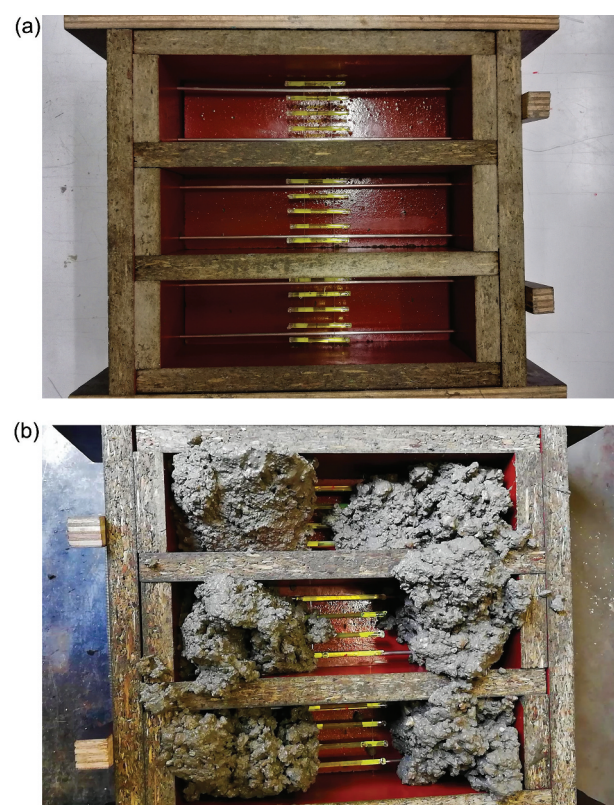
Figure 2. Moulds to make concrete specimens ($60 \times 60 \times 220 \text{ mm}^3$) with capsules (a: mould with five capsules; b: casting of specimens with four capsules).

All specimens were compacted on a vibration table. For the specimens with capsules, concrete was first placed next to the capsules, see Figure 2. The vibration table was then activated allowing the concrete to flow under and between the capsules, after which the rest of the concrete was added. The specimens were stored in a curing room (20°C and >95% relative humidity RH) and the day after casting they were demoulded. No compaction defects were visible for the specimens with five capsules, despite the limited distance between the outer capsules and the walls of the mould. The specimens were sealed in plastic foil in groups of three to prepare them for shipping. Up until the moment of shipping the specimens remained in a climate room at 20°C.

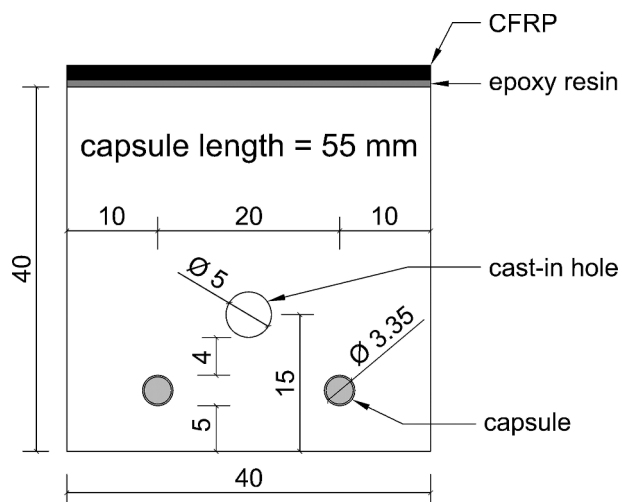
Figure 3. Cross-section of mortar specimens with capsules (dimensions in mm).

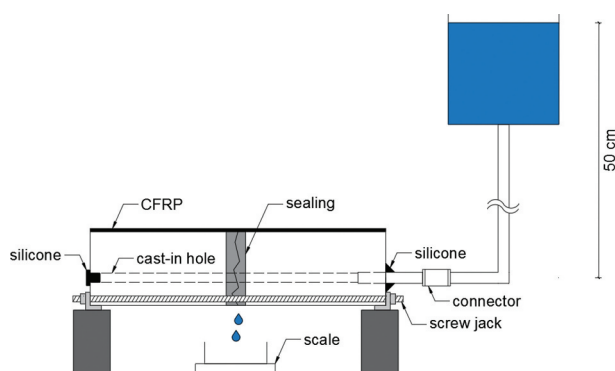
Figure 5. Water permeability measured by a constant head water flow test [33].

To measure the water permeability of the specimens a water flow test was used [10,33,34,44,45]. Prior to executing the test, specimens were stored dry in an indoor climate with their crack facing downwards for at least 1 day to allow the PU to polymerize. Afterwards, specimens were submersed in demineralized water for 24 to 48 hours to prevent any influence on the results from water absorption by the matrix. The specimens were then taken out of the water and were surface dried. To connect the specimens to the water flow setup, the cast-in hole was enlarged on one side to a diameter of 6 mm over a length of 25 ± 5 mm using a drill. This was done prior to cracking to prevent the vibrations from influencing the crack. A short tube (length of ± 60 mm, $\varnothing_{\text{external}}$ 6 mm, $\varnothing_{\text{internal}}$ 4 mm) was then inserted in the cast-in hole and a watertight connection was ensured using silicone. The other side of the cast-in hole was sealed completely (e.g. with silicone or a rubber stopper), see Figure 5. The inserted tube was connected to a tube (length of 130 ± 10 cm, $\varnothing_{\text{external}}$ 6 mm, $\varnothing_{\text{internal}}$ 4 mm) in contact with an open water reservoir. Instead of

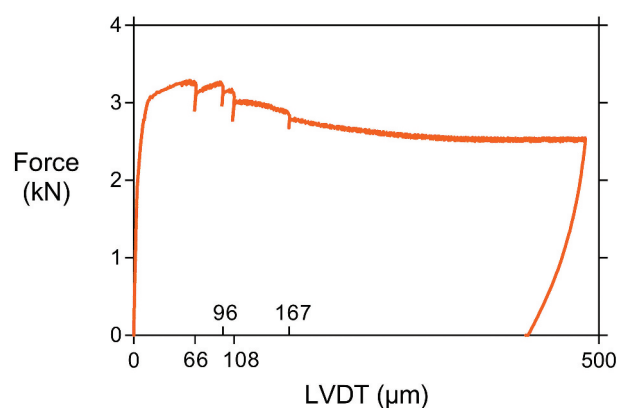
Figure 6. Load displacement graph of a CAPS specimen showing capsule rupture at 66, 96, 108, and 167 μ m.

From the data recorded during crack creation by three-point bending, controlled by using a displacement-controlled loading system, it was possible to plot load-displacement graphs. In the case of CAPS specimens, small drops in the load indicated the rupture of capsules. Figure 6 shows the load displacement graph of a representative concrete specimen with four capsules. In the represented case the four capsules broke at: 66, 96, 108 and 167 μ m of crack mouth opening. For some specimens, it was not possible to discern a discrete load drop for all of the contained capsules. The reason for this could be noise on the data or simultaneous breaking of multiple capsules. It has been reported for the type of capsules used in this study that the crack width at rupture at the location of the capsule is approximately 25 μ m [48]. This value was surpassed in all specimens; therefore, it can be assumed that all capsules inside of the concrete specimens ruptured.

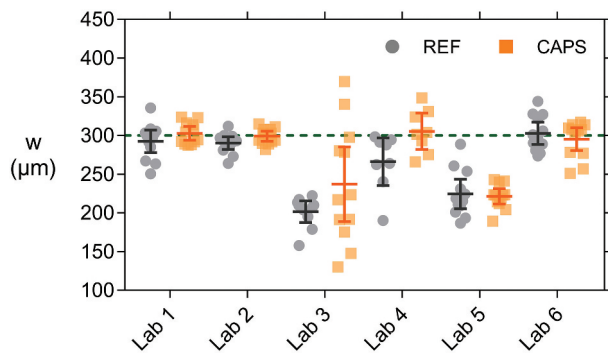
Figure 7. Crack width w of individual concrete specimens for which the mean of the series are indicated by horizontal lines and error bars give the 95% confidence interval on this mean. The horizontal dashed line indicates the target crack width of 300 μm .

After cracking, the crack width w at the bottom side of the concrete specimens was measured. Figure 7 shows the individual mean crack width of each specimen, as well as the mean of the series (horizontal lines) and the 95% confidence interval on this mean (error bars) for both REF and CAPS specimens. The horizontal-dashed line indicates the target crack width of 300 μ m. It is evident that there was quite some variation on the results, even though two minimal outliers (one of lab 3 REF and one of lab 4 REF) and two maximal outliers (two of lab 4 CAPS) were discarded from the dataset prior to plotting this graph and performing the subsequent statistical analysis. Table 5 shows the number of specimens for each lab after removing the outliers (lab 3 and lab 4 also lost some specimens while calibrating the cracking procedure). For each lab it was statistically analysed if the mean crack width of the REF, respectively CAPS specimens, was equal to the target crack width of 300 μ m (level of significance = 5.0%). Table 6 indicates that this

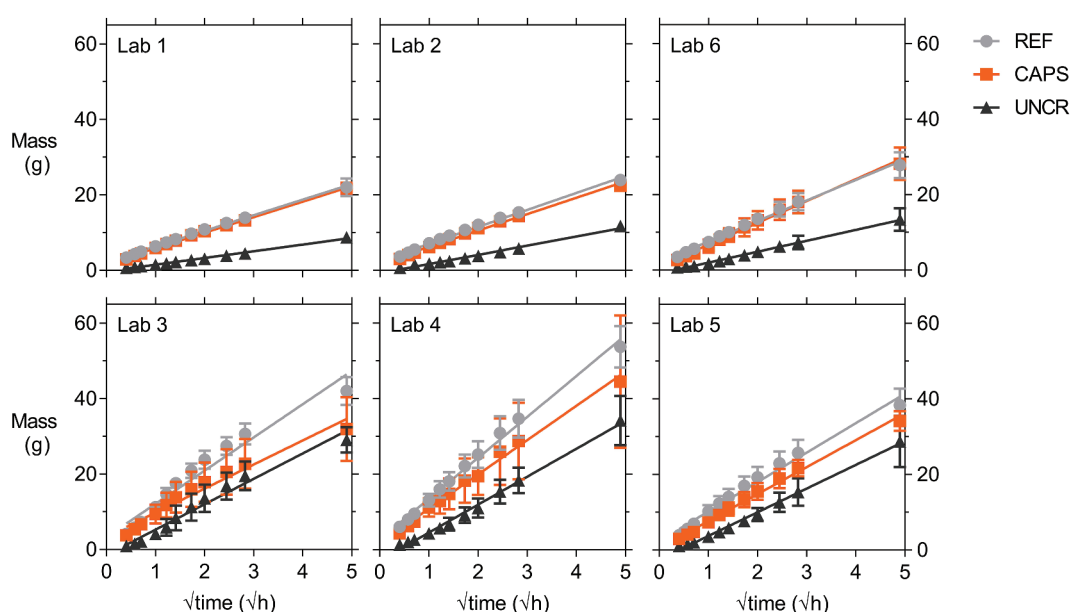
Figure 8. Cumulative mass gain versus the square root of time of REF, CAPS and UNCR specimens (waterproofed with aluminium tape) of all six labs with the linear regression line. Error bars indicate the standard deviation.

In order to calculate the sealing efficiency according to equation 1, the slope of the linear regression curve was determined both for waterproofing with aluminium tape and again for waterproofing with coating. It was noted that for nearly all cracked specimens the value after 24 hours of water contact fell below the regression curve, which was also the case when the specimens were waterproofed with aluminium tape (see Figure 8). In contrast, the uncracked

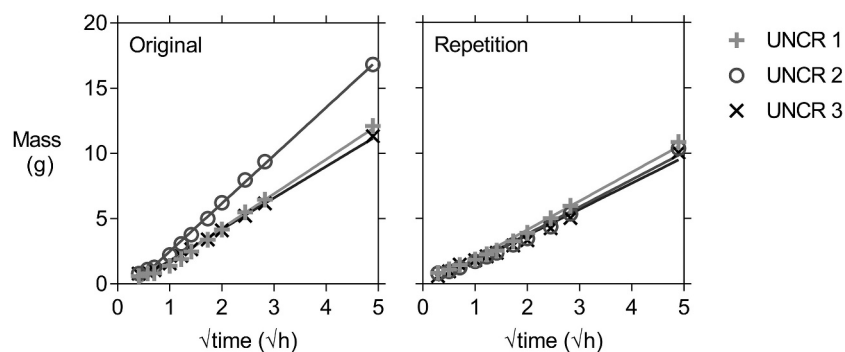
Figure 9. Comparison of the cumulative mass gain versus the square root of time for the uncracked specimens of lab 6 with the individual linear regression lines, showing a more uniform behaviour for the repeated waterproofing with aluminium tape compared to the original waterproofing with aluminium tape.

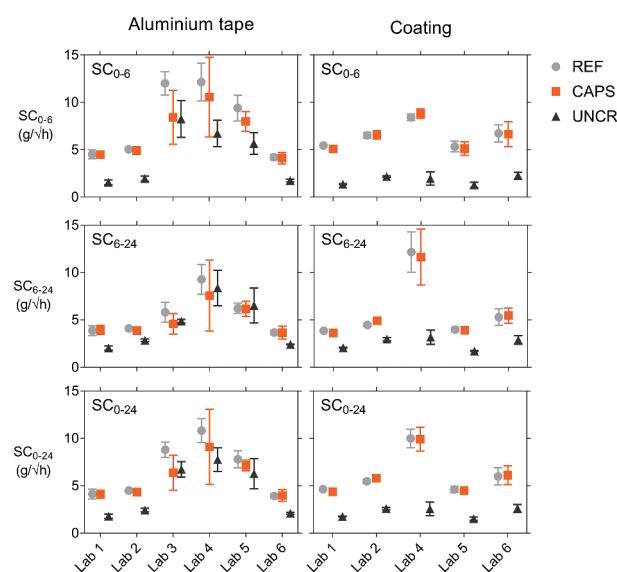
Figure 10. Sorption coefficients SC_{0-6} , SC_{6-24} and SC_{0-24} of REF, CAPS and UNCR specimens highlighting that an improved waterproofing quality results in more homogenous results. Error bars indicate the standard deviation.

Figure 10 gives a comparison of the three sorption coefficients, SC_{0-6} , SC_{6-24} and SC_{0-24} , in the case of waterproofing with aluminium tape and in the case of coating. The results with aluminium tape for lab 6 are the ones from the repeated test after removing and applying new aluminium tape. For the cracked specimens (REF and CAPS) with aluminium tape, it was clear that SC_{6-24} is lower than SC_{0-6} . As explained before, this was a result of the saturation of the concrete above the crack tip. All sets of specimens tested by the different labs exhibited this behaviour, but it was distinctly visible for labs 3, 4 and 5. On the other hand, the sorption coefficient of the second period SC_{6-24} of the uncracked specimens is higher than the one of the initial period SC_{0-6} , as can, for example be seen for the uncracked specimens of lab 5 with

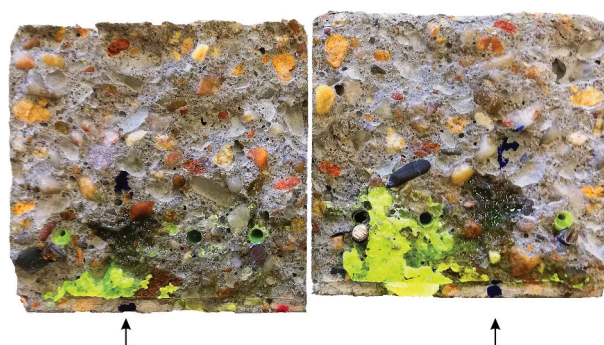
Figure 11. Crack surfaces (60 x 60 mm²) of one of the best performing CAPS specimen of lab 1. The hardened PU can be seen as fluorescent yellow. Arrows indicate the capsule from which fresh PU (visible as a dark stain) leaked on the surface when the specimen was broken. Image is highly saturated to improve visibility.

is amongst others also dependent on the thickness). Consequently, the PU inside the capsules sealed with epoxy in this study was not pressurised at the moment of cracking the specimens, explaining the low outflow of PU in the cracks.

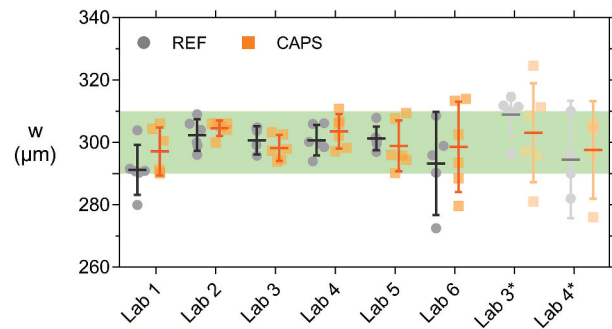
Figure 12. Crack width w of individual mortar specimens for which the mean of the series is indicated by a horizontal line and error bars give the 95% confidence interval on this mean. Most mortar specimens had a crack width w within the desired crack width range (shaded area).

After cracking the mortar specimens, they were restrained using screw jacks. The final mean crack width w measured by all labs after the active crack width restraining process is given in Figure 12. This figure shows the individual values, as well as the mean crack width of the series (horizontal lines) and the 95% confidence interval on this mean (error bars) for both REF and CAPS specimens. The green shaded band indicates the desired crack width range (290–310 μm). Lab 3 and lab 4 did a pre-test on a separately sent batch of specimens to familiarize themselves with the test technique, these are denoted by lab 3* and lab 4*. The crack width of many of these specimens fell outside of the intended range. Additionally, the screw jacks were not applying a significant pressure on the specimens, because the crack width of these specimens was rather limited after crack creation by three-point bending. In

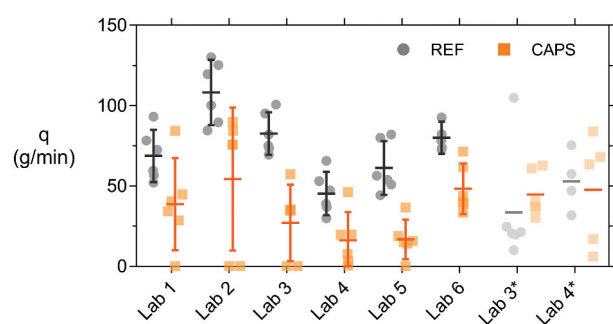
Figure 13. Individual flow rates q and the means of the different specimen batches indicated by horizontal lines. Error bars give the 95% confidence interval on the mean.

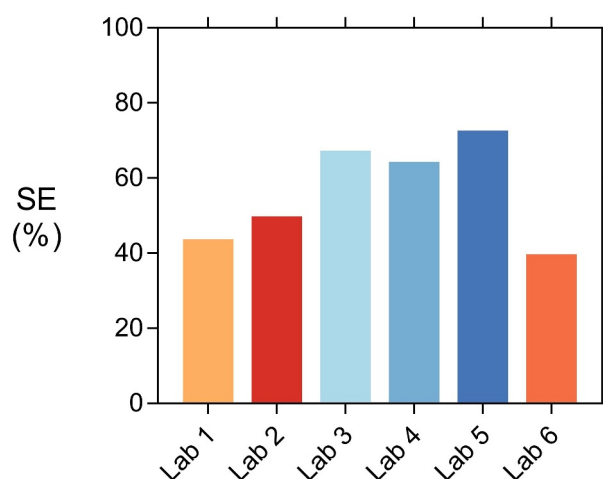
Figure 14. The sealing efficiency SE_{flow} measured in the different labs.

Figure 14. Figure 16 shows the water flow of the different specimens in function of their surface coverage. It is noted that it is impossible to obtain a perfect surface coverage since the area of the hole (used to induce the water in the permeability test) was taken into account in the total area. Anglani et al. [37] studied the same PU healing agent but encapsulated in one cementitious capsule with a larger diameter. These capsules had either an internal or an external epoxy coating to make them moisture-proof. They measured an average surface coverage of 36% for specimens with internally coated capsules and 47% for specimens with externally coated capsules. These values are comparable to the average surface coverage of the different labs, although it is noted that the variation is higher for the results reported here. The sealing efficiency measured by Anglani et al. [37], using the same permeability setup as is used in the current study, was equal to 79%, respectively 28%, for the specimens with an internally, respectively externally, coated capsule. Lab 1, 2, 4 and 5 obtained a sealing efficiency between 44% and 73% which falls in between these values.

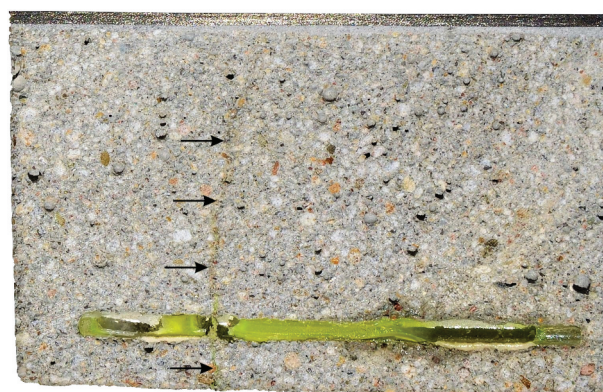
Figure 15. Mortar specimen with mortar removed from the side up to the location of a capsule (length approximately 55 mm) showing that most of the PU was retained in the capsule. Arrows indicate the location of the crack.

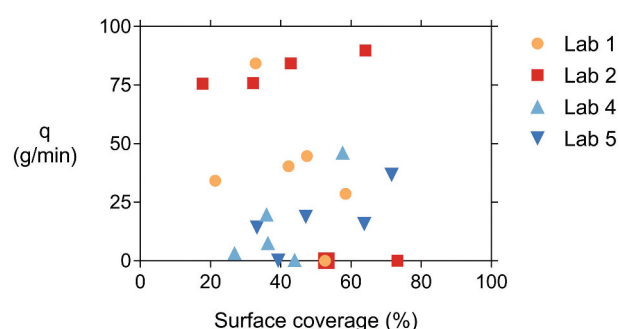
Figure 16. Water flow q versus the PU surface coverage for labs 1, 2, 4 and 5.

From Figure 16 it could also be concluded that a high surface coverage does not directly translate into a good sealing efficiency. There seems to be no strong relationship between the surface coverage and the water flow. Indeed, the surface coverage only has an indirect influence on the water flow. Figure 17 shows a crack surface overlaid with its filtered segmented image determined using the Trainable Weka Segmentation plugin in ImageJ, see section 2.3.4. The surface coverage of this sample was one of the highest (71.6%), yet the zone below the hole was not completely covered with PU, leaving a path for the water to leak out of the specimen. To seal a crack, it is sufficient if the crack mouth is filled with healing agent, or in the studied specimens if the water-inducing hole is surrounded with healing agent. For many specimens it was noted that the PU spread regions from the individual capsules did not connect, and thus a barrier to withstand the water pressure could not be created.

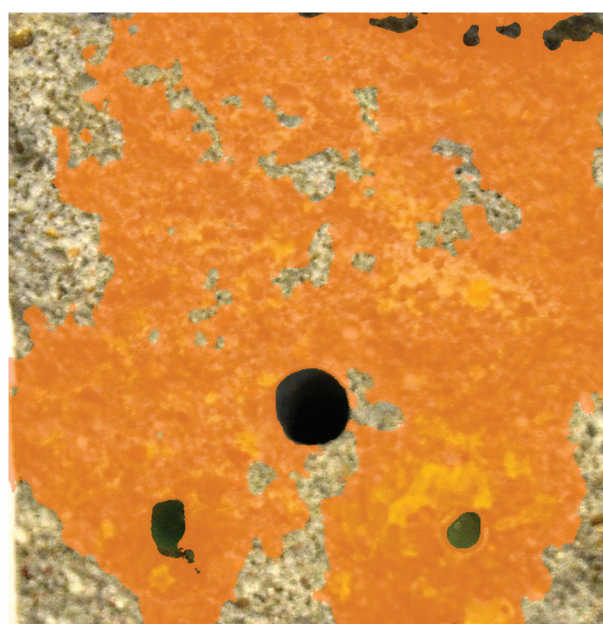
Figure 17. Crack surface ($40 \times 40 \text{ mm}^2$) of one of the specimens with the best PU surface coverage but still a significant flow due to an unconnected crack filling below the cast-in hole (through which water was induced during the permeability test). The crack mouth through which water leaked out of the specimen is oriented to the bottom, like in the water flow test.

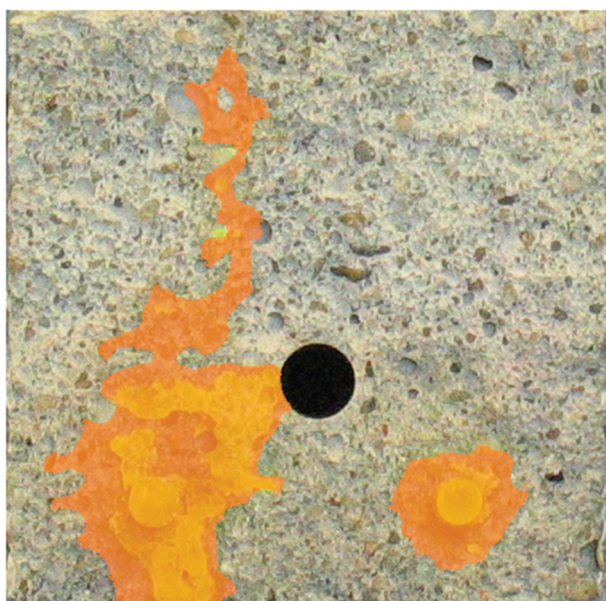
Figure 18. Crack surface ($40 \times 40 \text{ mm}^2$) of specimen with limited PU surface coverage. The crack mouth through which water leaked out of the specimen is oriented to the bottom, like in the water flow test.
