Accidental Destruction & Intentional Destruction. Considerations for archaeological sites and monuments

*Original*

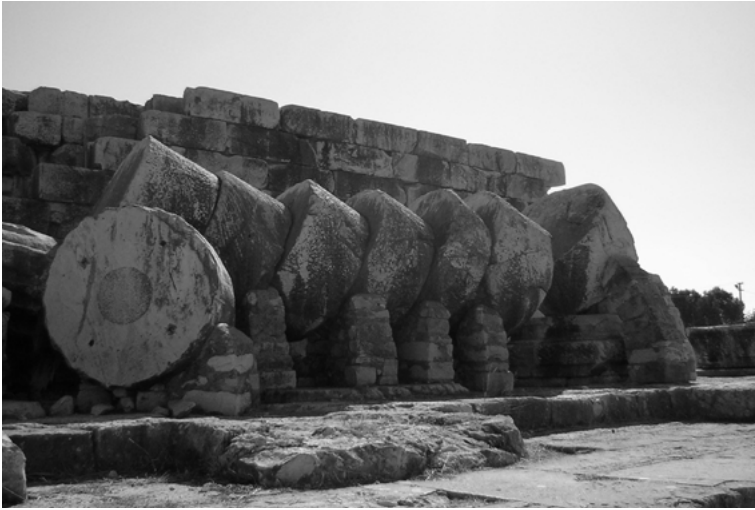
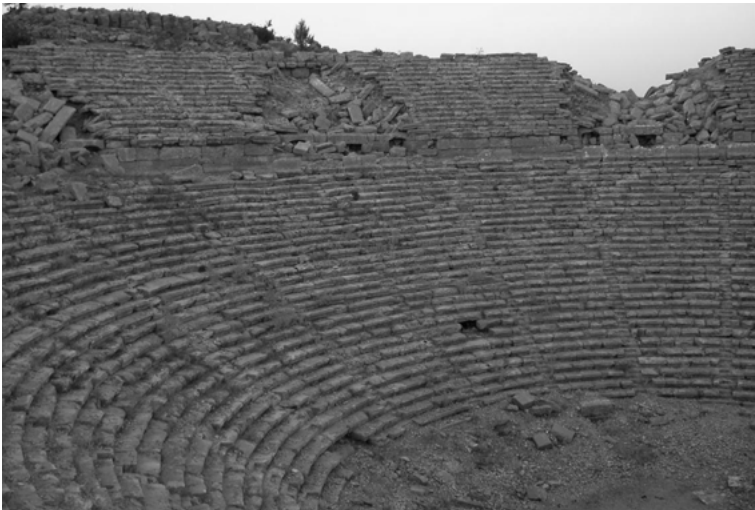
Didima and Selge: collapsed columns of the Apollo Temple and primary collapse in correspondence of the theatre cavea

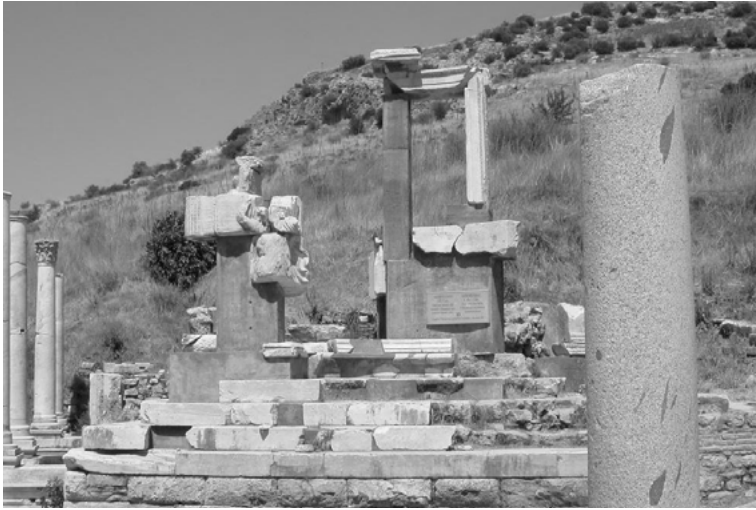
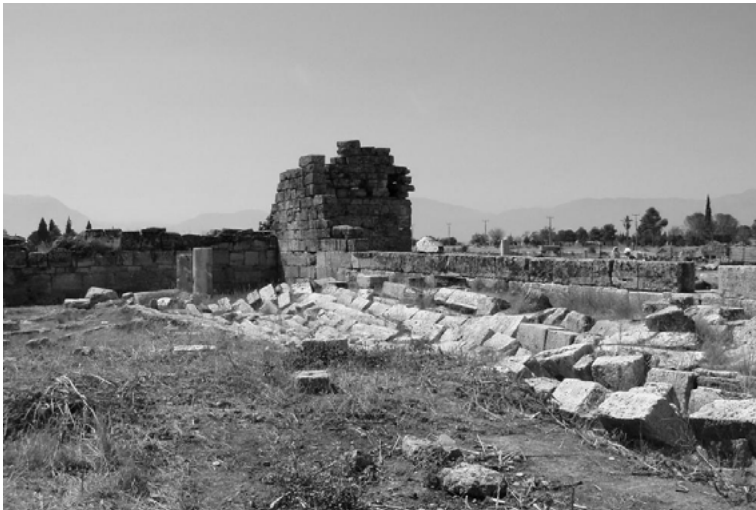
Ephesus: the re\_composition of the Memmio monument and Hierapolis: the primary collapse in the external wall in the Triton Neinpheum.

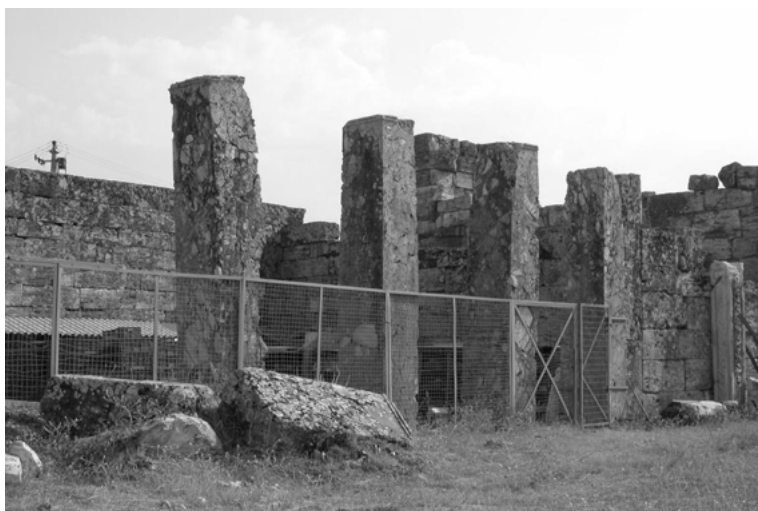
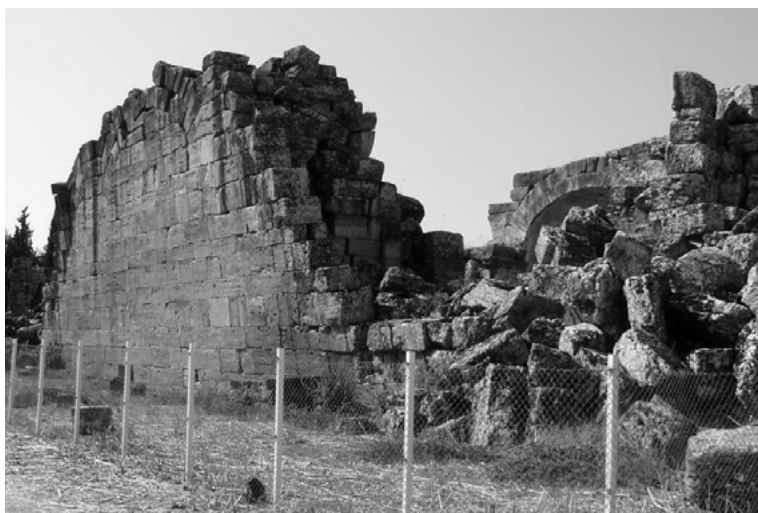
Hierapolis: the Thermae pillars deformed by the earthquake and the walls of the Thermae-Church deformation
