Safe Management of Stone Balconies: an Overview

Safe Management of Stone Balconies: an Overview / Manzone, Giuseppe; Patrucco, Mario; Nebbia, Rebecca. - ELETTRONICO. - (2020). ((Intervento presentato al convegno 30th European Safety and Reliability Conference and the 15th Probabilistic Safety Assessment and Management Conference tenutosi a Venice nel 1-5 November 2020.

# Safe Management of Stone Balconies: an Overview

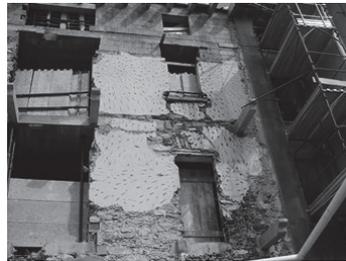
Figure 1. Sudden subsidence of a corbel of a balcony located on the third floor, with the fall of the slabs. The worker standing on its suffered fatal injuries.

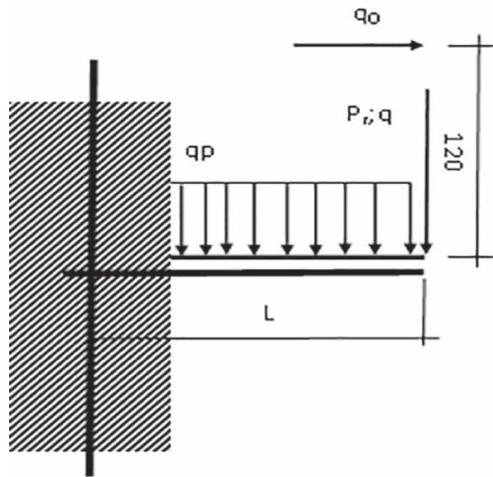
Finally, taking into account the assumptions, it can be supposed that the static scheme is as in figure 3, similar to what suggested by Lombardo and Luparello (1997).

Figure 3. Static scheme and loads on the corbel.  $P_r$ = load of the railing;  $q$ =permanent load (weight of the slab);  $q_0$ = horizontal load on the railing;  $q_p$ =permanent load (weight of the corbel);  $L$ =length of the corbel and width of the slab.

As a numerical example, Table 2 shows the possible results of the verification (assuming the static scheme of Figure 3) of 3 balconies, where corbels broke at the point of maximum stress, that is in correspondence with the vertical wall, in the absence of accidental overloads (events that occurred in Italy on which some of the Authors had access to detailed information as entrusted with the role of consultants in a Prosecutor's investigations).

Table 2 brings into evidence that the resulting stress values, maximum values calculated considering imperfect supports (corbel loaded at the tip and not in distributed load) must be halved if the corbel-slab support is continuous. The tensile stress values at the breaking time (in absence of overloads) are extremely modest. Considering a safety coefficient of at least 7÷8, the tensile strength's value results of approx. 1 kg/cm<sup>2</sup>, i.e. very close to zero. Thus, the low tensile strength of the stone material and the bending moment evaluated in these examples suggests that the stone is unsuitable for structural elements, subject to flexion such as balconies.
