16th World Conference on Earthquake Engineering

ENGINEERING RECONNAISSANCE FOLLOWING THE AUGUST 24, 2016M6.0 CENTRAL ITALY EARTHQUAKE

ENGINEERING RECONNAISSANCE FOLLOWING THE AUGUST 24, 2016 M6.0 CENTRAL ITALY EARTHQUAKE

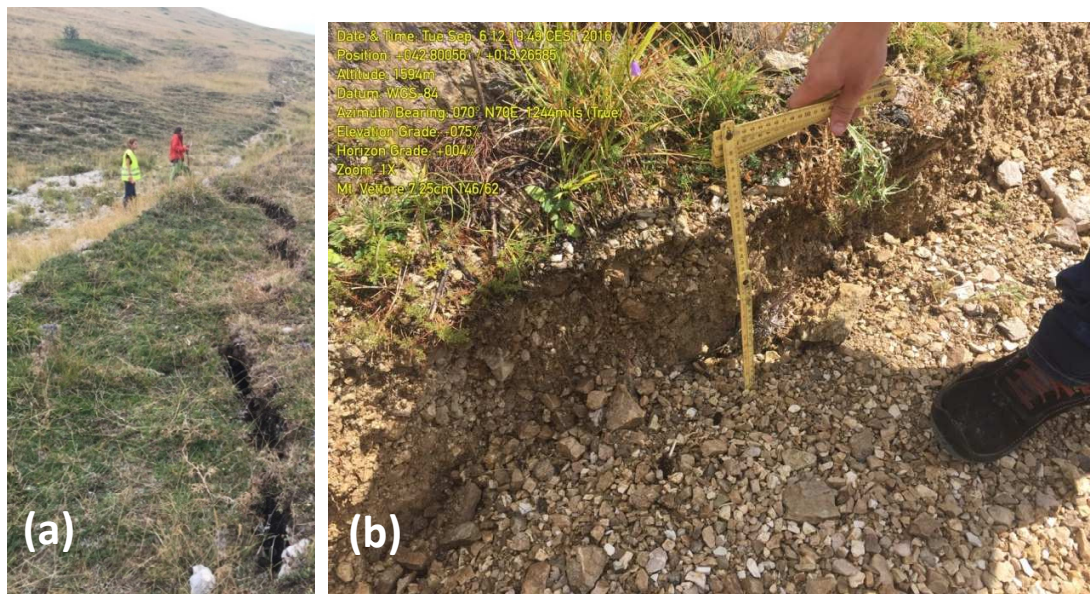
Fig 3 – (a) photographs of surface rupture on trace of Mt. Vettore fault (N42.79953, E13.26634, 5 September 2016) and (b) typical measurement (N42.8056, E13.26585, 6 September 2016).

Surface rupture occurred over a 4.8 km portion of the Mt. Vettore fault, as shown in Figure 1 and 2. Working with researchers at INGV (especially co-authors Galadini, Gori, and Falcucci), displacements on the primary rupture were measured as generally in the range of 10-25 cm. These displacements were down-dip, generally with no appreciable along-strike component. Figure 3 shows a general view of the fault trace (Figure 3a) and a typical displacement measurement on the fault (Figure 3b). We did not see secondary breaks on the hanging wall. Aerial imagery of the surface rupture is pending.

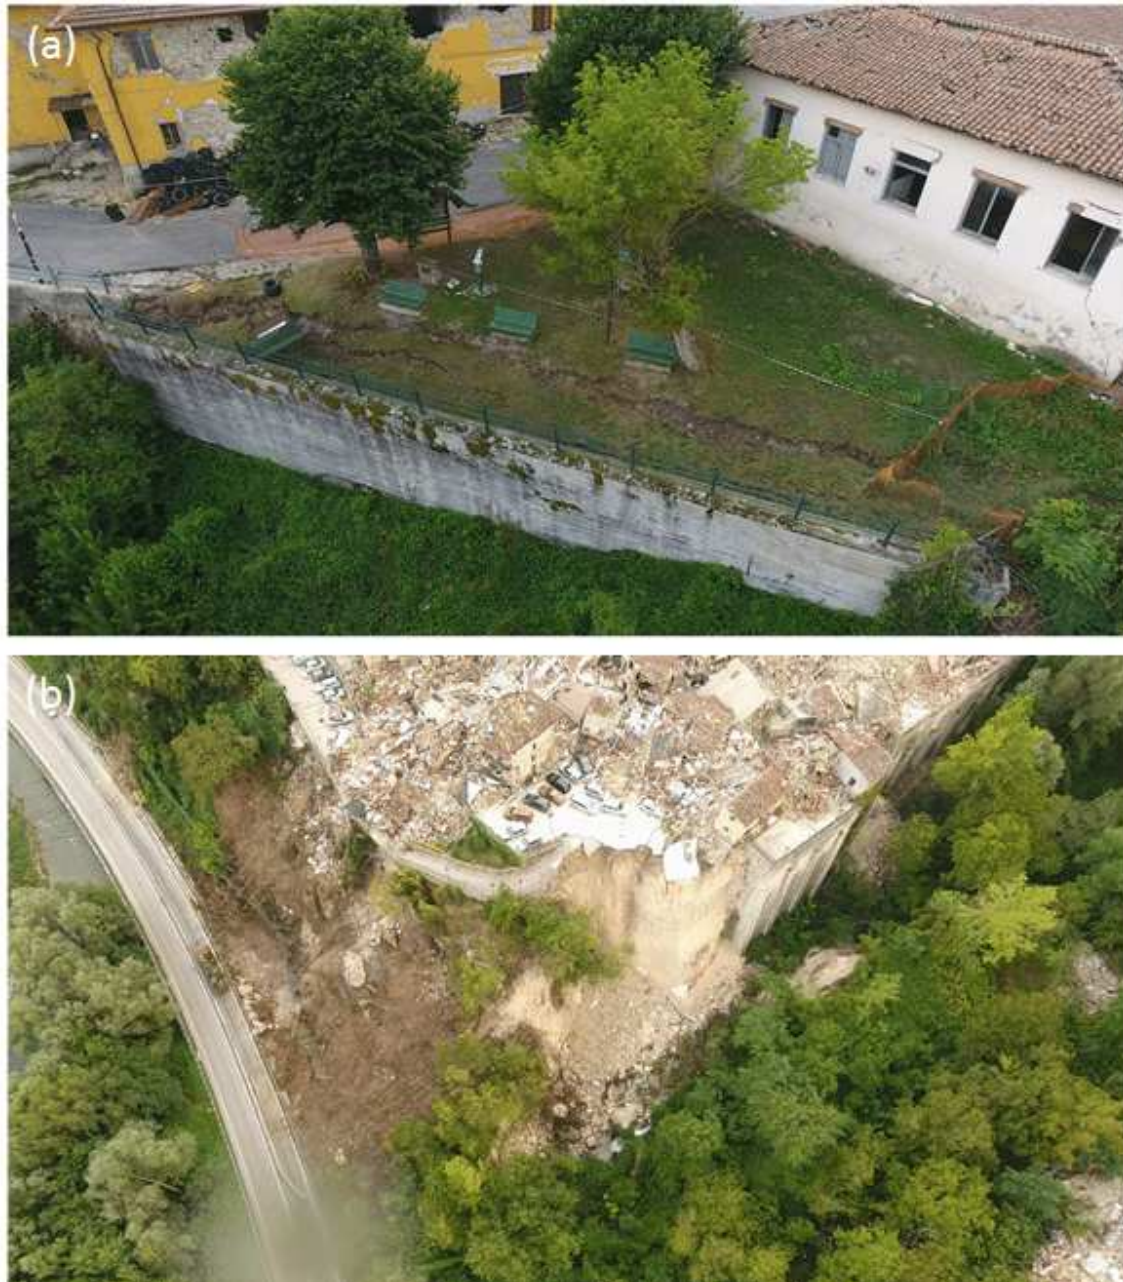
Fig 6 – Aerial photos taken by drones at: (a) Accumoli (N42.69425, E13.24993, 9 September 2016); and (b) Pescara del Tronto (N42.750401, E13.272109, 9 September 2016).

Using a DJI™ Phantom 4 drone, a customized Align™ T-Rex 800 drone, and an Ebee Sense Fly drone, we imaged the four locations shown in Figure 1. These data will be used also for high resolution digital map creation (orthophoto) Digital Surface Model (DSM) and 3D models of the acquired areas. Information on where to find down-sampled video for two of these locations (Accumoli and Pescara del Tronto) are provided on the Central Italy Earthquake event page within the GEER Association website (www.geerassociation.org). Figure 6 shows aerial photos taken by drones at Accumoli (Figure 6a) and Pescara del Tronto (Figure 6b).

Observed landslides were mainly small rock failures (wedge slides, topples and slides in intensely fractured/weak rocks) which very often generated rockfalls. One of the largest failures occurred on a slope that, in the past, was involved in similar instability phenomena (Pescara del Tronto, just above the Salaria State road, Figure 6b). In several instances (specifically Tufo, Pescara del Tronto and Accumoli, Figure 6a), retaining structures underwent displacements and rotation (toppling) with consequences to the backfill and hence to the areas behind (including roads).
