Mineralogical and chemical characterization of surface orange layers on the limestone of the Monastery of Batalha, Central Portugal

Abstract – Samples of orange surface patinas found on the limestone balustrade and sculptures of the Batalha Monastery in Portugal, have been investigated by X-ray micro-diffractometry (μ -XRD) and Low-Vacuum Scanning Electron Microscopy coupled with Energy Dispersive Spectrometry (LV-SEM + EDS). Aim of the study was to assess whether the orange layers have been intentionally applied or were resulting from stone weathering. Preliminary results suggest that the orange layer on the surface is mainly consisted of gypsum and hematite with halite and weddellite as minor components. This discovery implies the possibility that such orange patinas were applied intentionally instead of having been formed naturally by decay. A comparison was made between this patina and the “scialbatura”, a protective coating often applied by conservators on limestones and marbles in monuments.

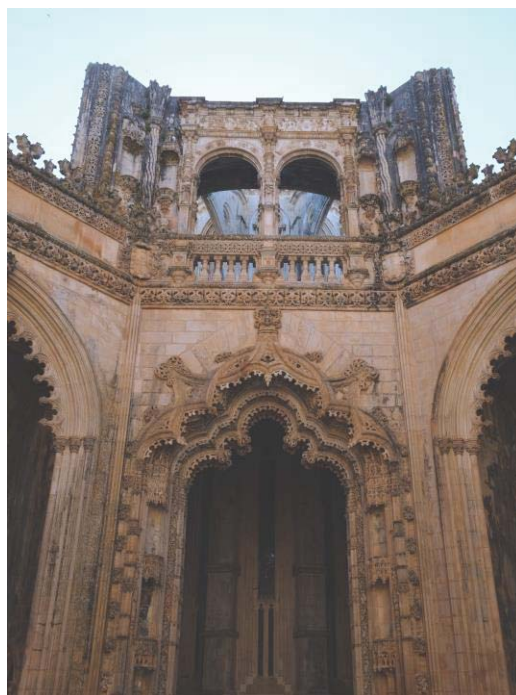
Fig. 1. Facade and sculptures with orange patina at the Imperfect Chapels, Batalha Monastery.

In the famous Batalha Monastery located in Central Portugal, an orange patina is commonly seen on the surface of sculptures, facades, column and walls (Figure 1). Few studies on this subject can be found in the literature. Rattazzi and coworkers examined two statues kept in the Monastery museum storage: the external orange layers were found to show a rather homogeneous texture with traces of gypsum and clay minerals; FTIR analysis showed bands of Al-silicates, and iron oxides, interpreted as Earth of Sienna natural and Red Ochre pigments [1]. Aires-Barros et al. investigated the original 15th century Saint Matthew statue and the external walls of the main façade. On the former, they revealed the presence of calcite, with nitrate, silicate and organic products like benzoic acid, while on the external walls the orange patina was found to be predominantly composed by calcium oxalates: whewellite ($\text{CaC}_2\text{O}_4 \cdot \text{H}_2\text{O}$) and some weddellite ($\text{CaC}_2\text{O}_4 \cdot 2\text{H}_2\text{O}$), as well some hydroxyapatite ($\text{Ca}_5(\text{PO}_4)_3(\text{OH})$), halloysite and nitrates [2].
