# Mineralogical and chemical characterization of surface orange layers on the limestone of the Monastery of Batalha, Central Portugal

**Abstract** – Samples of orange surface patinas found on the limestone balustrade and sculptures of the Batalha Monastery in Portugal, have been investigated by X-ray micro-diffractometry ( $\mu$ -XRD) and Low-Vacuum Scanning Electron Microscopy coupled with Energy Dispersive Spectrometry (LV-SEM + EDS). Aim of the study was to assess whether the orange layers have been intentionally applied or were resulting from stone weathering. Preliminary results suggest that the orange layer on the surface is mainly consisted of gypsum and hematite with halite and weddellite as minor components. This discovery implies the possibility that such orange patinas were applied intentionally instead of having been formed naturally by decay. A comparison was made between this patina and the “scialbatura”, a protective coating often applied by conservators on limestones and marbles in monuments.

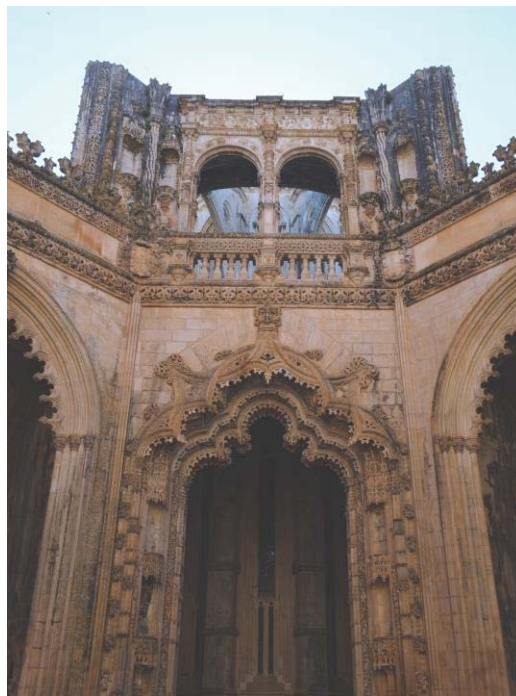
Fig. 1. Facade and sculptures with orange patina at the Imperfect Chapels, Batalha Monastery.

In the famous Batalha Monastery located in Central Portugal, an orange patina is commonly seen on the surface of sculptures, facades, column and walls (Figure 1). Few studies on this subject can be found in the literature. Rattazzi and coworkers examined two statues kept in the Monastery museum storage: the external orange layers were found to show a rather homogeneous texture with traces of gypsum and clay minerals; FTIR analysis showed bands of Al-silicates, and iron oxides, interpreted as Earth of Sienna natural and Red Ochre pigments [1]. Aires-Barros et al. investigated the original 15<sup>th</sup> century Saint Matthew statue and the external walls of the main façade. On the former, they revealed the presence of calcite, with nitrate, silicate and organic products like benzoic acid, while on the external walls the orange patina was found to be predominantly composed by calcium oxalates: whewellite ( $\text{CaC}_2\text{O}_4 \cdot \text{H}_2\text{O}$ ) and some weddellite ( $\text{CaC}_2\text{O}_4 \cdot 2\text{H}_2\text{O}$ ), as well some hydroxyapatite ( $\text{Ca}_5(\text{PO}_4)_3(\text{OH})$ ), halloysite and nitrates [2].
