Condition Assessment of an Early Thin Reinforced Concrete Vaulted System

Condition assessment of an early thin reinforced concrete vaulted system

Erica Lenticchia^{1,2} · Gaetano Miraglia^{*1,2} · Antonino Quattrone¹ · Rosario Ceravolo^{1,2}

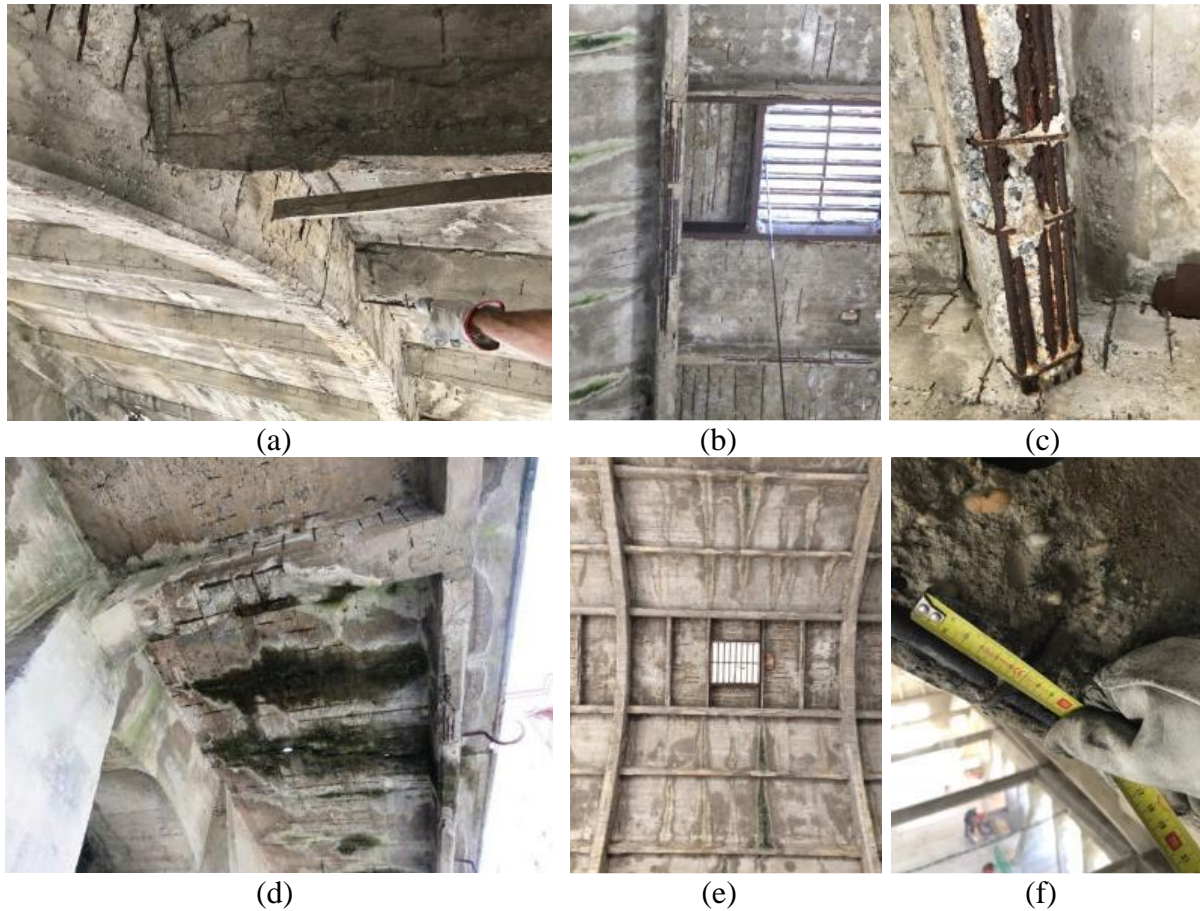
Figure 7: Damage and degradation on the building: (a) exposed rebars on the AR; (b-c) exposed rebars and detachments of concrete of the joists and roofing panels; (d) water staining and bio growth on the elements of the outdoors shelter; (e) a general view of the interior of the Paraboloide showing water staining and bio growth on the roofing panels; (f) a detail of the exposed rebars of a parabolic arch.

The visual investigations detected a diffuse degradation of the concrete, moisture stains, bio growth, rust stains, cracks, delamination and detachments, and consequent corrosion of the reinforcements. Moreover, pronounced and widespread cracks and high degrees of corrosion of the reinforcements are present in the whole body of the building, often accompanied by the complete detachment of the concrete cover. The degradation is mainly due to physical causes,

The decay is particularly noticeable on the intrados of the building and especially on the elements constituting the parabolic vault: the arches, the joists, and the panels (Figure 7) where Invernizzi et al. [14] highlighted that water staining and bio-growth cover the 40% of the area of the roofing.
