Condition Assessment of an Early Thin Reinforced Concrete Vaulted System

# Condition assessment of an early thin reinforced concrete vaulted system

This paper reports the direct experience acquired from an extensive experimental campaign conducted on the Paraboloid in Casale Monferrato. The study aims to be an example of how condition assessment of the structural heritage of the early 1900s, with an apparently simple geometric shape and composition, can actually contribute in understanding hidden structural complexity. Moreover, this work may provide useful information to researchers and practitioners who are approaching this specific structural typology (e.g., the industrial heritage represented by parabolic concrete silos). In more details, results are presented regarding the in-situ investigations, and the laboratory tests carried out to analyze the mechanical performance inherent to both (i) local aspects of the structure, such as the quality of the materials and connections, and (ii) global aspects, such as the modal response of the structure. Furthermore,

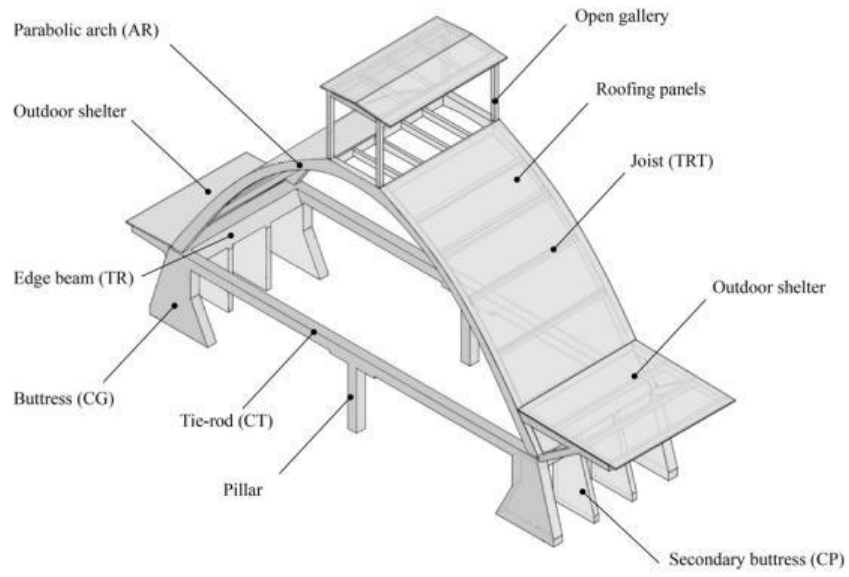
*Figure 5: Scheme reporting the main elements of the Parabolide, which would have become the distinctive elements of the parabolic silo building typology.*

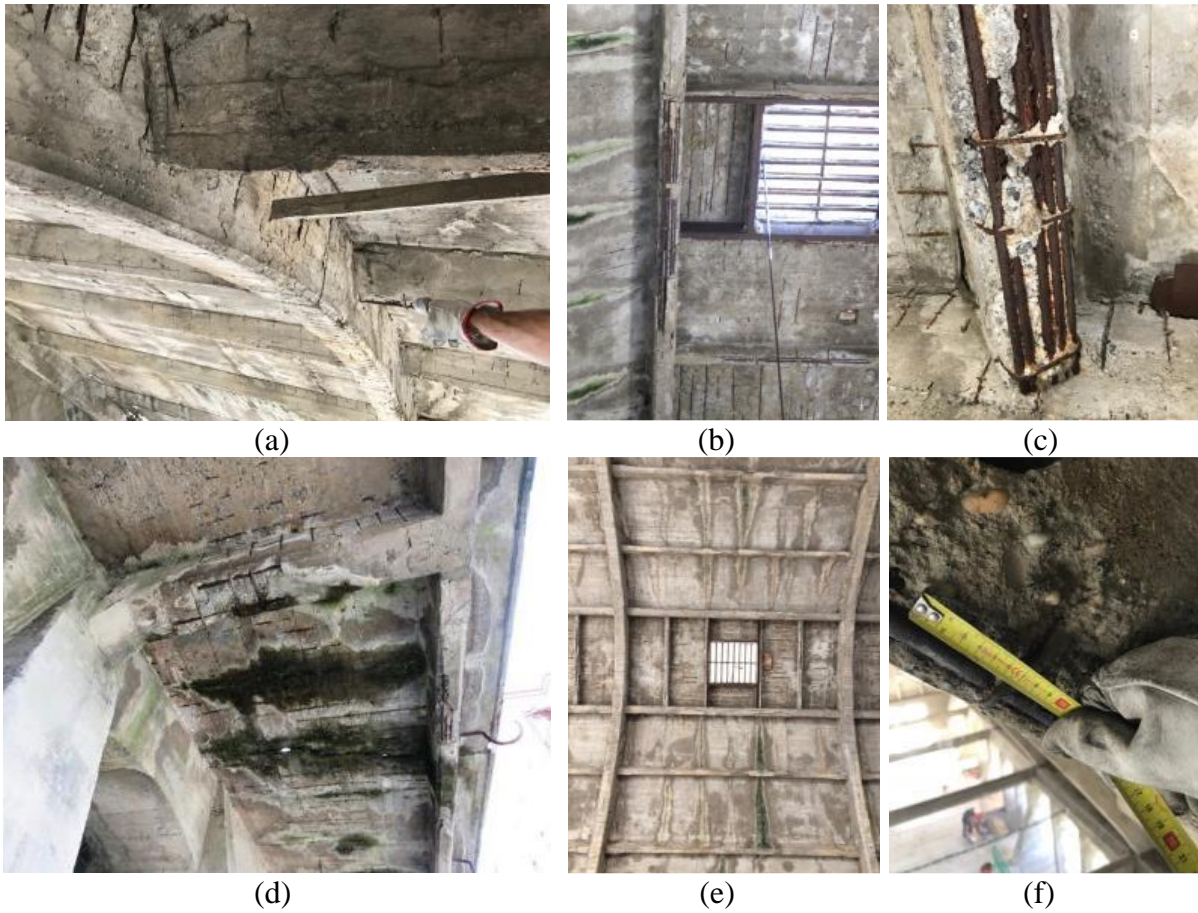
The visual investigations detected a diffuse degradation of the concrete, moisture stains, bio growth, rust stains, cracks, delamination and detachments, and consequent corrosion of the reinforcements. Moreover, pronounced and widespread cracks and high degrees of corrosion of the reinforcements are present in the whole body of the building, often accompanied by the complete detachment of the concrete cover. The degradation is mainly due to physical causes,

linked to frost and defrost cycles, and corrosion phenomena, due to the lack of maintenance of the building, that favored infiltration and percolation of rainwater.

The decay is particularly noticeable on the intrados of the building and especially on the elements constituting the parabolic vault: the arches, the joists, and the panels (Figure 7) where Invernizzi et al. [14] highlighted that water staining and bio-growth cover the 40% of the area of the roofing.

Figure 7: Damage and degradation on the building: (a) exposed rebars on the AR; (b-c) exposed rebars and detachments of concrete of the joists and roofing panels; (d) water staining and bio growth on the elements of the outdoors shelter; (e) a general view of the interior of the Paraboloid showing water staining and bio growth on the roofing panels; (f) a detail of the exposed rebars of a parabolic arch.

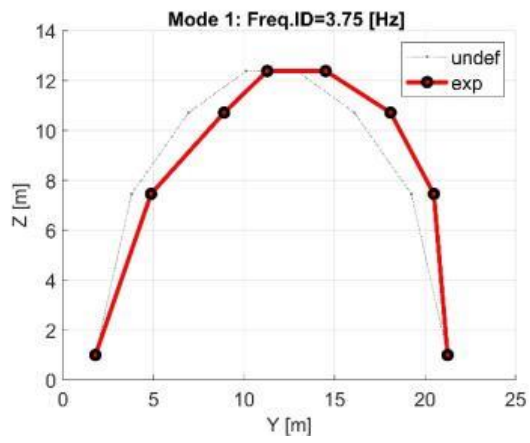
Frequency [Hz]	Damping ratio [-]
3.747	0.006
5.668	0.009
8.008	0.040
8.702	0.034
9.015	0.032
9.227	0.006

Figure 11: Identified modes of the Paraboloide by plotting only the horizontal components: (a) first mode; (b) second mode; (c) clustering diagram; and (d) identified natural frequencies and damping ratio obtained after the clustering analysis.
