Mechanical Properties of Historic Masonry Stones Obtained by In Situ Non-Destructive Tests on the St. Agostino Church in Amatrice (Italy)

Featured Application: The use of non-destructive diagnostic techniques for the in situ and non-invasive mechanical characterization of historic stone masonry.

Keywords: historic building; masonry stone; Amatrice earthquake; structural safety; non-destructive techniques (NDT); ultrasonic test; impact test

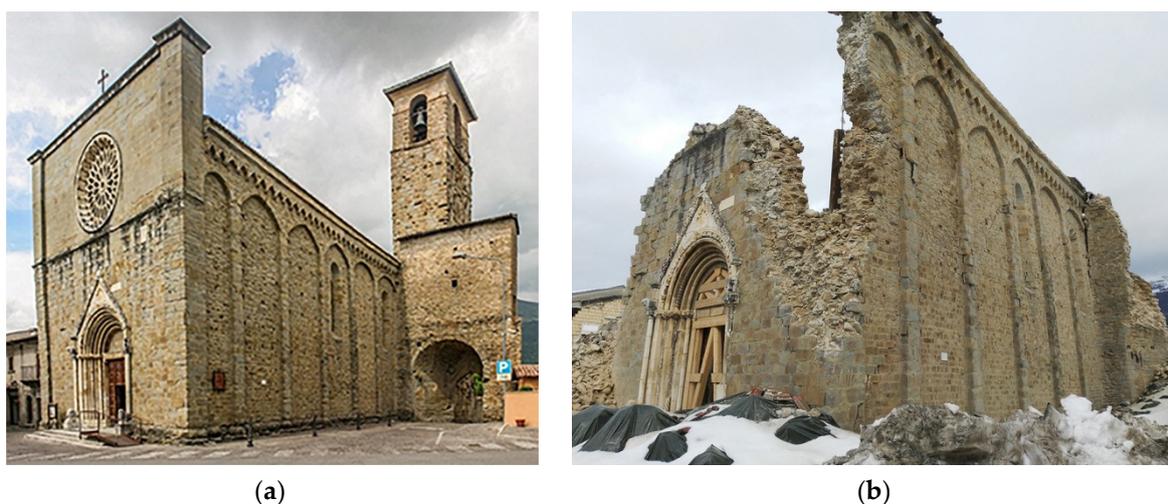
Figure 1. St. Agostino church in Amatrice before (a) and after (b) the seismic earthquake swarm of 2016 in Central Italy.

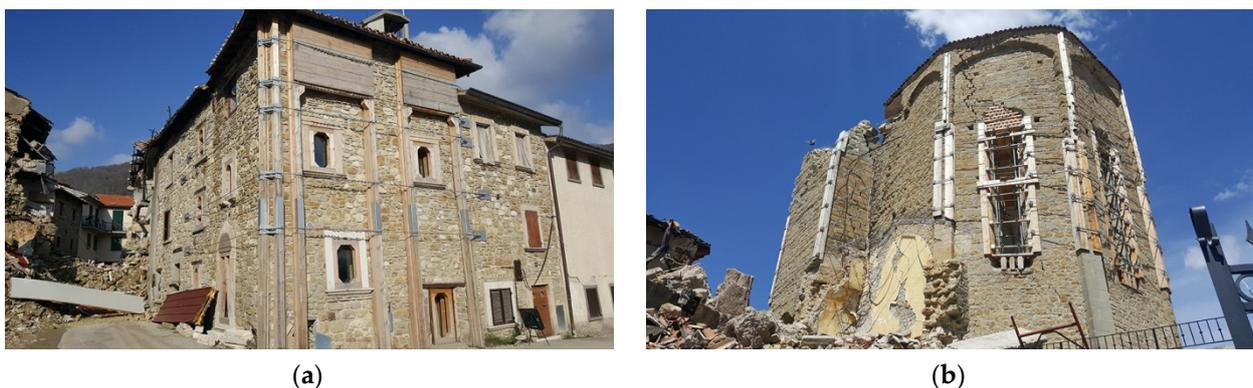
Figure 2. (a) Damaged masonry buildings in the area around the epicenter of the 2016 Central Italy earthquake; (b) St. Francesco church in Amatrice, damaged by the same earthquake.

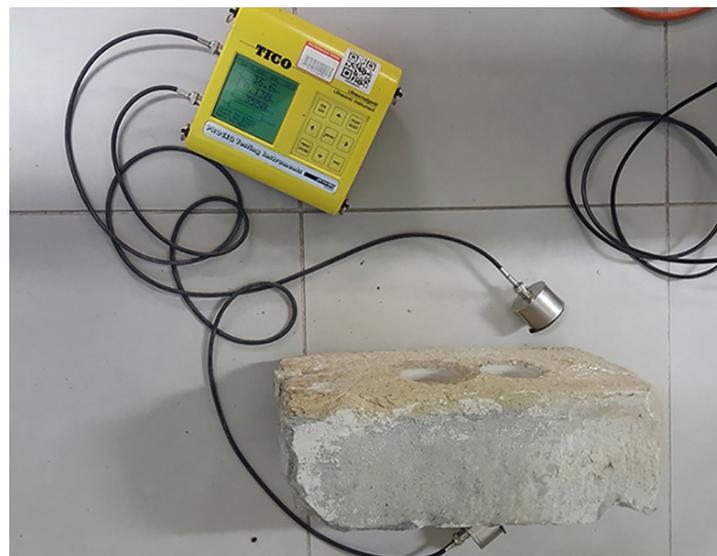
Figure 4. Ultrasonic test setup.

- Ultrasonic tests for the determination of the elastic dynamic modulus performed on the same stones (Figure 4);
- Impact tests carried out on the same stones (Figure 5).

Ultrasonic tests were also conducted on the same stones to estimate the dynamic elastic modulus (E_d). Ultrasonic inspection is a non-destructive method, in which high frequency sound waves are introduced into the material to be examined, in order to highlight any surface or internal defects. Longitudinal waves were produced by means of an electro-acoustic transducer (emitting probe in piezoelectric or magnetostrictive material) placed in contact with the stone surface under test; after passing through a path of known length, the train of waves was converted by a second transducer (receiving probe) into an electrical signal processed by electronic timing circuits that allow measurement of the transit time of the impulses. The ultrasonic test device consisted of: a Proceq Tico[®] pulse generator; two transducers of 54 kHz (one emitting and the other receiving); a pulse amplifier; and an electronic device for measuring the time interval (Figure 4). The speed of the wave (v) depends on the presence of any defects inside the material, and is related to the value of the dynamic elastic modulus (E_d) through the density (ρ) and the Poisson's ratio (ν) of the material. Therefore, the value of the dynamic elastic modulus (E_d) of the stone can be obtained using the following relationship, in accordance with the technical standards ASTM D2845 1995 and UNI EN 12504-4: 2005 [27,28]:
