Mechanical Properties of Historic Masonry Stones Obtained by In Situ Non-Destructive Tests on the St. Agostino Church in Amatrice (Italy)

Featured Application: The use of non-destructive diagnostic techniques for the in situ and non-invasive mechanical characterization of historic stone masonry.

Keywords: historic building; masonry stone; Amatrice earthquake; structural safety; non-destructive techniques (NDT); ultrasonic test; impact test

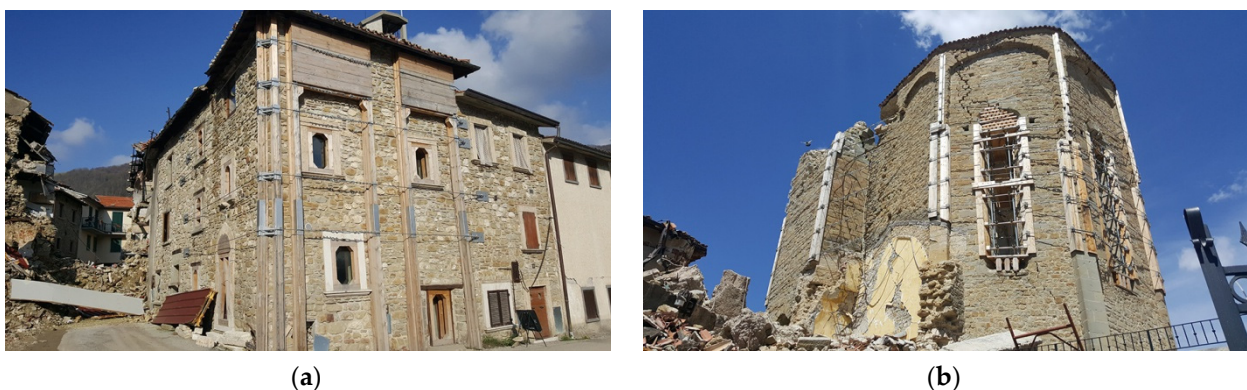
Figure 2. (a) Damaged masonry buildings in the area around the epicenter of the 2016 Central Italy earthquake; (b) St. Francesco church in Amatrice, damaged by the same earthquake.
