# Mechanical Properties of Historic Masonry Stones Obtained by In Situ Non-Destructive Tests on the St. Agostino Church in Amatrice (Italy)

**Featured Application:** The use of non-destructive diagnostic techniques for the in situ and non-invasive mechanical characterization of historic stone masonry.

**Keywords:** historic building; masonry stone; Amatrice earthquake; structural safety; non-destructive techniques (NDT); ultrasonic test; impact test

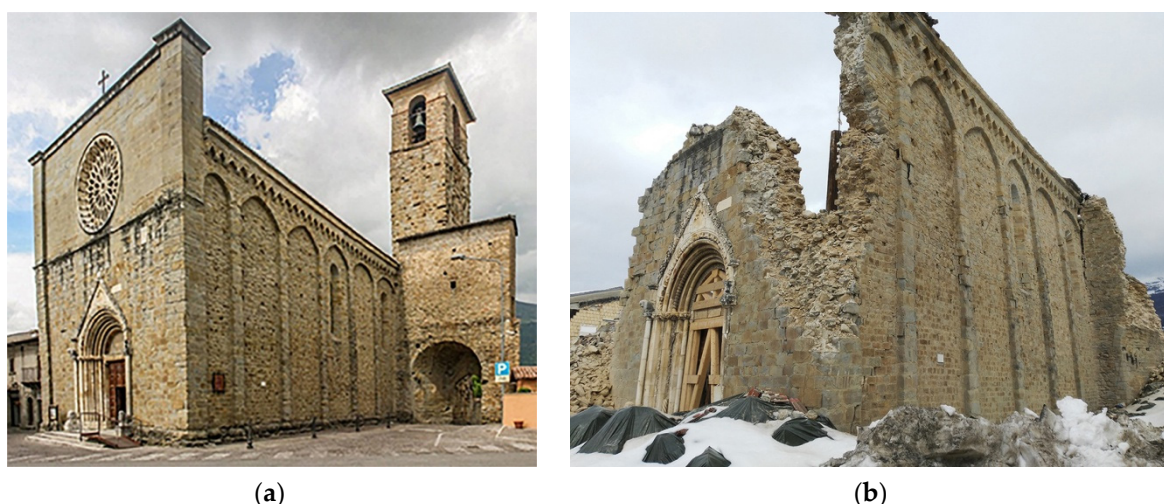
**Figure 1.** St. Agostino church in Amatrice before (a) and after (b) the seismic earthquake swarm of 2016 in Central Italy.

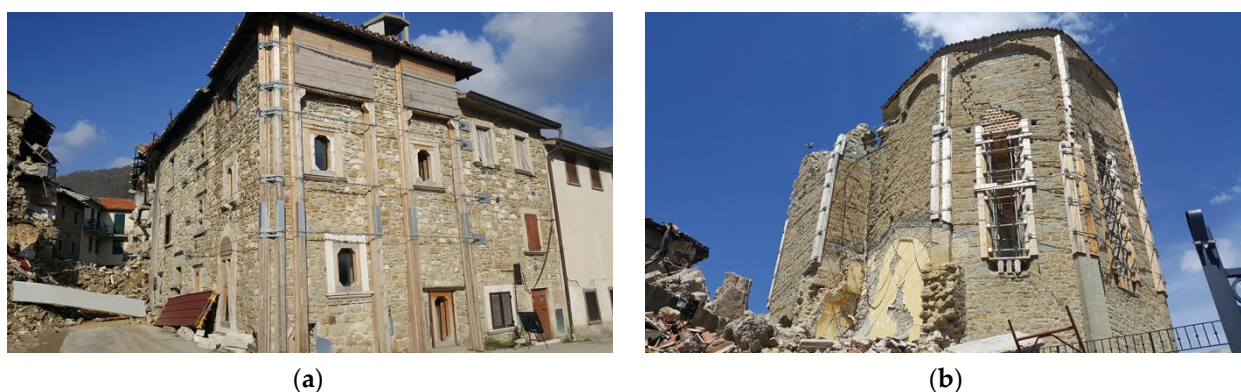
**Figure 2.** (a) Damaged masonry buildings in the area around the epicenter of the 2016 Central Italy earthquake; (b) St. Francesco church in Amatrice, damaged by the same earthquake.

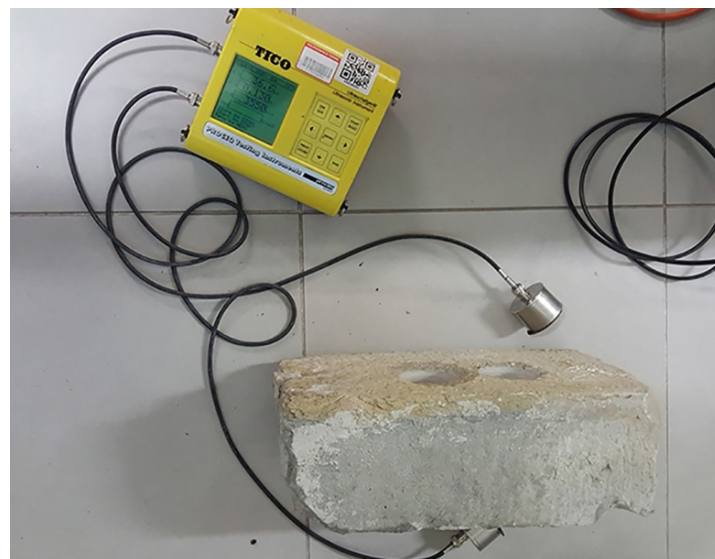
**Figure 4.** Ultrasonic test setup.

- Ultrasonic tests for the determination of the elastic dynamic modulus performed on the same stones (Figure 4);
- Impact tests carried out on the same stones (Figure 5).

Ultrasonic tests were also conducted on the same stones to estimate the dynamic elastic modulus ( $E_d$ ). Ultrasonic inspection is a non-destructive method, in which high frequency sound waves are introduced into the material to be examined, in order to highlight any surface or internal defects. Longitudinal waves were produced by means of an electro-acoustic transducer (emitting probe in piezoelectric or magnetostrictive material) placed in contact with the stone surface under test; after passing through a path of known length, the train of waves was converted by a second transducer (receiving probe) into an electrical signal processed by electronic timing circuits that allow measurement of the transit time of the impulses. The ultrasonic test device consisted of: a Proceq Tico<sup>®</sup> pulse generator; two transducers of 54 kHz (one emitting and the other receiving); a pulse amplifier; and an electronic device for measuring the time interval (Figure 4). The speed of the wave ( $v$ ) depends on the presence of any defects inside the material, and is related to the value of the dynamic elastic modulus ( $E_d$ ) through the density ( $\rho$ ) and the Poisson's ratio ( $\nu$ ) of the material. Therefore, the value of the dynamic elastic modulus ( $E_d$ ) of the stone can be obtained using the following relationship, in accordance with the technical standards ASTM D2845 1995 and UNI EN 12504-4: 2005 [27,28]:
