Combining Multiband Imaging, Photogrammetric Techniques, and FOSS GIS for Affordable Degradation Mapping of Stone Monuments

Abstract: The detailed documentation of degradation constitutes a fundamental step for weathering diagnosis and, consequently, for successful planning and implementation of conservation measures for stone heritage. Mapping the surface patterns of stone is a non-destructive procedure critical for the qualitative and quantitative rating of the preservation state. Furthermore, mapping is employed for the annotation of weathering categories and the calculation of damage indexes. However, it is often a time-consuming task, which is conducted manually. Thus, practical methods need to be developed to automatize degradation mapping without significantly increasing the diagnostic process's cost for conservation specialists. This work aims to develop and evaluate a methodology based on affordable close-range sensing techniques, image processing, and free and open source software for the spatial description, annotation, qualitative analysis, and rating of stone weathering-induced damage. Low-cost cameras were used to record images in the visible, near-infrared, and ther

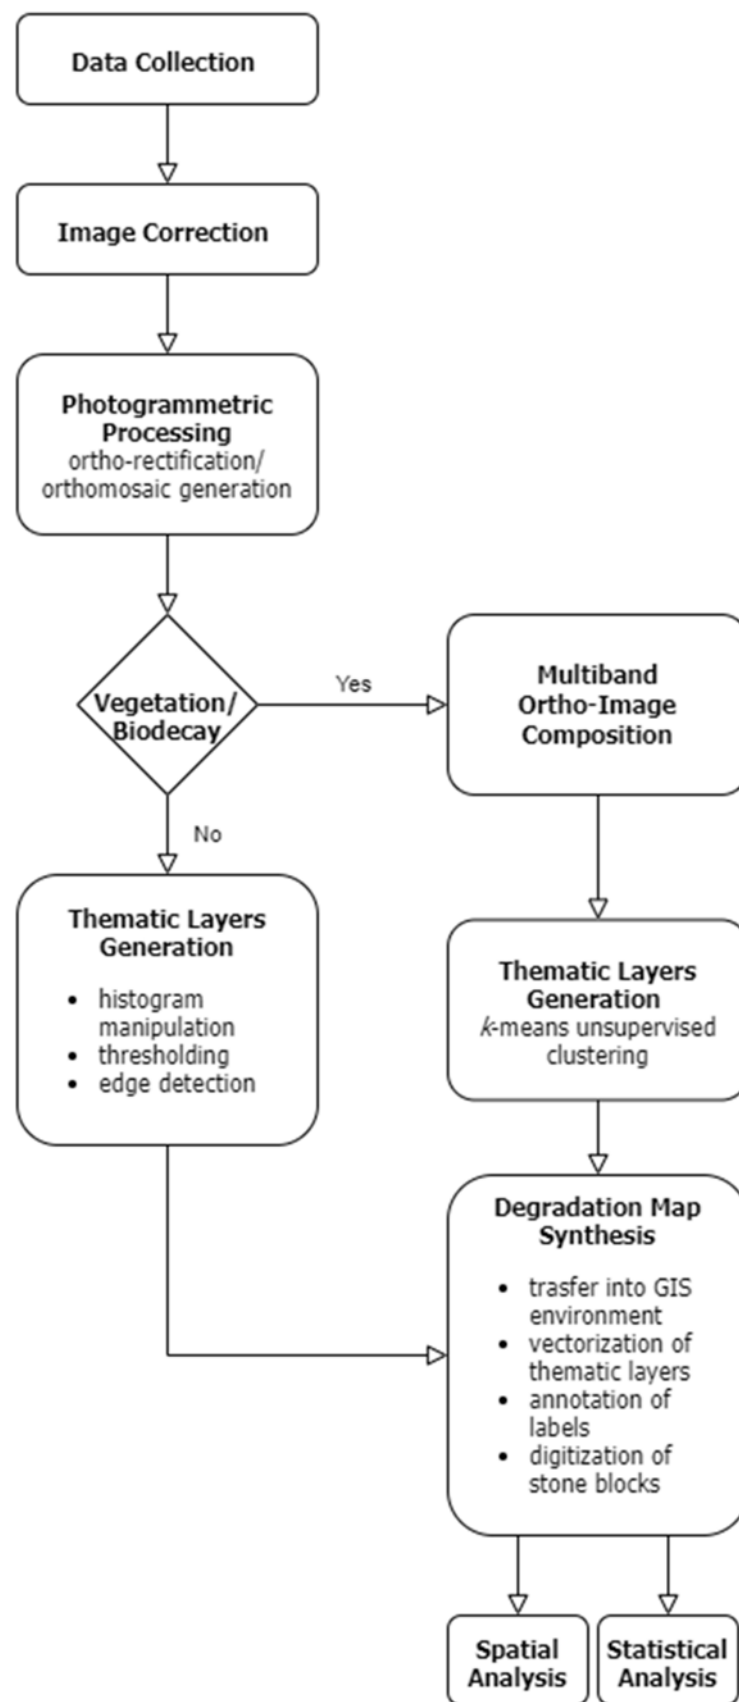
Figure 1. Schematic representation of the methodological workflow.

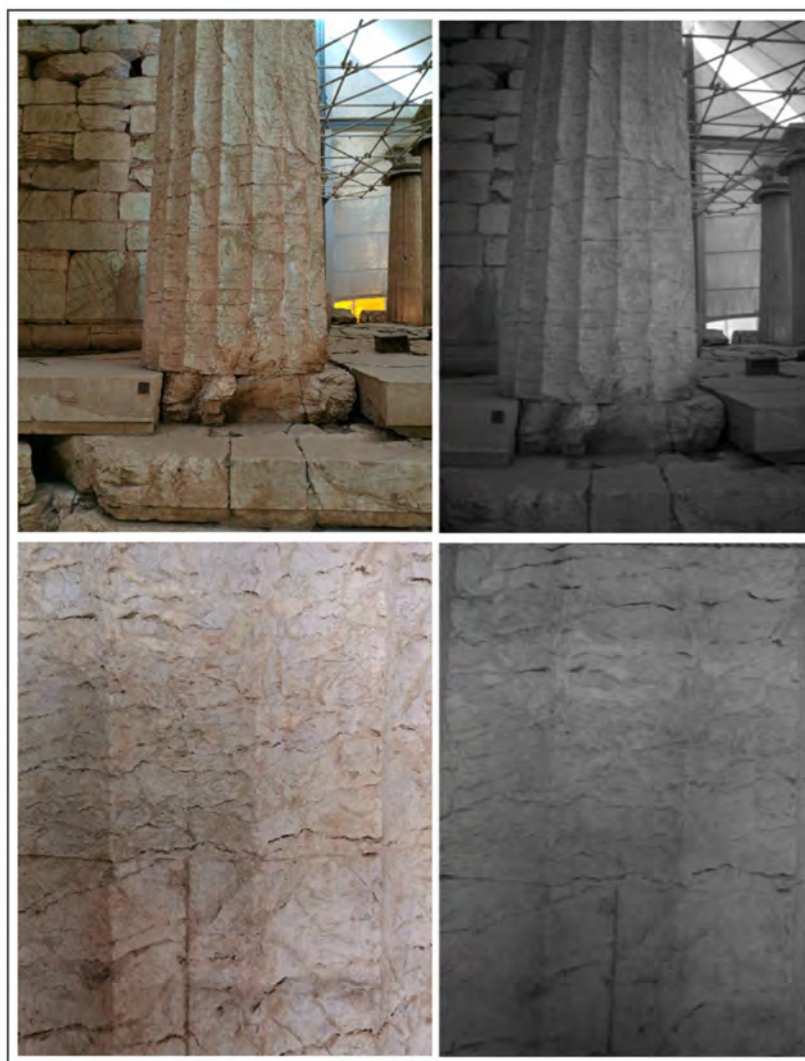
Figure 4. Color (left) and near-infrared reflectance (right) images of the same column captured at the Temple of Apollo Epikourios at Bassae, from further and closer range.

The thematic data about characteristic surfaces at the Temple of Apollo Epikourios were produced by digitally manipulating NIR reflectance images. These images presented more homogeneous radiometry, which was extremely important in order to extract suitable thematic information. In particular, the original and restoration materials that had been previously used presented more similar reflectance characteristics in the near-infrared than in the visible spectrum. Thus, by using NIR reflectance images, the misinterpretation of other degradation forms could be avoided (Figure 4). The architectural surfaces had been mostly cleaned, and therefore, the observable categories of degradation were only loss of material, cracks, and in certain places discoloration. After the NIR images had been corrected and rectified, binary images representing these different categories were produced. Thresholding was applied for identifying discoloration after flat-field correction, which eliminated any remaining inhomogeneous illumination problems. Edge detection and afterward binarization was performed on the first principal component of the images to detect cracks. Finally, histogram equalization and thresholding were performed to identify the loss of material. Figure 5 presents the generation of the binarized category-specific degradation images for an architectural surface and the production of thematic layers in the FOSS GIS environment. The thematic maps produced for investigated characteristic surfaces are presented in Figures 6 and 7.

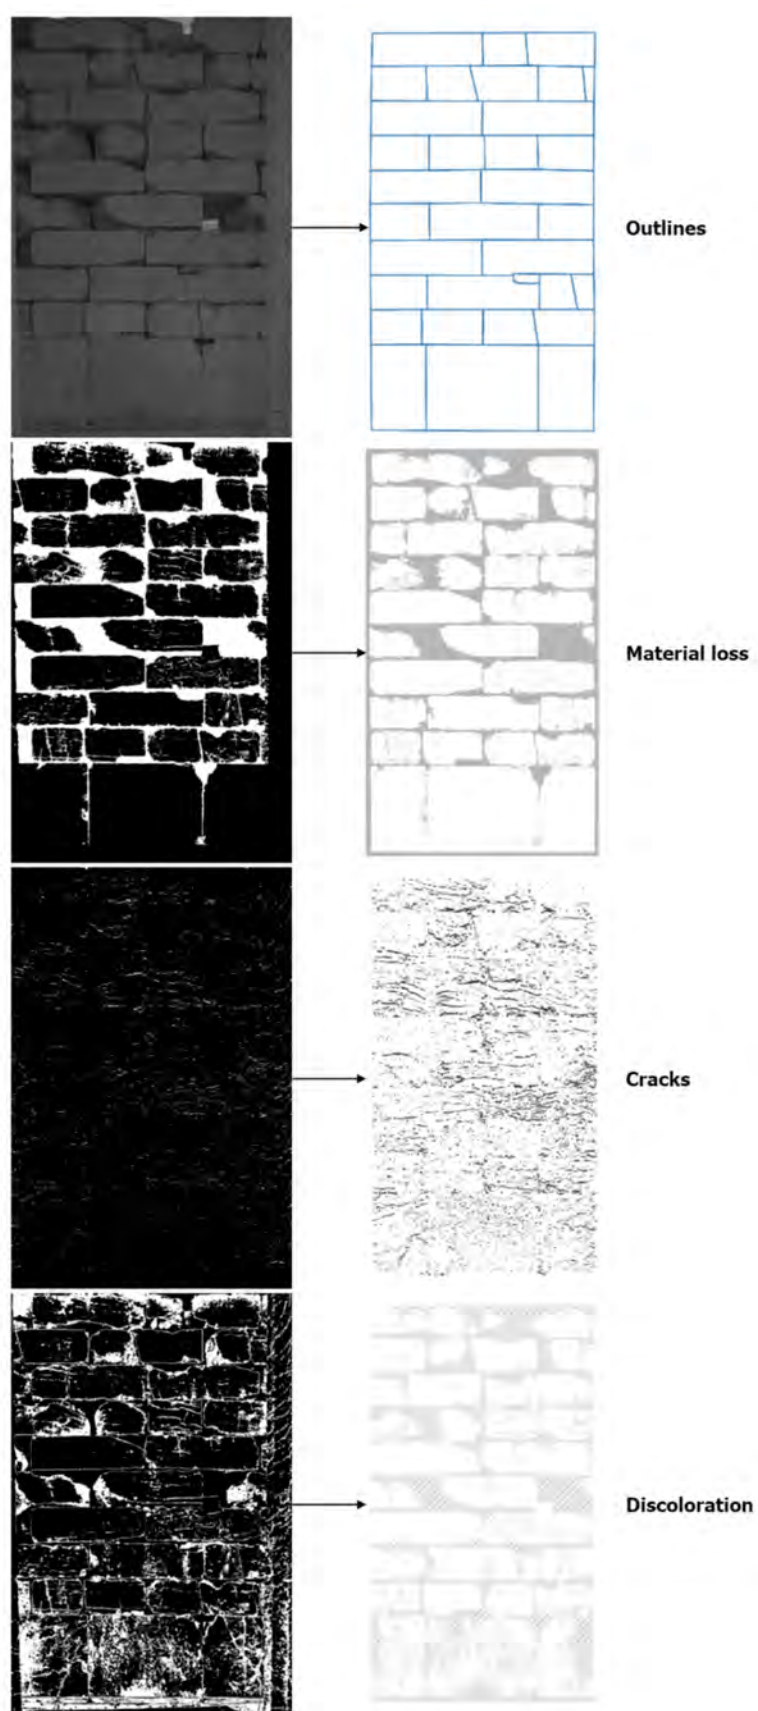
Figure 5. Generation of thematic map layers (**right**) in QGIS using features extracted from rectified near-infrared reflectance images (**left**) for the Temple of Apollo Epikourios.

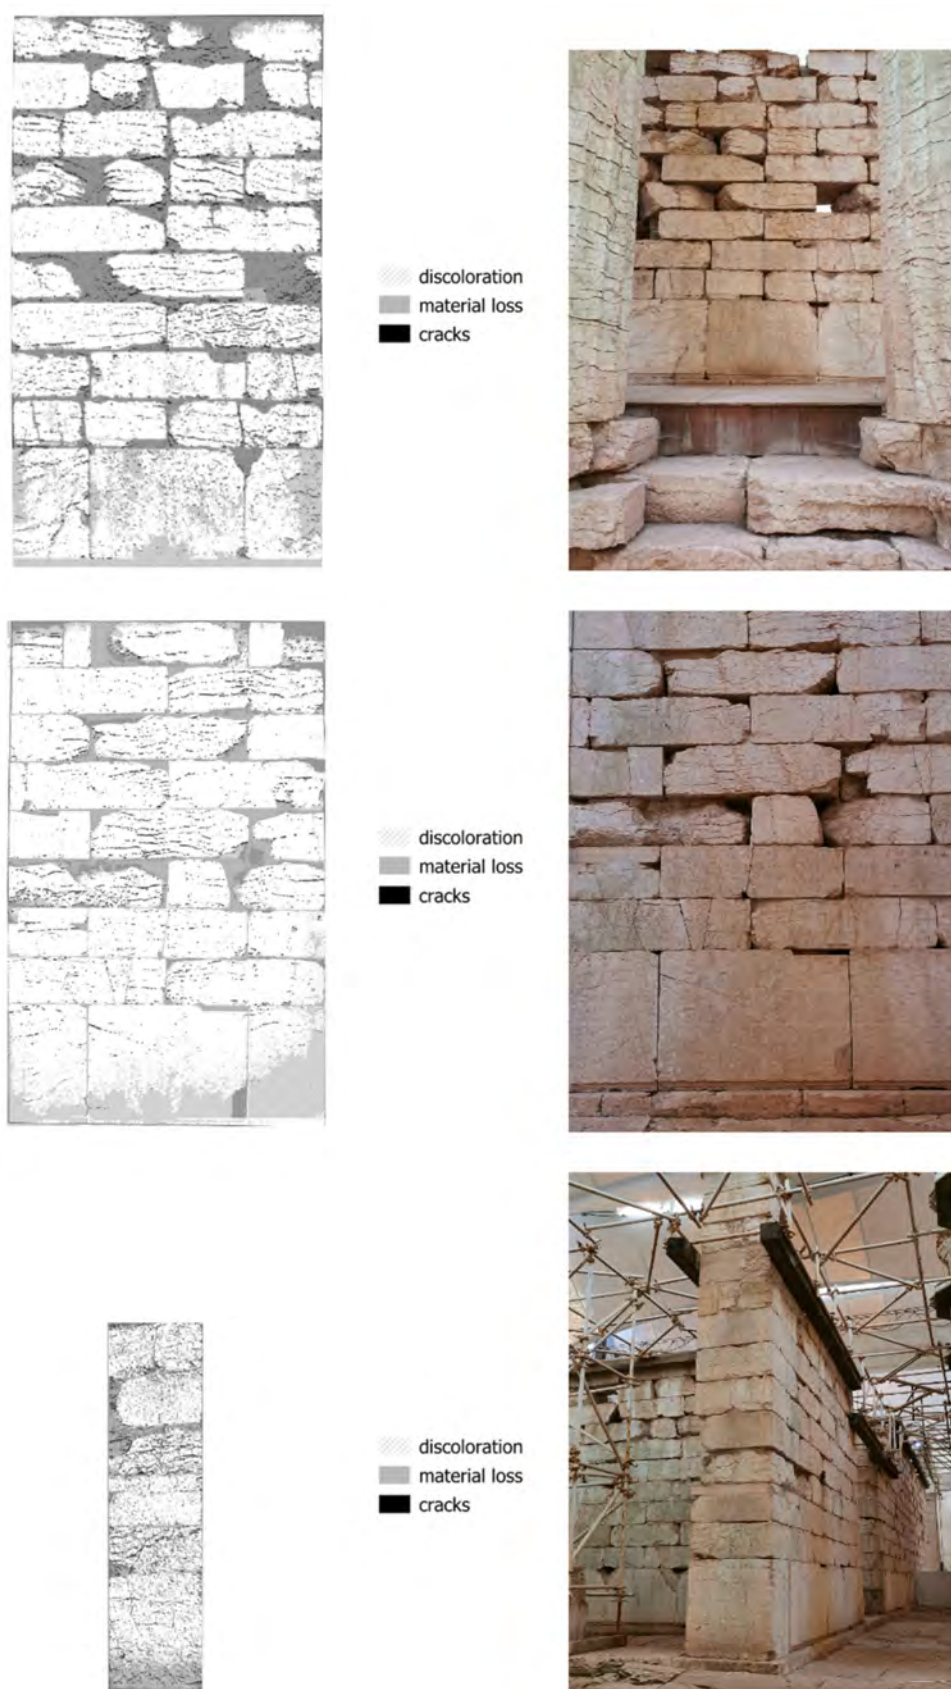
Figure 6. Degradation maps and corresponding images for characteristic areas of walls at the Temple of Apollo Epikourios.

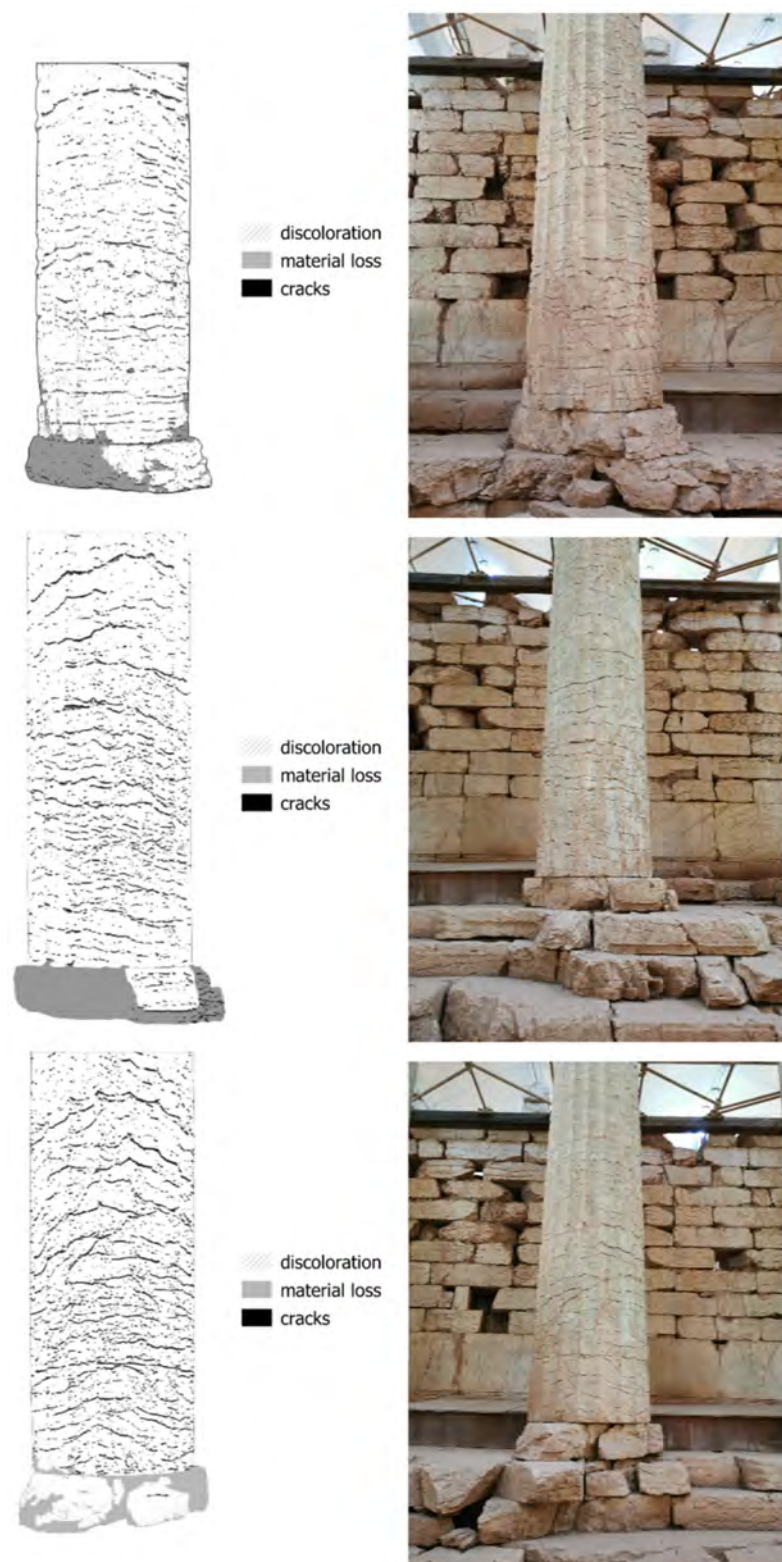
Figure 7. Degradation maps and corresponding images for characteristic areas of columns at the Temple of Apollo Epikourios.

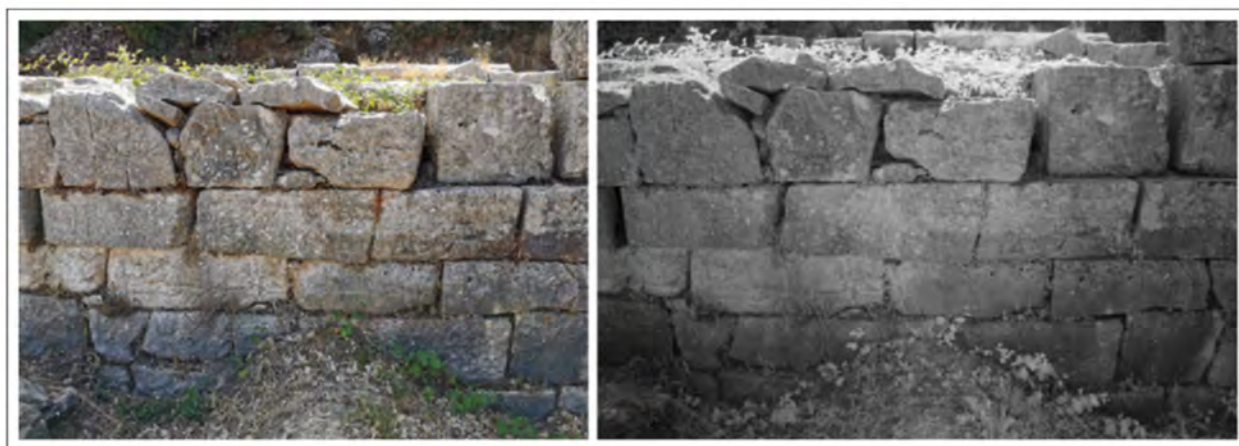
Figure 9. Color and near-infrared images captured at the Temple of Athena and Zeus Sotiros.

For this case study, the use of both visible and NIR-spectrum images was opted due to the existence of biological colonization (moss, lichens, biogenic crusts, vegetation), benefiting from the dissimilar reflectance characteristics that it presents at different wavelengths (Figure 9). Using a photogrammetric approach, orthoimage mosaics were generated for parts of the cella and the cubic stone pedestal with the RGB and NIR-reflectance images. Then, they were blended to create pseudo-color orthoimage mosaics (using the Green, Red, and NIR bands) in the HyperCube software. Next, the resulting base maps were segmented to the areas presenting different degradation forms following a *k*-means unsupervised clustering approach with centroids initialized using the *k*-means++ algorithm. Finally, the classified images were digitized, and the degradation was semantically annotated in QGIS to the corresponding thematic layers (Figures 10–14). A map of damage categories regarding the Temple of Athena and Zeus Sotiros remains could also be produced. Figure 15 additionally provides statistics of the coverage of the historical stone surfaces by various degradation forms. Both investigated surfaces were in their entirety covered by biogenic material or discolored.

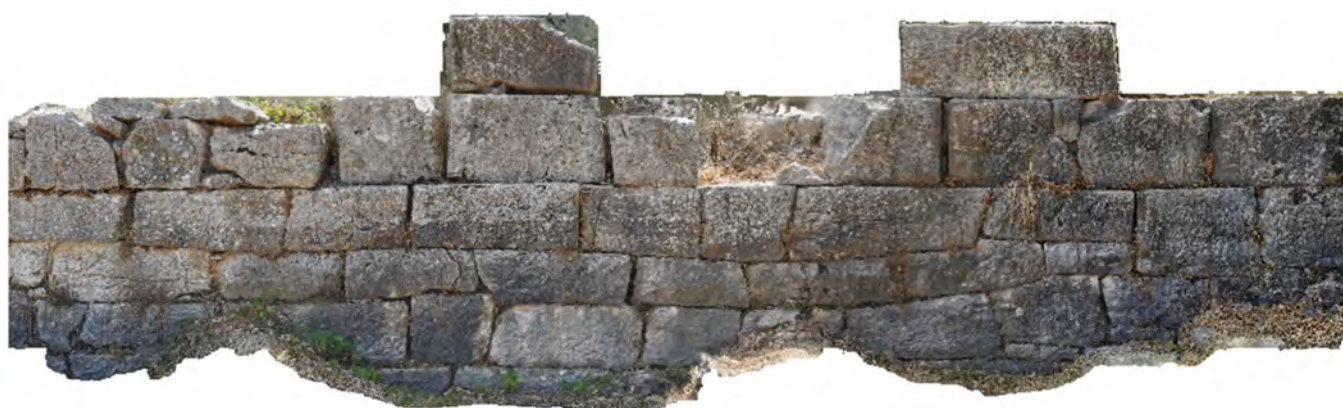
Figure 10. Orthoimage mosaic, cella wall remains at the Temple of Athena and Zeus Sotiros.

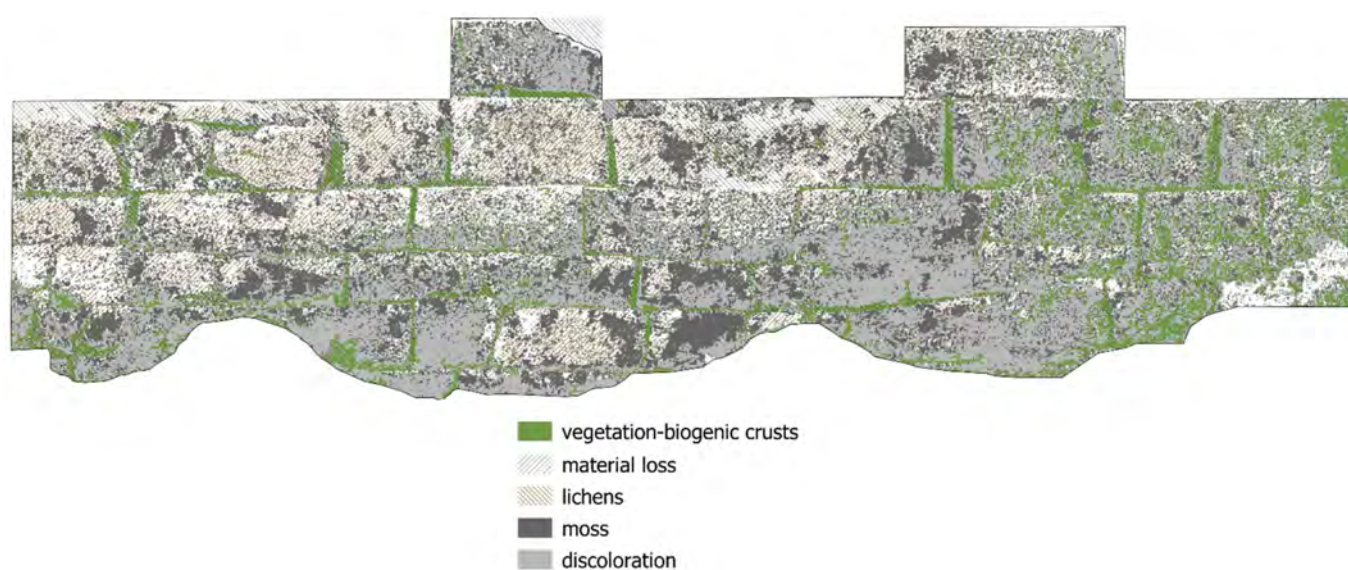
Figure 11. Degradation map, cella wall remains at the Temple of Athena and Zeus Sotiros.

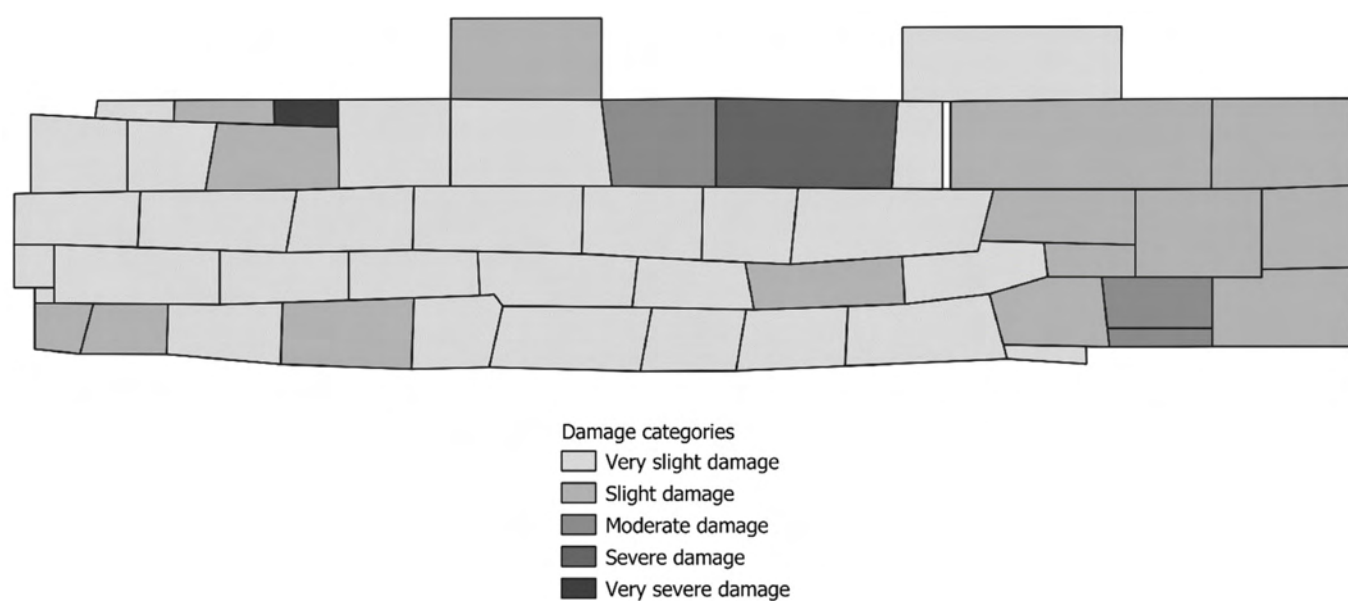
Figure 12. Damage index map, cella wall remains at the Temple of Athena and Zeus Sotiros.

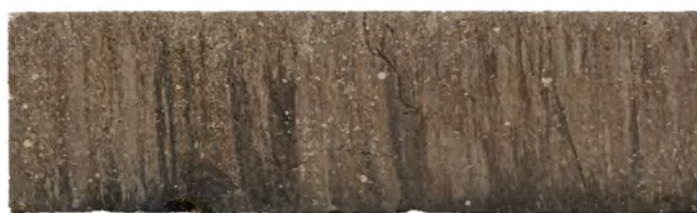
Figure 13. Orthoimage mosaic, cubic stone pedestal at the Temple of Athena and Zeus Sotiros.

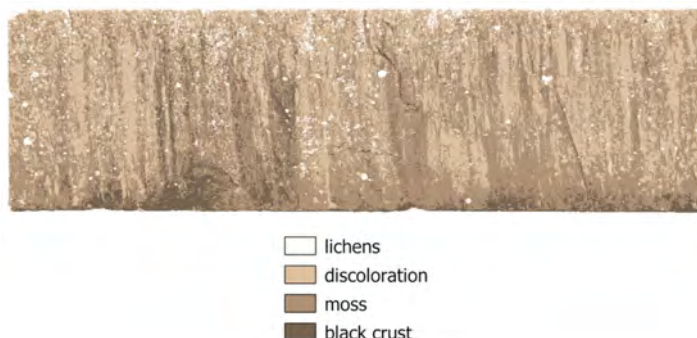
Figure 14. Degradation map, cubic stone pedestal at the Temple of Athena and Zeus Sotiros.

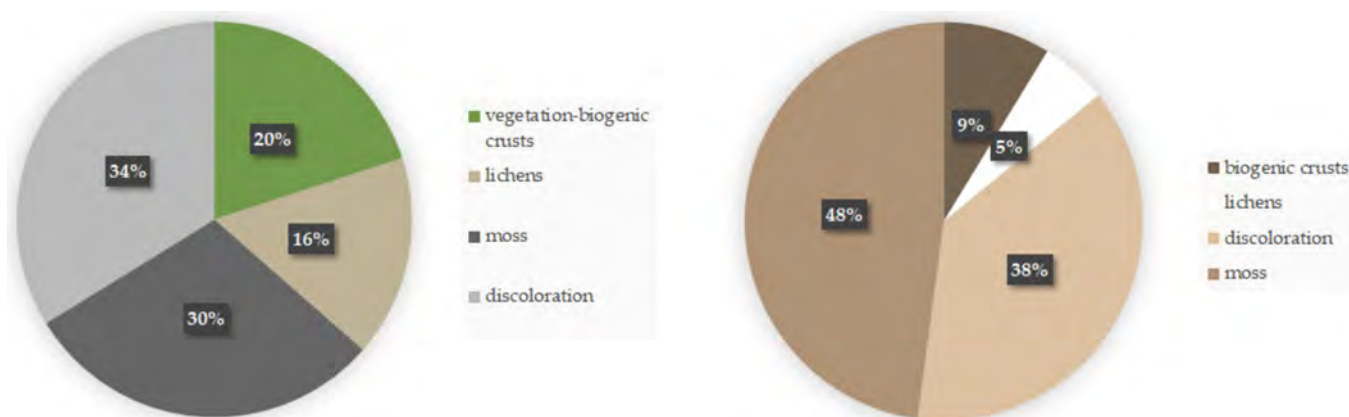
Figure 15. Degradation pattern statistics for the investigated surfaces at the remains of the Temple of Athena and Zeus Sotiros; cella wall (left) and cubic stone pedestal (right).

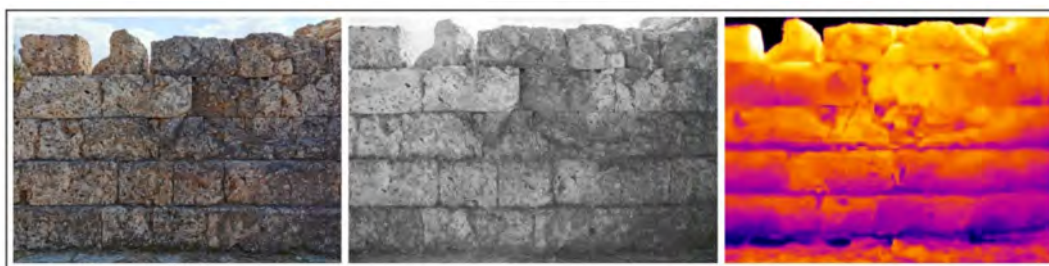
Figure 17. Reflectance images captured at the archaeological site of Lepreum: (from left to right) visible-spectrum, near-infrared, and a thermal-infrared image.

For this case study, photogrammetric approaches were followed using multiband datasets (examples of reflectance images shown in Figure 17), as described in Section 3.2, to generate the necessary base maps for the mapping process. The thermal orthoimage mosaic was produced following a hybrid approach exploiting both the visible and thermal images captured by the FLIR One Pro camera [58] (Figure 18). The false-color multiband image mosaic composed of three single-band mosaics (RGB, NIR, and TIR) was classified to create the thematic map (true-color image shown in Figure 19 and final degradation map in Figure 20). Statistics were again calculated for the coverage of the historic surface by various degradation forms (Figure 21), while the damage map (Figure 22) considered the presence of vegetation, moss, and biocolonization. Additionally, in this case study, the historical surface was almost entirely covered by biogenic material or discolored.

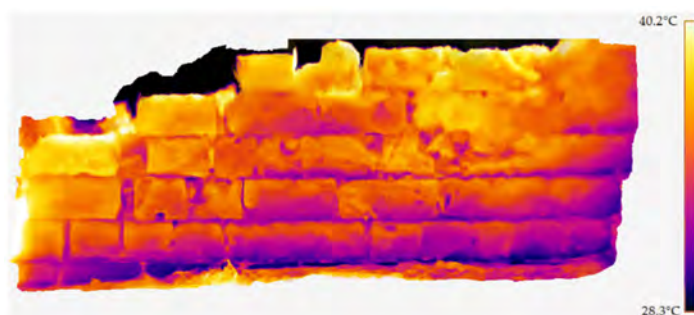
Figure 18. Thermal orthomosaic of an ancient wall at the archaeological site of Lepreum.

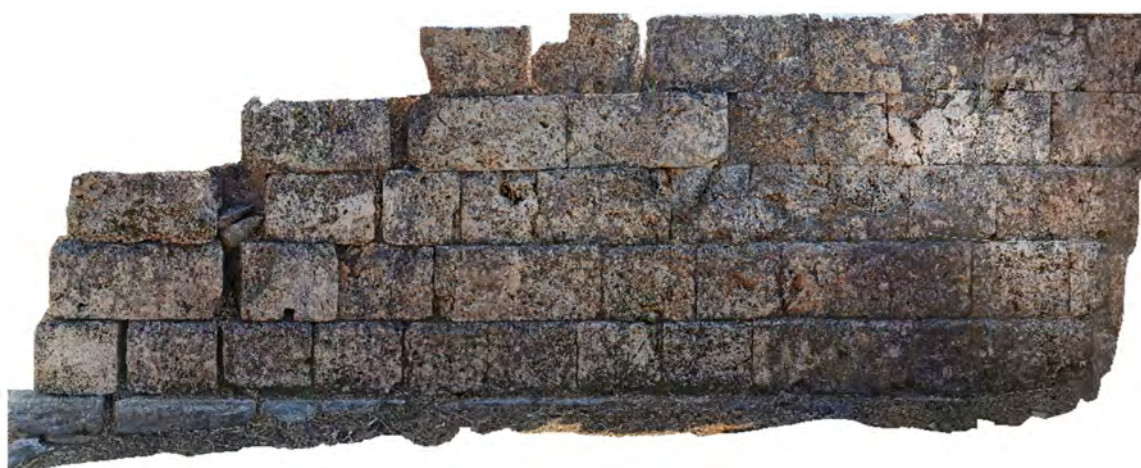
Figure 19. Orthomosaic of an ancient wall at the archaeological site of Lepreum.

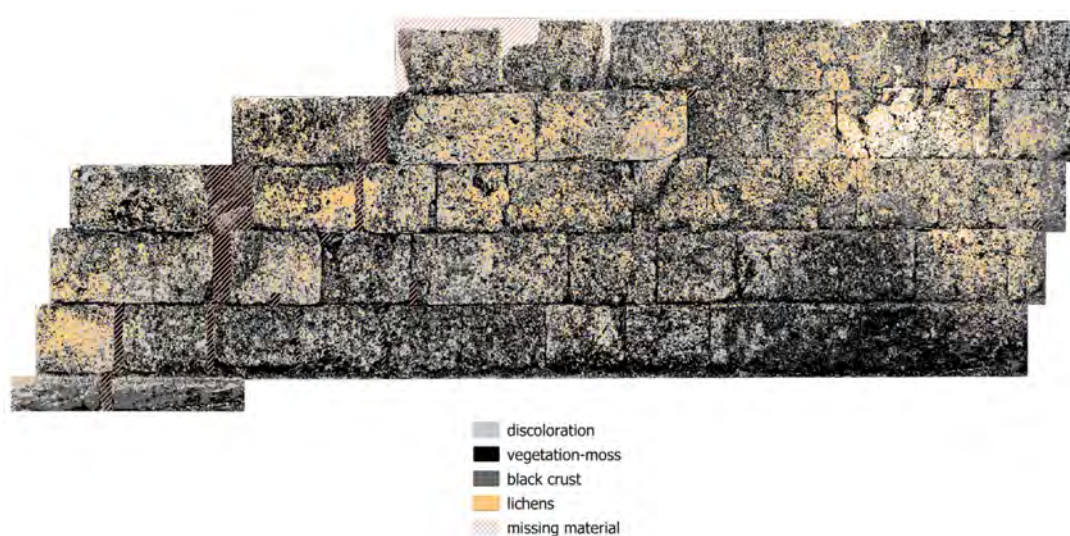
Figure 20. Degradation map of an ancient wall at the archaeological site of Lepreum.

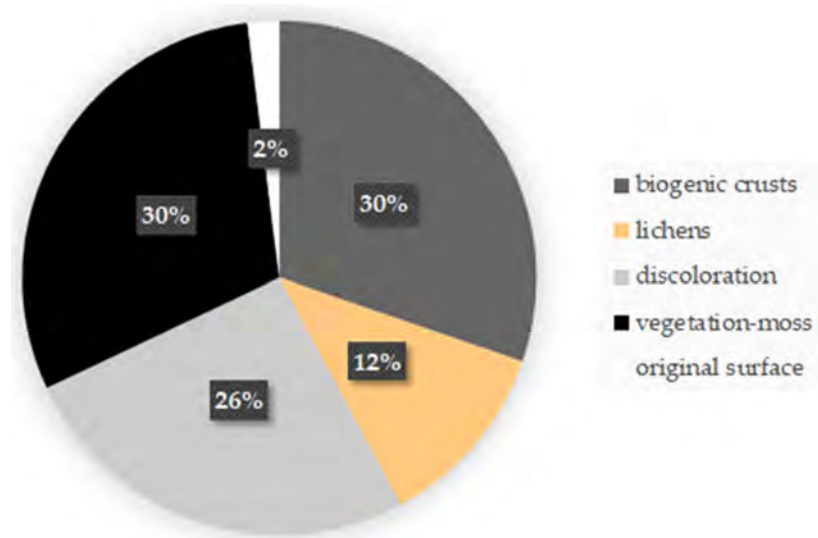
Figure 21. Degradation pattern statistics for the investigated surface of the wall at the archaeological site of Lepreum.

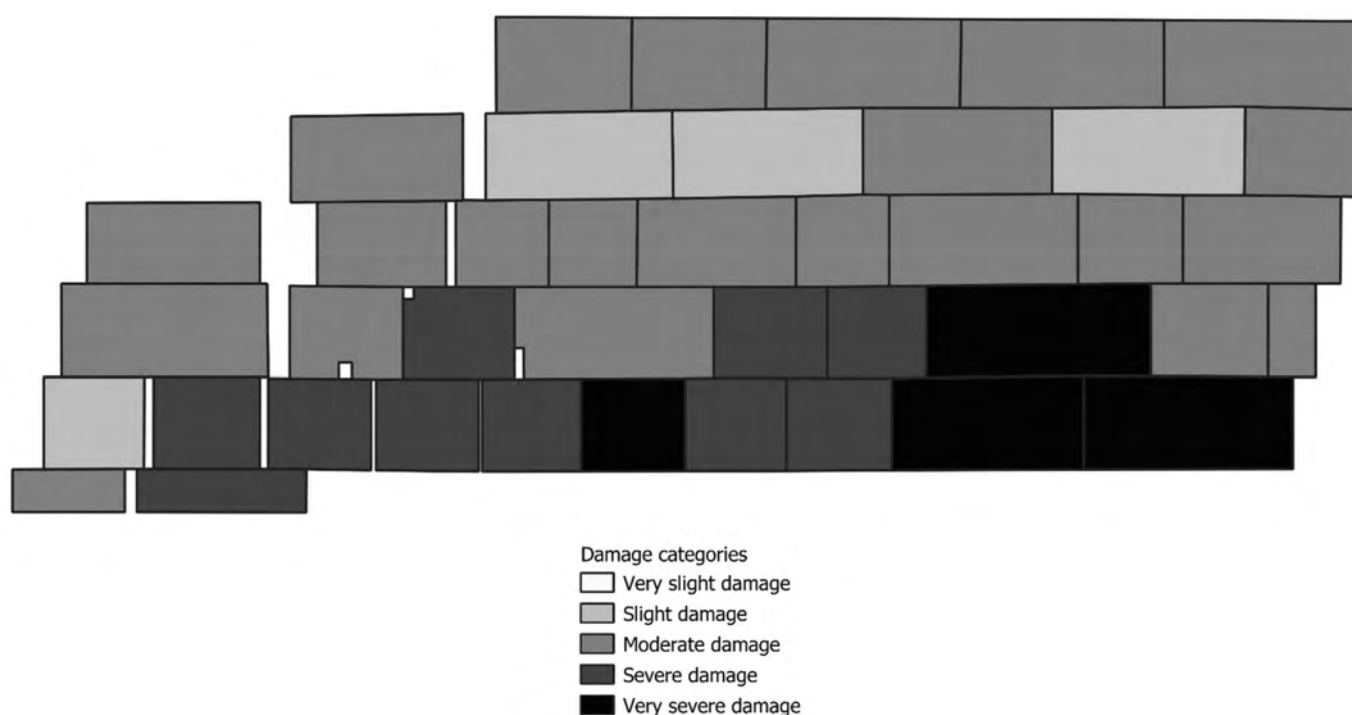
Figure 22. Damage index map, of an ancient wall at the archaeological site of Lepreum.
