Combining Multiband Imaging, Photogrammetric Techniques, and FOSS GIS for Affordable Degradation Mapping of Stone Monuments

Abstract: The detailed documentation of degradation constitutes a fundamental step for weathering diagnosis and, consequently, for successful planning and implementation of conservation measures for stone heritage. Mapping the surface patterns of stone is a non-destructive procedure critical for the qualitative and quantitative rating of the preservation state. Furthermore, mapping is employed for the annotation of weathering categories and the calculation of damage indexes. However, it is often a time-consuming task, which is conducted manually. Thus, practical methods need to be developed to automatize degradation mapping without significantly increasing the diagnostic process's cost for conservation specialists. This work aims to develop and evaluate a methodology based on affordable close-range sensing techniques, image processing, and free and open source software for the spatial description, annotation, qualitative analysis, and rating of stone weathering-induced damage. Low-cost cameras were used to record images in the visible, near-infrared, and ther

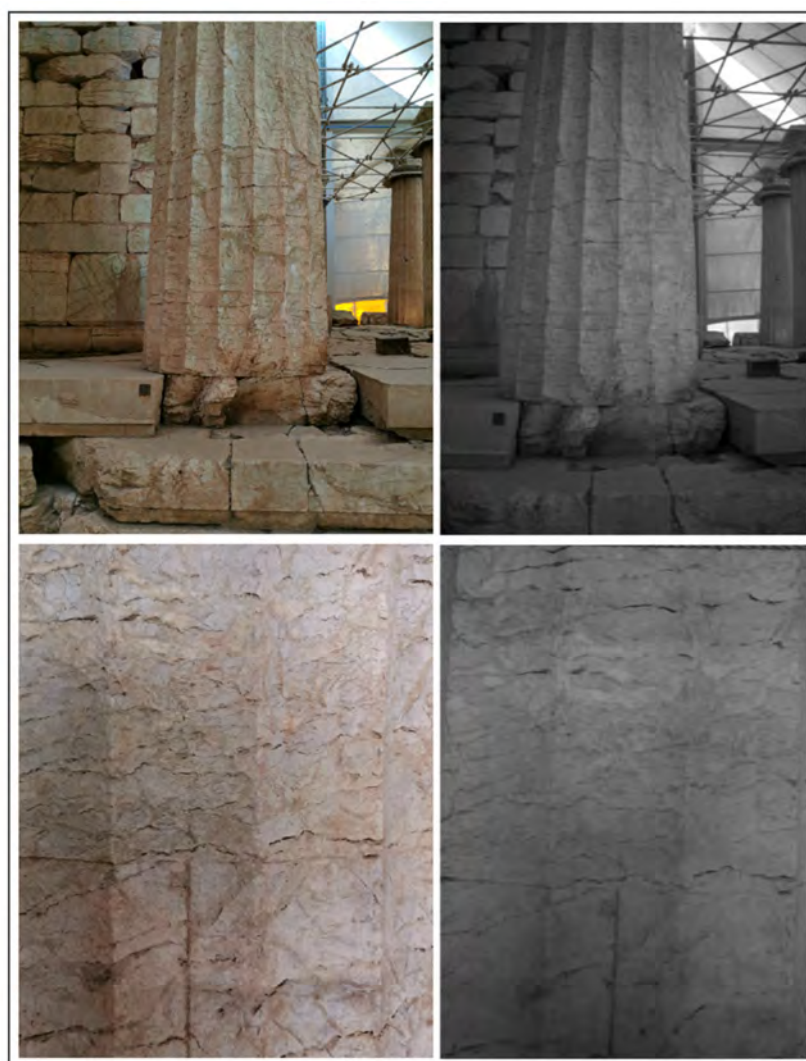
Figure 4. Color (left) and near-infrared reflectance (right) images of the same column captured at the Temple of Apollo Epikourios at Bassae, from further and closer range.

The thematic data about characteristic surfaces at the Temple of Apollo Epikourios were produced by digitally manipulating NIR reflectance images. These images presented more homogeneous radiometry, which was extremely important in order to extract suitable thematic information. In particular, the original and restoration materials that had been previously used presented more similar reflectance characteristics in the near-infrared than in the visible spectrum. Thus, by using NIR reflectance images, the misinterpretation of other degradation forms could be avoided (Figure 4). The architectural surfaces had been mostly cleaned, and therefore, the observable categories of degradation were only loss of material, cracks, and in certain places discoloration. After the NIR images had been corrected and rectified, binary images representing these different categories were produced. Thresholding was applied for identifying discoloration after flat-field correction, which eliminated any remaining inhomogeneous illumination problems. Edge detection and afterward binarization was performed on the first principal component of the images to detect cracks. Finally, histogram equalization and thresholding were performed to identify the loss of material. Figure 5 presents the generation of the binarized category-specific degradation images for an architectural surface and the production of thematic layers in the FOSS GIS environment. The thematic maps produced for investigated characteristic surfaces are presented in Figures 6 and 7.

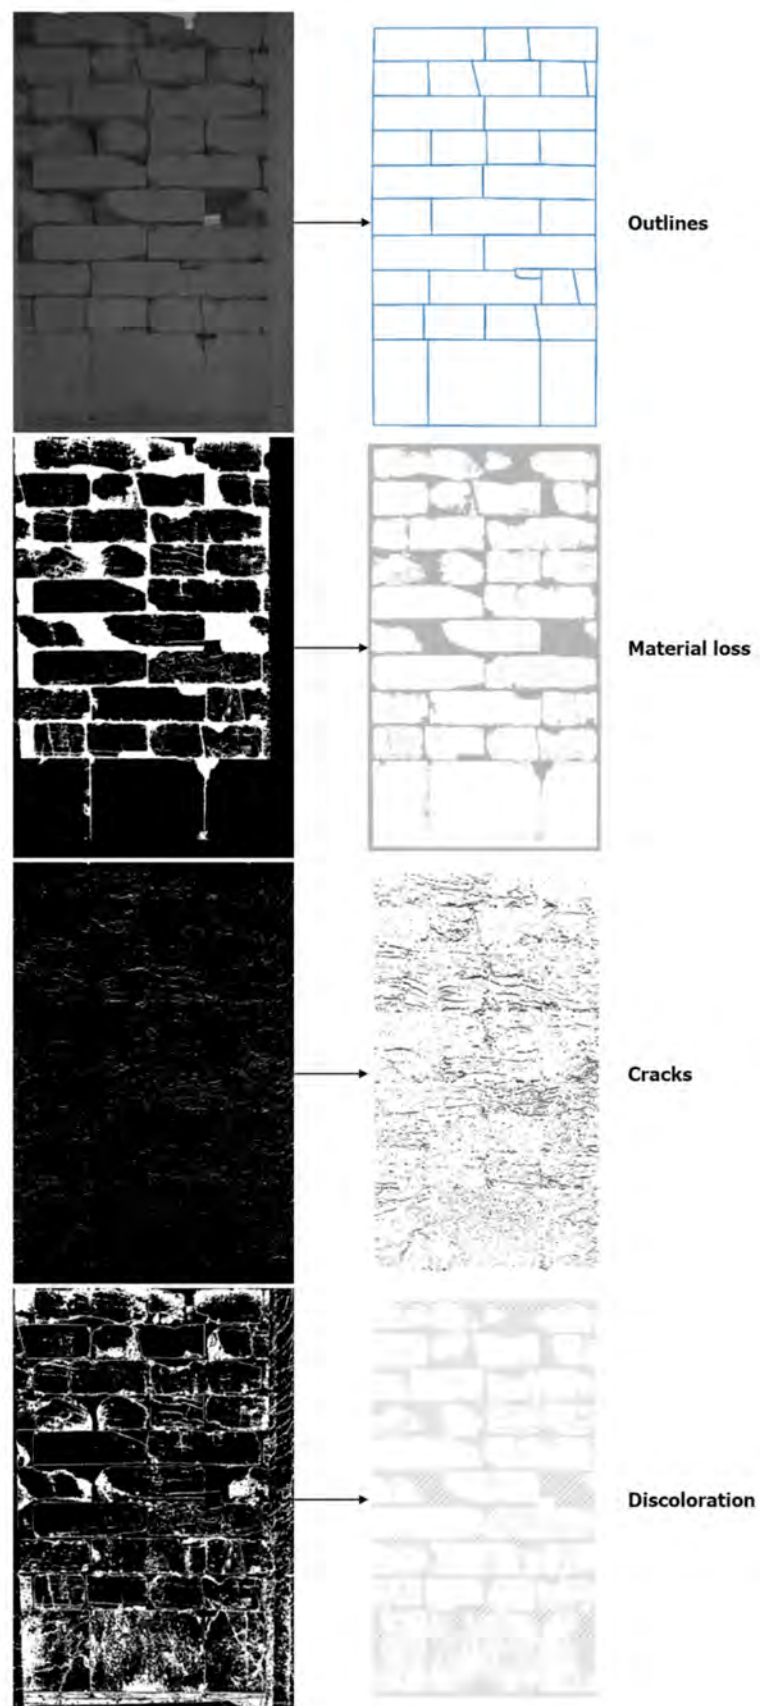
Figure 5. Generation of thematic map layers (**right**) in QGIS using features extracted from rectified near-infrared reflectance images (**left**) for the Temple of Apollo Epikourios.

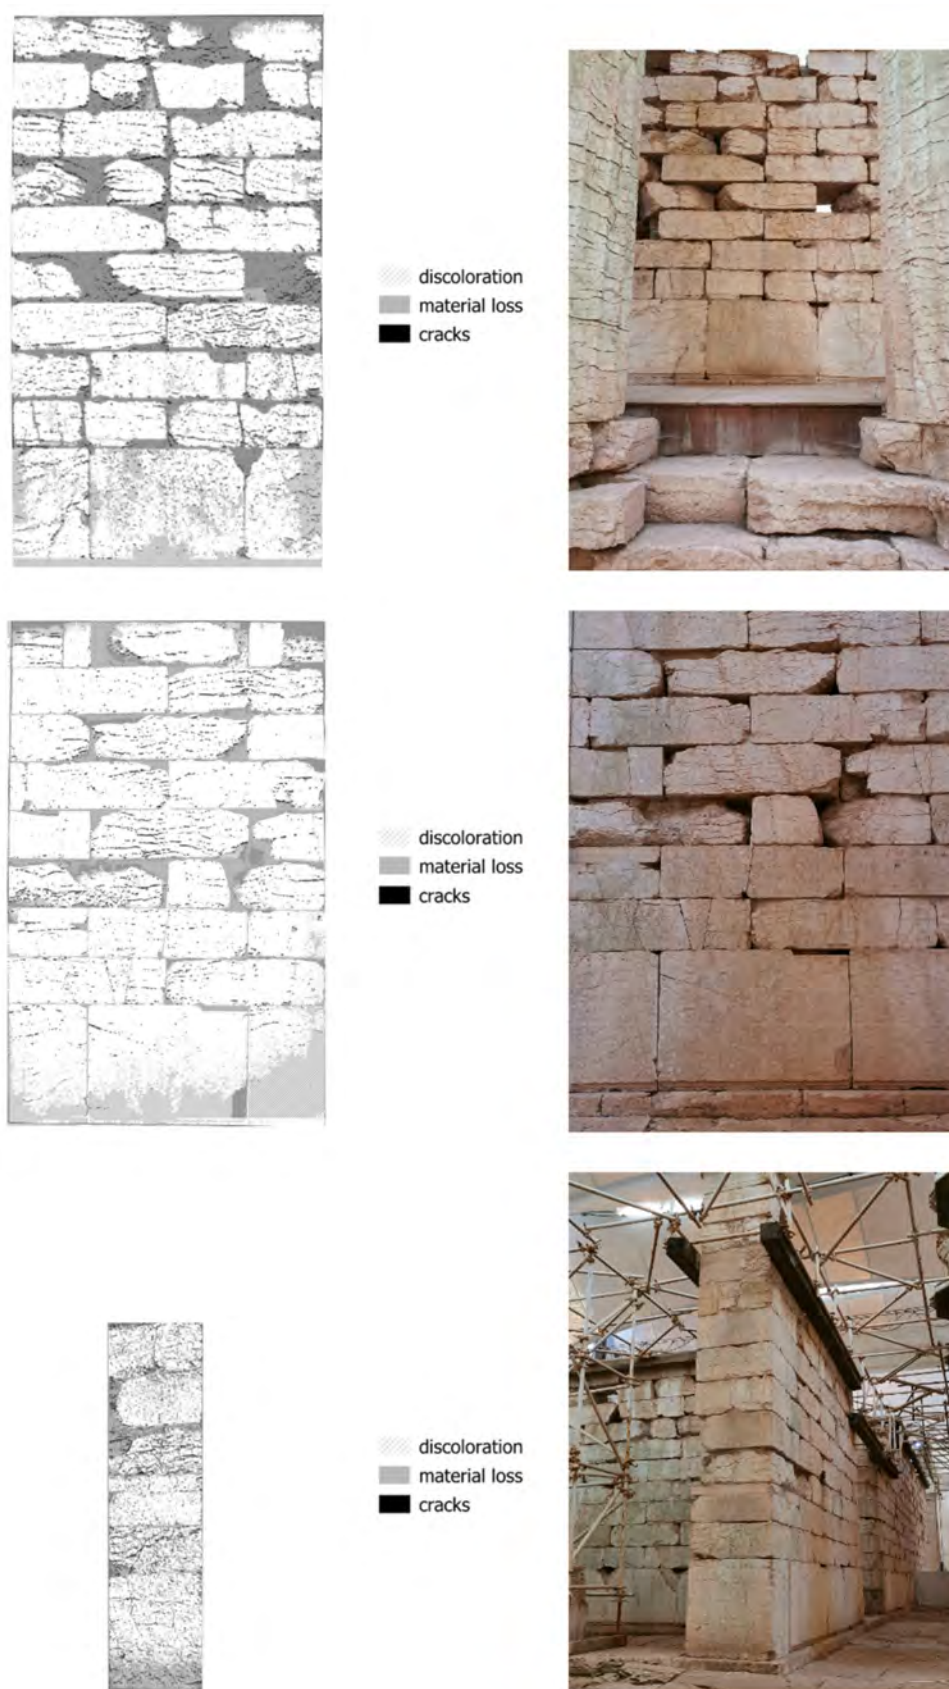
Figure 6. Degradation maps and corresponding images for characteristic areas of walls at the Temple of Apollo Epikourios.

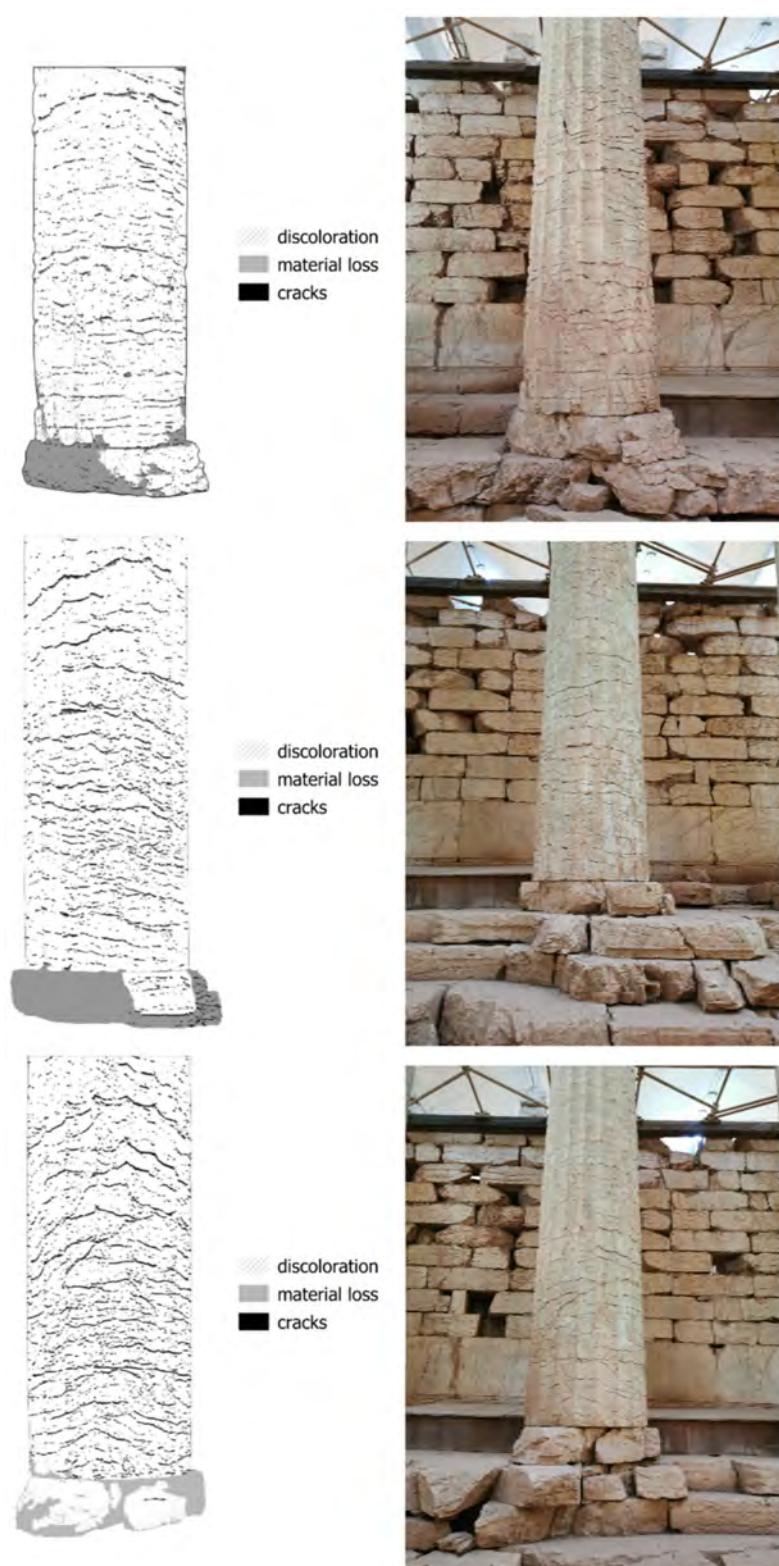
Figure 7. Degradation maps and corresponding images for characteristic areas of columns at the Temple of Apollo Epikourios.

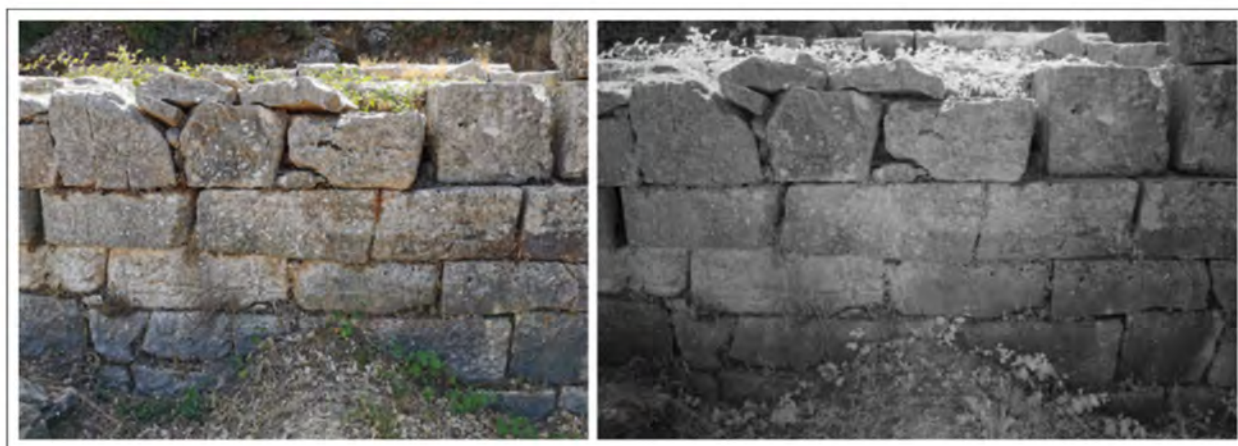
Figure 9. Color and near-infrared images captured at the Temple of Athena and Zeus Sotiros.

For this case study, the use of both visible and NIR-spectrum images was opted due to the existence of biological colonization (moss, lichens, biogenic crusts, vegetation), benefiting from the dissimilar reflectance characteristics that it presents at different wavelengths (Figure 9). Using a photogrammetric approach, orthoimage mosaics were generated for parts of the cella and the cubic stone pedestal with the RGB and NIR-reflectance images. Then, they were blended to create pseudo-color orthoimage mosaics (using the Green, Red, and NIR bands) in the HyperCube software. Next, the resulting base maps were segmented to the areas presenting different degradation forms following a *k*-means unsupervised clustering approach with centroids initialized using the *k*-means++ algorithm. Finally, the classified images were digitized, and the degradation was semantically annotated in QGIS to the corresponding thematic layers (Figures 10–14). A map of damage categories regarding the Temple of Athena and Zeus Sotiros remains could also be produced. Figure 15 additionally provides statistics of the coverage of the historical stone surfaces by various degradation forms. Both investigated surfaces were in their entirety covered by biogenic material or discolored.

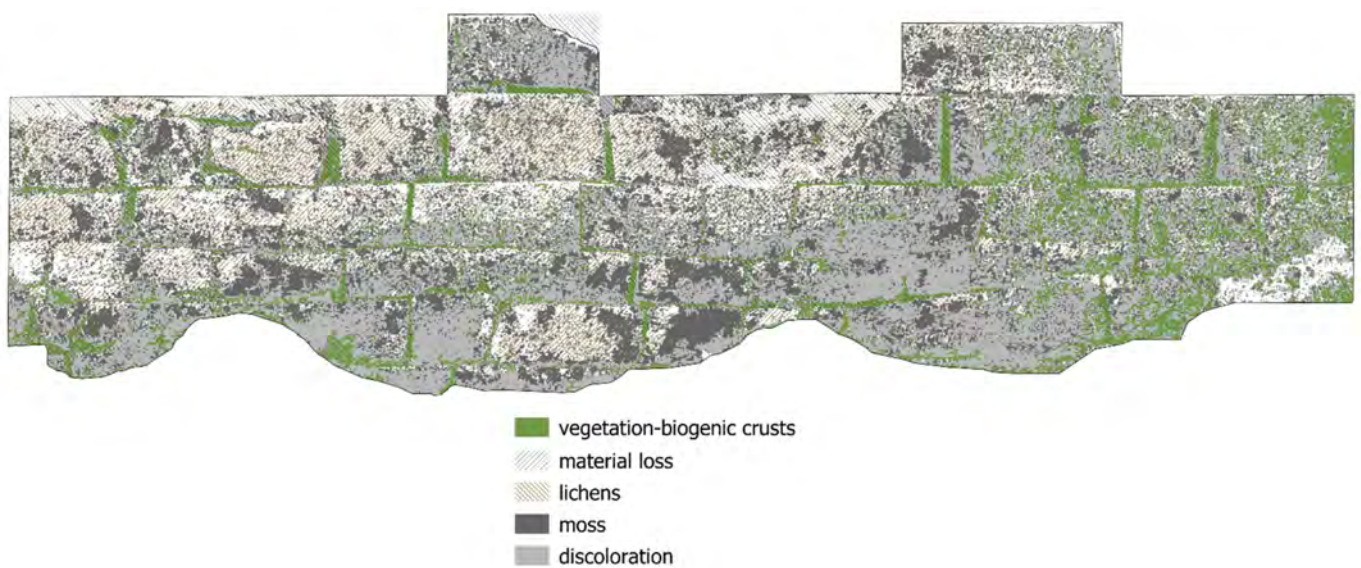
Figure 11. Degradation map, cella wall remains at the Temple of Athena and Zeus Sotiros.

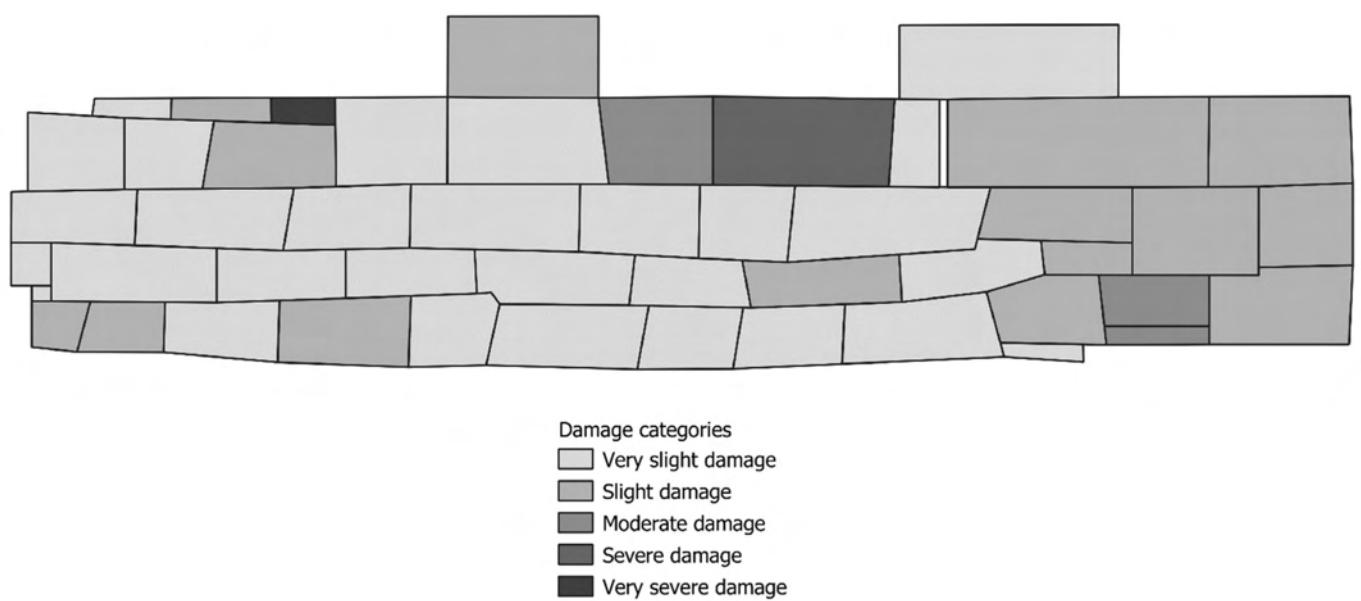
Figure 12. Damage index map, cella wall remains at the Temple of Athena and Zeus Sotiros.

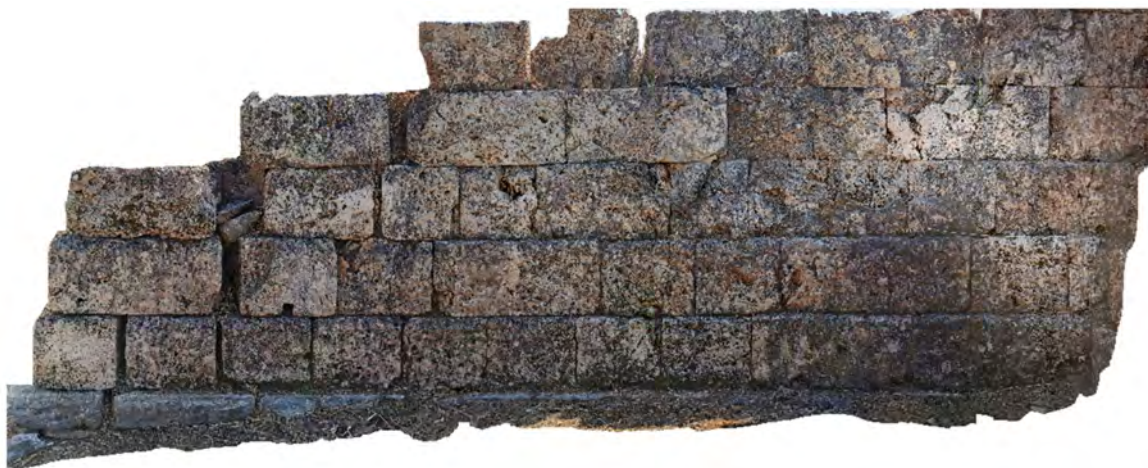
Figure 19. Orthomosaic of an ancient wall at the archaeological site of Lepreum.

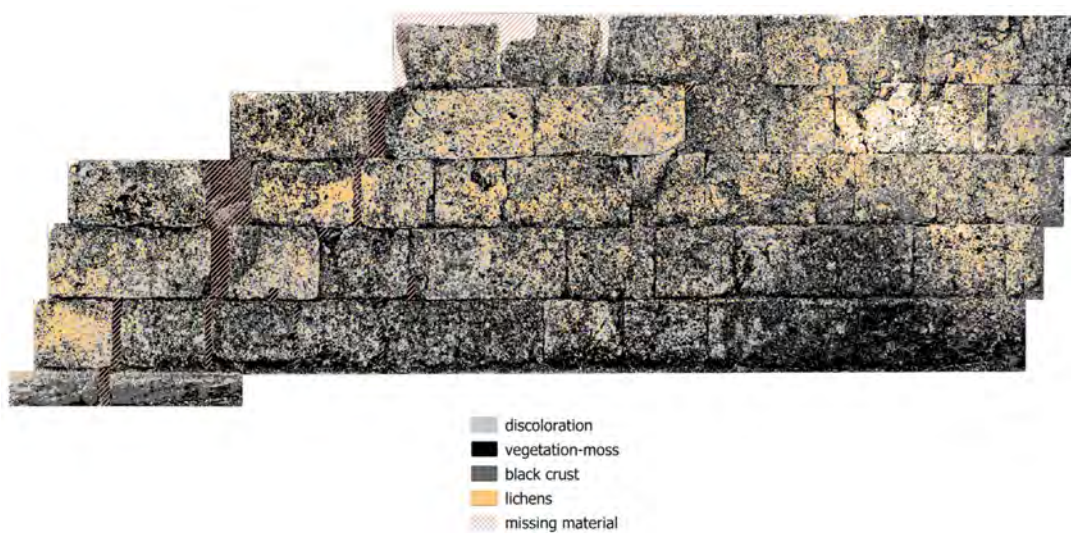
Figure 20. Degradation map of an ancient wall at the archaeological site of Lepreum.

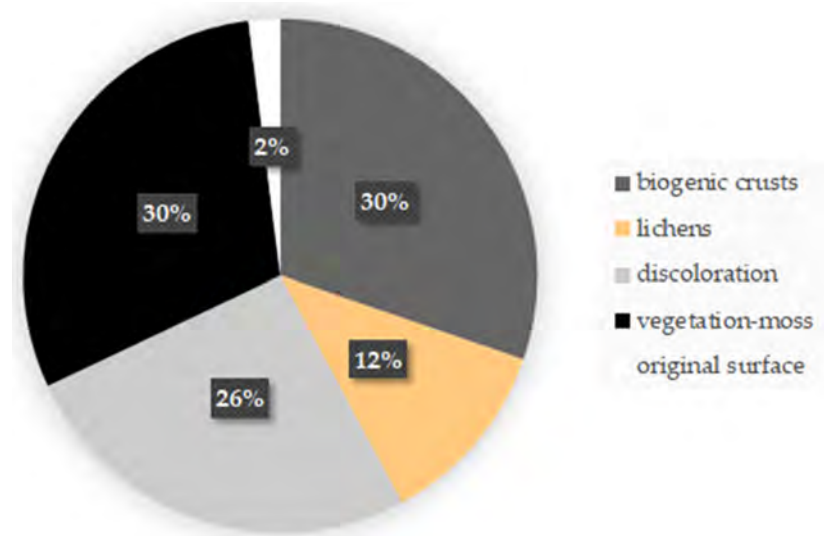
Figure 21. Degradation pattern statistics for the investigated surface of the wall at the archaeological site of Lepreum.
