Debris flow and rockslide analysis with advanced photogrammetry techniques based on high-resolution rpas data. Ponte formazza case study (nw alps)

# Debris Flow and Rockslide Analysis with Advanced Photogrammetry Techniques Based on High-Resolution RPAS Data. Ponte Formazza Case Study (NW Alps)

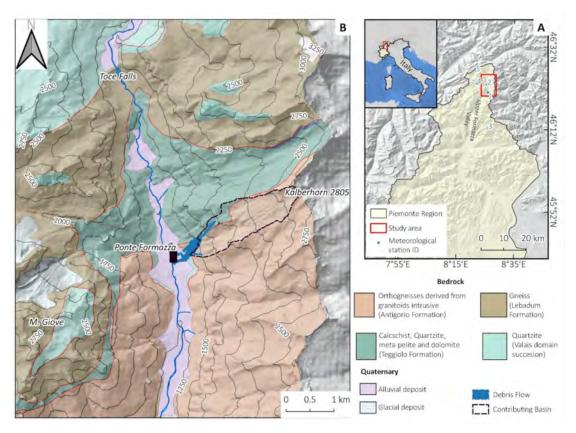
**Figure 1.** (**A**) Location of the study area. (**B**) Geological settings of the study area modified from [32] and available on https://webgis.arpa.piemonte.it/Geoviewer2D/index.html?config=other-configs/geologia250k\_config.json (accessed on 2 May 2021) and the location of the debris flow and its contributing basin.

The study area (Figure 1) is inside Lepotine nappe of the Pennidic domain, and it is located at the tectonic boundaries between Teggiolo formation (made by calcschist, metapelite lithology) and the Antigorio formation (orthogneiss lithotype) [32].

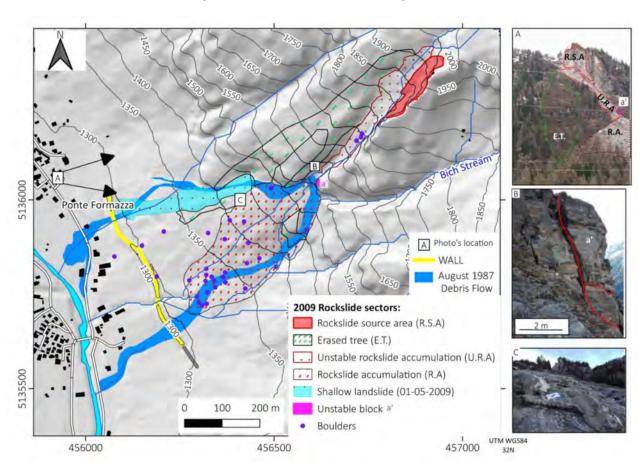
**Figure 2.** Map of April 2009 rockslide event and 1987 debris flow. Photo **A** shows a general view of the rockslide just after April 2009 (Photo Credit Colluccino M.) and the location of a'. Photo **B** shows a large  $(10 \times 3 \text{ m})$  unstable block (a') in autumn 2017, which collapsed during the 2019 event. Photo **C** shows a marker used to fix RPAS photos placed on a large boulder of the rockslide.

The most massive event in recent time occurred on 9 April 2009, when a massive rockslide (Figure 2) created a large deposit that can be considered the main predisposing factor for the event that occurred in June 2019.

In 2009, the rock mass release area (R.S.A. in Figure 2) was located on a ridge at 1950 m elevation and oriented parallel to NE–SW striking steeply dipping faults. The initial failure likely occurred along such a fault, then the detached mass fell in a steep gorge on the north side of the cliff [34–36].

The rockslide mass moved quickly along the slope, which has an inclination of about  $40^{\circ}$ . The direction of the detached mass was about  $210^{\circ}$  with a drop height of 530 m over a horizontal distance of 600 m. The estimated total volume was 700,000 m<sup>3</sup>. On 1 May 2009, a few days after the rockslide, a small shallow landslide affected the colluvial deposit where vegetation was eradicated (E.T. in Figure 2) [34].

The unstable rockslide accumulation (U.R.A. in Figure 2A), formed by some boulders of up to tens of metres in size, was partially blocked in a steep channel at the cliff base. This meta-stable deposit was massively moved by debris flow in June 2019. The field survey of 2017 also allowed us to detect an unstable block (a' in Figure 2B) that collapsed during the 2019 event.

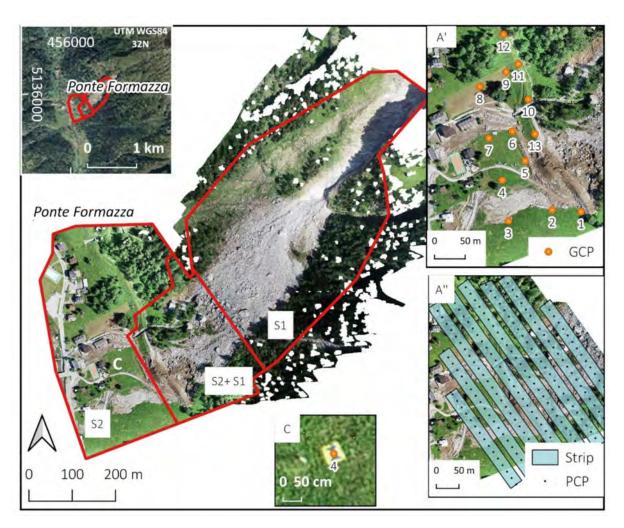
**Figure 3.** Area covered by 2019 RPAS survey. **(S1)** Higher sector, mapped by RPAS and processed with Structure from Motion. **(S2)** Lower sector mapped RtK RPAS and processed with high-precision photogrammetry with two approaches **(A')** Traditional photogrammetric approach: GCPS location; **(A'')** Direct Photogrammetry approach: Projection Center Point (PCPs) coordinates. In S1+S2 the flights overlap. **(C)** Example of plastic GCP  $50 \times 50$  cm (Marker004).

Considering these logistic limits, the area affected by 2019 debris flow was divided into two main parts (S1 and S2, in Figure 3) that partly overlap (S1+S2, in Figure 3).

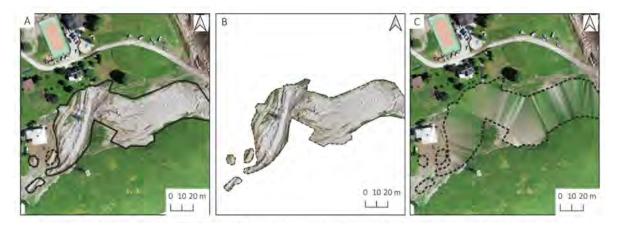
**Figure 4.** (**A**) Lower sector interested by debris flow; (**B**) clipped low-energy debris flow; (**C**) interpolated DSM that fill the clipped part.

- we first cut out from DSM the area covered by debris (Figure 4B);
- we proceeded to interpolate the clipped part to reconstruct the surface before the event (Figure 4C);
- we calculated the difference between the original raw DSM and the reconstructed DSM pre-event. This allowed us to estimate the volume also of this sector (see Figure 8A in the results).

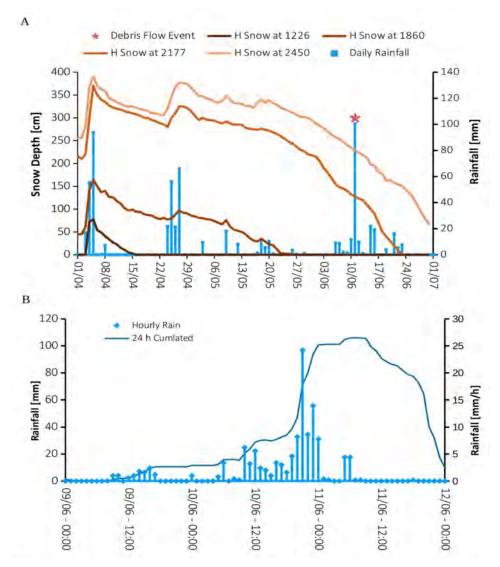
**Figure 5.** (**A**) Daily rainfall and snow depth at a different elevation from 1 April to 30 June 2019. (**B**) Hourly and cumulated precipitation at Formazza Bruggi rain gauge from 9 June 2019 00 UTC to 12 June 2019 00 UTC.

The debris flow was triggered by intense rainfall on 10–11 June 2019, with accumulated rainfall of 100 mm in 24 h and a peak of 25 mm/h (Figure 5B). These values are not extreme for the area; however, they occurred in the period of intense snow-melting that probably saturated the soil (Figure 5A). From the data of snow depth of the nearby stations and the Sentinel-2 images of 01 June 2019 (Figure 6B), it is possible to estimate snow depth and coverage at the moment of triggering rainstorm (Figure 6A). Half of the basin that contributed to debris flow was covered by snowpack that in the highest sector (>2500 m) reached about 200 cm of thickness. From the end of May 2019, the snowpack starts a rapid melting at 8 cm/days. All these factors contributed to soil saturation at the moment of the storm.

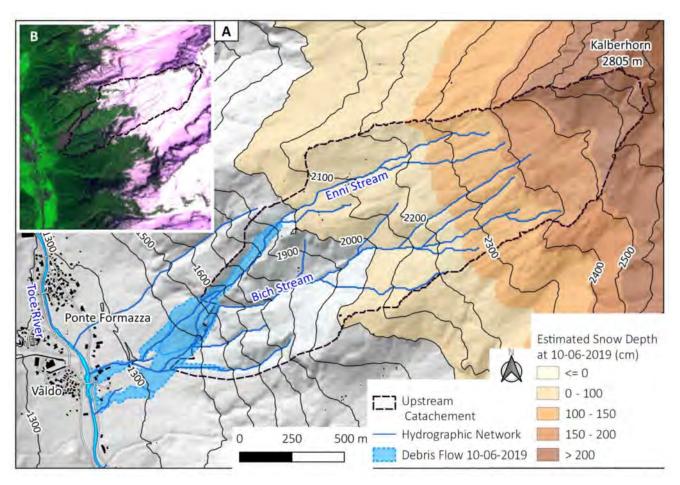
**Figure 6.** (**A**) The contributing watershed basin upstream from the debris flow area and estimated snow depth and coverage at the moment of the storm (10–11 June 2019) based on snow depth data, Sentinel-2 images and DTM data. (**B**) Sentinel-2 image acquired on 1 June 2019.

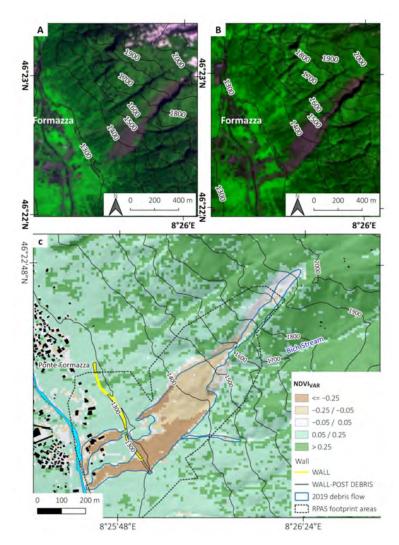
**Figure 7.** Low-Resolution debris flow mapping made with Sentinel-2 data. **(A)** Pre-event image 1 June 2019; **(B)** Post-event image 16 June 2019; **(C)** NDVI<sub>var</sub> map and the boundaries of debris flow furtherly mapped with RPASS

The processing of Sentinel-2 images (Figure 7A,B) allowed us to map the area affected by debris flow in 2019 quickly. Thanks to the first post-event images available a few

Figure 7C shows the  $NDVI_{var}$  perfectly matching the boundary of the debris flow area furtherly mapped with RPAS, especially in the bottom deposits sector. It is also possible to see that the decrease of NDVI is higher in the lower sector of the slope where vegetation was erased. The areas already occupied by debris and boulder of the 2009 event show a negative  $NDVI_{var}$  because the debris flow buried pioneer vegetation of the 2009 rockslide deposits.

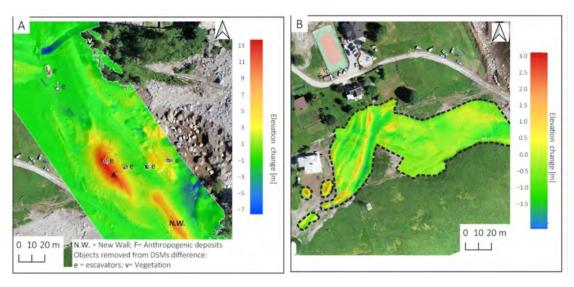
**Figure 8.** (**A**) DTM of difference (2018–2019) of the wall sector, the volume of accumulated materials is 31,064 m<sup>3</sup> (Case 3c). (**B**) Low-energy debris flow sector DTM of difference made with clipping and interpolation of 2019 DSM (estimated volume 155 m<sup>3</sup>).

The results Figure 8A show that the volume of accumulated material is respectively  $30,909 \, \mathrm{m}^3$  (Case 3b) and  $31,064 \, \mathrm{m}^3$  (Case 3c). The difference between direct photogrammetry with only 3 GCPs and full solution (3c) is about  $720 \, \mathrm{m}^3$  (2.4%); this is excellent accuracy results for geomorphological analysis. It is possible to appreciate that the excavators were also removed from the volume computation.

Using the methodology described in paragraph 3.4, we calculated the DTM of change and the volume for the low-energy sector of the debris flow (Figure 8B) where there is no available 2018 data (12s in Figure 13). In this case, the estimated cumulated volume is about 155 m<sup>3</sup>, a modest amount compared with the rest of the debris flow volume (described in Section 4.3.4).

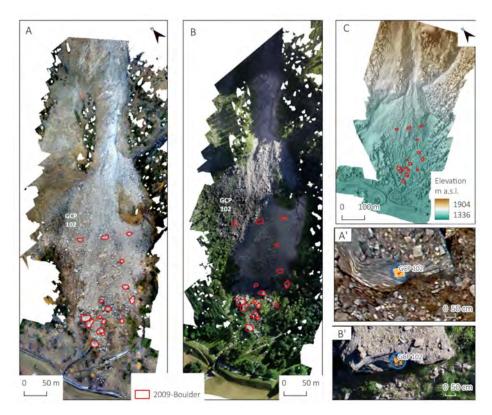
**Figure 9.** High-resolution orthophoto of 2009 rockslide deposits made with RPAS in November 2017 (**A**) and July 2018 (**B**), a detailed zoom view on GCP 102 in 2017 (**A**') and 2018 (**B**'). In panel (**C**) the 2017 DSM made with SfM used for the comparison with the 2019 post-event DSM.

The High-resolution RPAS surveys carried out in 2017 and 2018 allowed to obtain an extremely detailed orthophoto (Figure 9A,B) and DSM of the rockslide accumulation (Figure 9C). The 3-D views allowed us to measure and estimated the volumes of large boulders as on the field. It is interesting to note how most of the GCPs installed in 2017 are still well visible in the 2018 orthophoto (e.g., Figure 9A',B').

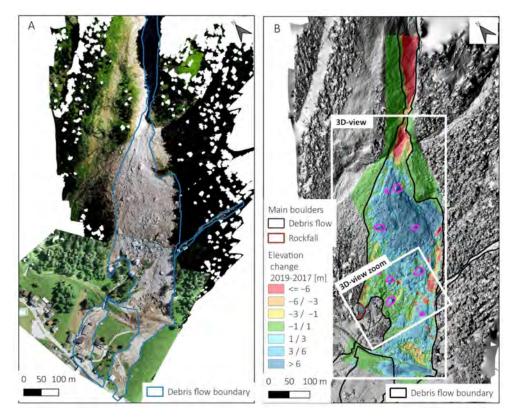
**Figure 10.** 2019 event (**A**) UAV post-event orthophoto with the boundary of the debris flow; (**B**) DSM change (2019–2017) draped on the hillshade model and the most massive boulders mobilized during the 2019 event.

The orthophoto allowed a precise mapping of most debris flows (Figure 10A), especially in the lower part, and at the downslope of the wall. Here the relatively low-energy flow created fine-sized debris deposits (from the decimetric block to the sand matrix). Some UAV footage available on the Local Team web video platform [46] shows the debris flow deposit just a few hours after the event. The videos helped to understand some depositional patterns of the restored area at the moment of our RPAS flight 15 days later.

The difference between DSM 2019 and 2017 allowed us to understand the complexity of the processes during the 2019 event (Figure 10B). The main events and their geomorphological evidence can be resumed as follows: (i) The canyon of Enni Stream was utterly washed out of the 30 m thickness of debris and boulders, and now the bedrock is not covered by rockslide deposits; (ii) the giant block a' that was positioned at the top of the fan fall down during the 2019 event following a linear trajectory independent from the rest of debris flow; (iii) most of the debris mass was deposited in the middle sector of the slope, here it is possible to see how the Enni stream migrated from the central part of the fan to the left sector joining the Rich stream; (iv) a sector characterized by the presence of a heterogeneous deposit composed by large blocks in a coarse-grained matrix due to the debris flow transport effect and the rolling component of the movement of unstable rock blocks; (v) the contribution of Rich stream energy and water to the lower sector of the debris flow that accumulated 10 m of materials behind the wall built after the 2009 rockslide; (vi) part of debris flow overpassed the wall, and the rest get around the wall and reached the main Toce river, with two separate branches. These flows hit several buildings, roads, and some sports facilities. The relatively low-energy debris flow avoided more severe damage to buildings, and the few residents were evacuated some minutes before, avoiding life risk.

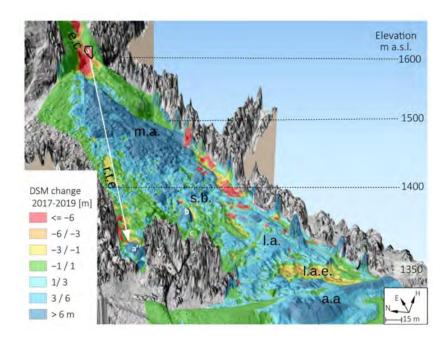
**Figure 11.** 3-D shadow model of the affected area with DSM change 2019-2017 draped on. It is possible to detect: the erosion channel (e.c.); the collapsed block (a'), its rolling/bounce erosion trace (r.t.e.) and its final position (a"); the main accumulation (m.a.); the area with large sparse boulders (s.b.); the lower accumulation (l.a.) partially excavated (l.a.e); the anthropogenic accumulation (a.a.).

In the general 3D view (Figure 11), it is possible to detect the area of erosion in the upper part of the channel, the detachment on the large boulders (a'), and its trajectory until its final position (a"). The main accumulation (m.a.) is located at an altitude of 1500 m. In the lower part of the slope, the debris flow shows the fine-size of the blocks (i.a.), and the restoration work moved part of this debris (l.a.e) to make a new section of the wall (a.a.).

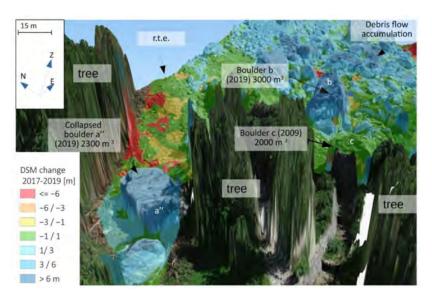
**Figure 12.** A detailed 3d view of the accumulation. It is possible to detect the most massive boulders from 2009 (c with no change in DSM difference) and 2019 events (a" and b). The areas covered by trees are excluded from DSMs differences.

In Figure 12, a 3D view of the areas with the largest boulders is represented with more detail. It is interesting to note how the DSM difference allowed us to distinguish the boulder "c" that is part of the 2009 rockslide, from the block a" derived from the new detachment and the rest of the boulders like "b" that is part of the debris flow.

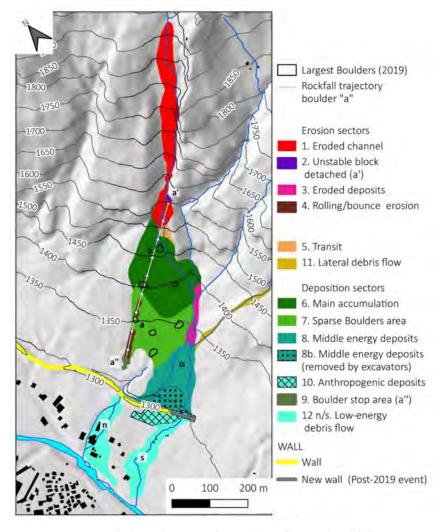
Figure 13. Geomorphological sectors of 2019 debris flow and rockfall.

• Erosion sectors (red/violet colors in Figure 13). Here it is possible to find the eroded channel (1) (source of most of the material mobilized; the area of the detachment of the block a') (2) and the erosion caused by its rolling and bounce (4 a/b); a small area of erosion (3) on the left side of the rockslide deposit related to debris flow action increased by the Bich stream.

- Deposition sectors (green colors in Figure 13). Most of the debris was deposits in the middle sector of the slope just after the channel (6) at 1400 m a.s.l. Just below this deposit, we can find a dispersed accumulation where most of the boulders stopped (about 211,000 m³) (7); the lower sector of the slope (under 1350 m) is characterized by middle energy deposits blocked by the wall (8) and partly removed by remedial work in July 2019 (8b). Part of the removed material was used to build a new section of the wall (10). On the right side of the accumulation, we can also find the collapsed boulder a" (2000 m³) that stopped about 30 m from the wall (9).

- Low-energy sectors (cyan colors in Figure 13). A small portion of debris flow overpassed the wall for these deposits (11). We calculated the volume for the 's' portion (155 m<sup>3</sup>) with the method described in Section 3.5 and showed in Figure 8B.
