# Debris Flow and Rockslide Analysis with Advanced Photogrammetry Techniques Based on High-Resolution RPAS Data. Ponte Formazza Case Study (NW Alps)

**Abstract:** The use of a Remotely Piloted Aircraft System (RPAS) for the characterization and monitoring of landslides has been widely improved in the last decade. In particular, the use of this system is particularly effective for the study of areas prone to geohazards. Zones affected by landslides, such as rock slides and debris flows, are often quite critical in terms of accessibility due to unstable blocs that can strongly limit the direct access to the studied area. In this paper, we present the case study of Ponte Formazza in NW Italian Alps. In June 2019, a massive and complex debris flow re-mobilized about 300,000 m<sup>3</sup> of a rockslide deposit that occurred in 2009. In this particular environment, we tested traditional, direct and mixed photogrammetric approaches using various configurations of Ground Control Points (GCPs) of the photogrammetric block and by calculating the relative errors. The minimum configuration of GCPs was established to reduce in situ measurements without degrading the accuracy of the cartograph

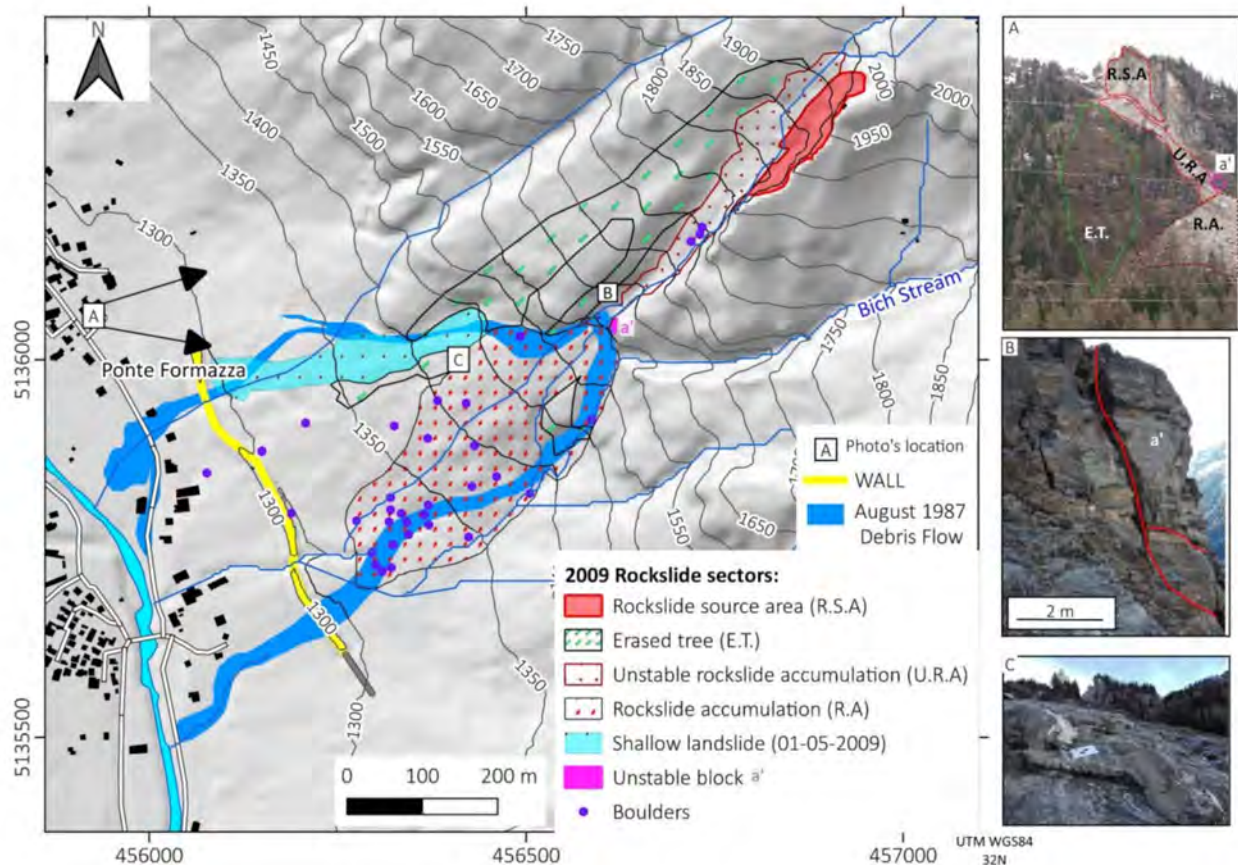
**Figure 2.** Map of April 2009 rockslide event and 1987 debris flow. Photo A shows a general view of the rockslide just after April 2009 (Photo Credit Colluccino M.) and the location of a'. Photo B shows a large (10 × 3 m) unstable block (a') in autumn 2017, which collapsed during the 2019 event. Photo C shows a marker used to fix RPAS photos placed on a large boulder of the rockslide.

The most massive event in recent time occurred on 9 April 2009, when a massive rockslide (Figure 2) created a large deposit that can be considered the main predisposing factor for the event that occurred in June 2019.

In 2009, the rock mass release area (R.S.A. in Figure 2) was located on a ridge at 1950 m elevation and oriented parallel to NE–SW striking steeply dipping faults. The initial failure likely occurred along such a fault, then the detached mass fell in a steep gorge on the north side of the cliff [34–36].

The rockslide mass moved quickly along the slope, which has an inclination of about  $40^\circ$ . The direction of the detached mass was about  $210^\circ$  with a drop height of 530 m over a horizontal distance of 600 m. The estimated total volume was  $700,000 \text{ m}^3$ . On 1 May 2009, a few days after the rockslide, a small shallow landslide affected the colluvial deposit where vegetation was eradicated (E.T. in Figure 2) [34].

The unstable rockslide accumulation (U.R.A. in Figure 2A), formed by some boulders of up to tens of metres in size, was partially blocked in a steep channel at the cliff base. This meta-stable deposit was massively moved by debris flow in June 2019. The field survey of 2017 also allowed us to detect an unstable block (a' in Figure 2B) that collapsed during the 2019 event.

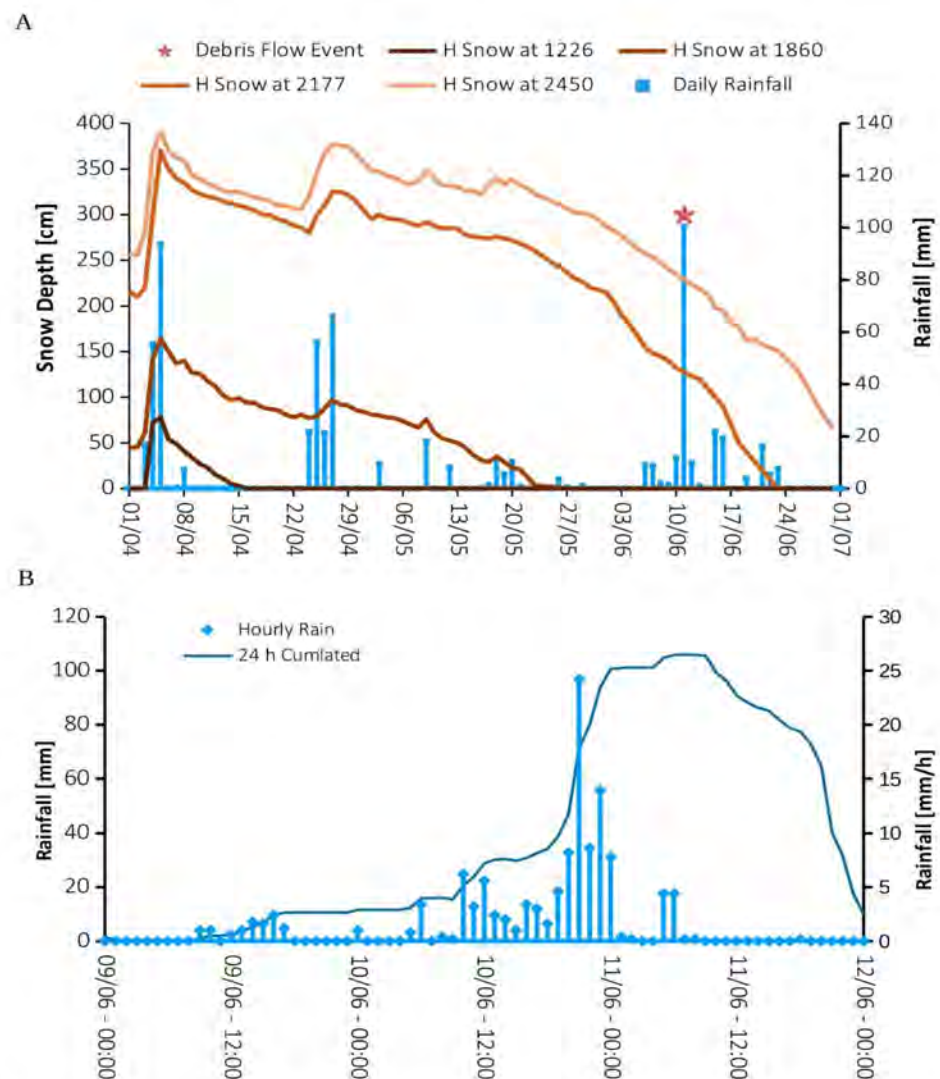
**Figure 5.** (A) Daily rainfall and snow depth at a different elevation from 1 April to 30 June 2019. (B) Hourly and cumulated precipitation at Formazza Bruggi rain gauge from 9 June 2019 00 UTC to 12 June 2019 00 UTC.

The debris flow was triggered by intense rainfall on 10–11 June 2019, with accumulated rainfall of 100 mm in 24 h and a peak of 25 mm/h (Figure 5B). These values are not extreme for the area; however, they occurred in the period of intense snow-melting that probably saturated the soil (Figure 5A). From the data of snow depth of the nearby stations and the Sentinel-2 images of 01 June 2019 (Figure 6B), it is possible to estimate snow depth and coverage at the moment of triggering rainstorm (Figure 6A). Half of the basin that contributed to debris flow was covered by snowpack that in the highest sector (>2500 m) reached about 200 cm of thickness. From the end of May 2019, the snowpack starts a rapid melting at 8 cm/days. All these factors contributed to soil saturation at the moment of the storm.
