Debris flow and rockslide analysis with advanced photogrammetry techniques based on high-resolution rpas data. Ponte formazza case study (nw alps)

# Debris Flow and Rockslide Analysis with Advanced Photogrammetry Techniques Based on High-Resolution RPAS Data. Ponte Formazza Case Study (NW Alps)

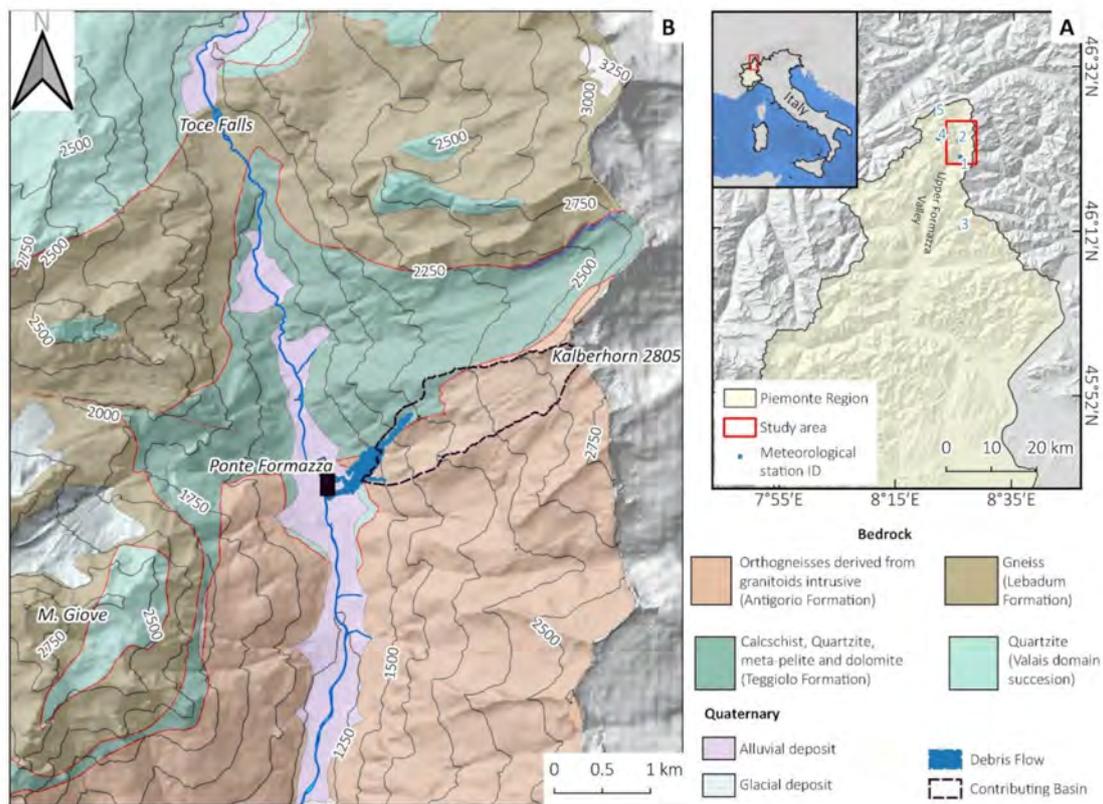
**Figure 1.** (A) Location of the study area. (B) Geological settings of the study area modified from [32] and available on [https://webgis.arpa.piemonte.it/Geoviewer2D/index.html?config=other-configs/geologia250k\\_config.json](https://webgis.arpa.piemonte.it/Geoviewer2D/index.html?config=other-configs/geologia250k_config.json) (accessed on 2 May 2021) and the location of the debris flow and its contributing basin.

The study area (Figure 1) is inside Lepontine nappe of the Penninic domain, and it is located at the tectonic boundaries between Teggiolo formation (made by calcschist, metapelite lithology) and the Antigorio formation (orthogneiss lithotype) [32].

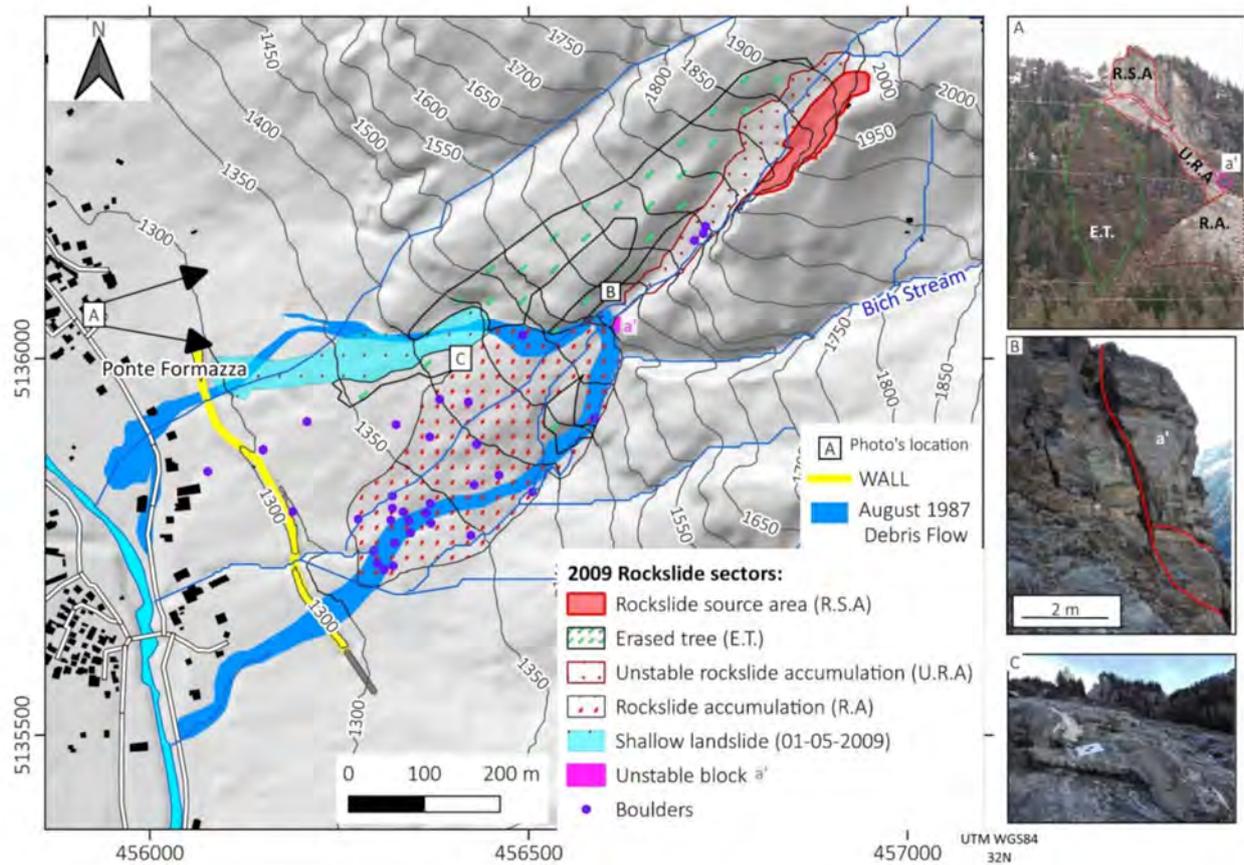
**Figure 2.** Map of April 2009 rockslide event and 1987 debris flow. Photo A shows a general view of the rockslide just after April 2009 (Photo Credit Colluccino M.) and the location of a'. Photo B shows a large ( $10 \times 3 \text{ m}$ ) unstable block (a') in autumn 2017, which collapsed during the 2019 event. Photo C shows a marker used to fix RPAS photos placed on a large boulder of the rockslide.

The most massive event in recent time occurred on 9 April 2009, when a massive rockslide (Figure 2) created a large deposit that can be considered the main predisposing factor for the event that occurred in June 2019.

In 2009, the rock mass release area (R.S.A. in Figure 2) was located on a ridge at 1950 m elevation and oriented parallel to NE–SW striking steeply dipping faults. The initial failure likely occurred along such a fault, then the detached mass fell in a steep gorge on the north side of the cliff [34–36].

The rockslide mass moved quickly along the slope, which has an inclination of about  $40^\circ$ . The direction of the detached mass was about  $210^\circ$  with a drop height of 530 m over a horizontal distance of 600 m. The estimated total volume was  $700,000 \text{ m}^3$ . On 1 May 2009, a few days after the rockslide, a small shallow landslide affected the colluvial deposit where vegetation was eradicated (E.T. in Figure 2) [34].

The unstable rockslide accumulation (U.R.A. in Figure 2A), formed by some boulders of up to tens of metres in size, was partially blocked in a steep channel at the cliff base. This meta-stable deposit was massively moved by debris flow in June 2019. The field survey of 2017 also allowed us to detect an unstable block (a' in Figure 2B) that collapsed during the 2019 event.

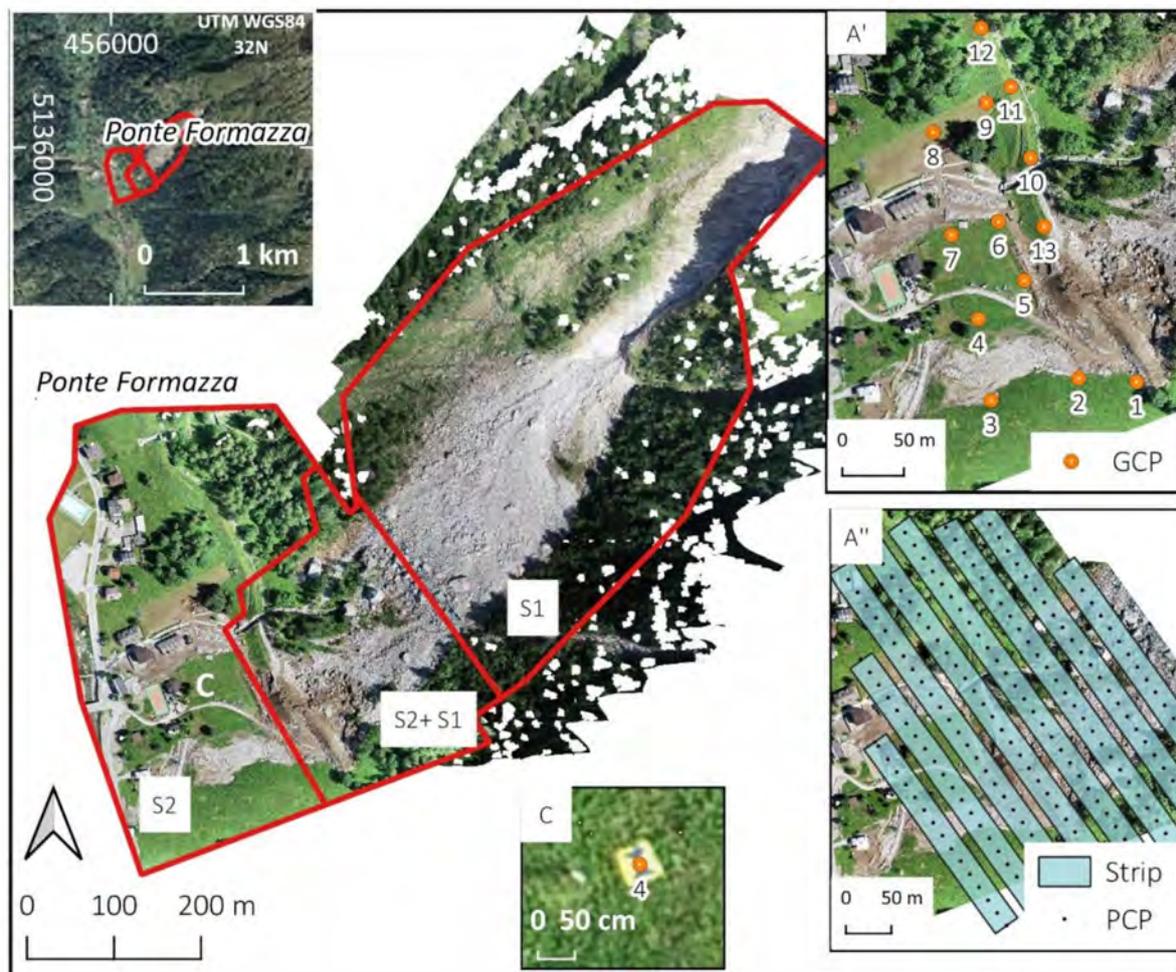
**Figure 3.** Area covered by 2019 RPAS survey. (S1) Higher sector, mapped by RPAS and processed with Structure from Motion. (S2) Lower sector mapped Rtk RPAS and processed with high-precision photogrammetry with two approaches (A') Traditional photogrammetric approach: GCPs location; (A'') Direct Photogrammetry approach: Projection Center Point (PCPs) coordinates. In S1+S2 the flights overlap. (C) Example of plastic GCP 50 × 50 cm (Marker004).

For the lower part of debris flow (sector S2 in Figure 3) covered only by the 2019 RPAS Rtk survey (A), we evaluated the volume with a different methodology that is made of three steps, made with Agisoft Metashape™ software:

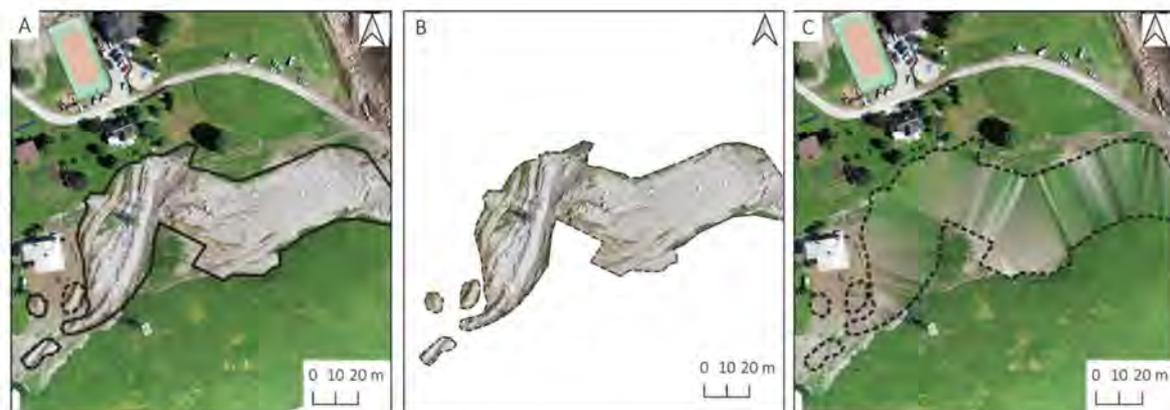
**Figure 4.** (A) Lower sector interested by debris flow; (B) clipped low-energy debris flow; (C) interpolated DSM that fill the clipped part.

- we first cut out from DSM the area covered by debris (Figure 4B);
- we proceeded to interpolate the clipped part to reconstruct the surface before the event (Figure 4C);
- we calculated the difference between the original raw DSM and the reconstructed DSM pre-event. This allowed us to estimate the volume also of this sector (see Figure 8A in the results).

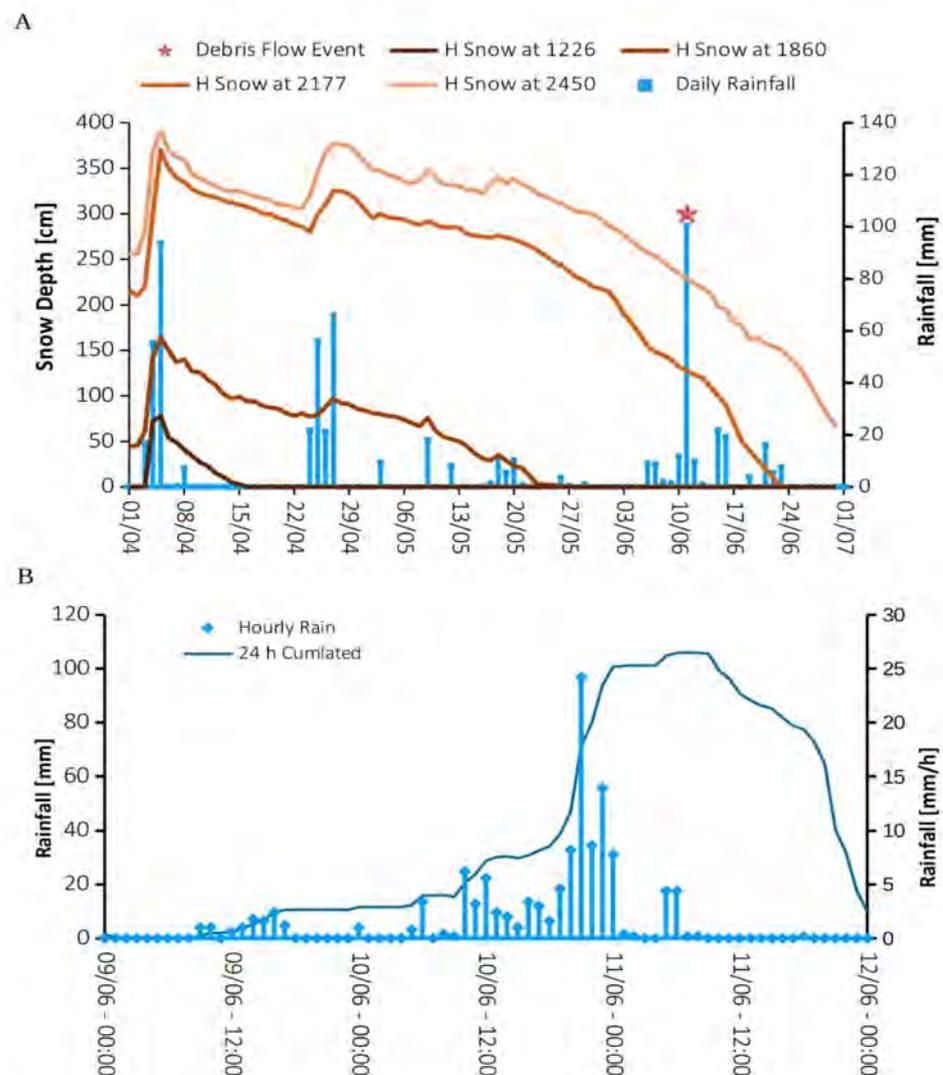
**Figure 5.** (A) Daily rainfall and snow depth at a different elevation from 1 April to 30 June 2019. (B) Hourly and cumulated precipitation at Formazza Bruggi rain gauge from 9 June 2019 00 UTC to 12 June 2019 00 UTC.

The debris flow was triggered by intense rainfall on 10–11 June 2019, with accumulated rainfall of 100 mm in 24 h and a peak of 25 mm/h (Figure 5B). These values are not extreme for the area; however, they occurred in the period of intense snow-melting that probably saturated the soil (Figure 5A). From the data of snow depth of the nearby stations and the Sentinel-2 images of 01 June 2019 (Figure 6B), it is possible to estimate snow depth and coverage at the moment of triggering rainstorm (Figure 6A). Half of the basin that contributed to debris flow was covered by snowpack that in the highest sector (>2500 m) reached about 200 cm of thickness. From the end of May 2019, the snowpack starts a rapid melting at 8 cm/days. All these factors contributed to soil saturation at the moment of the storm.

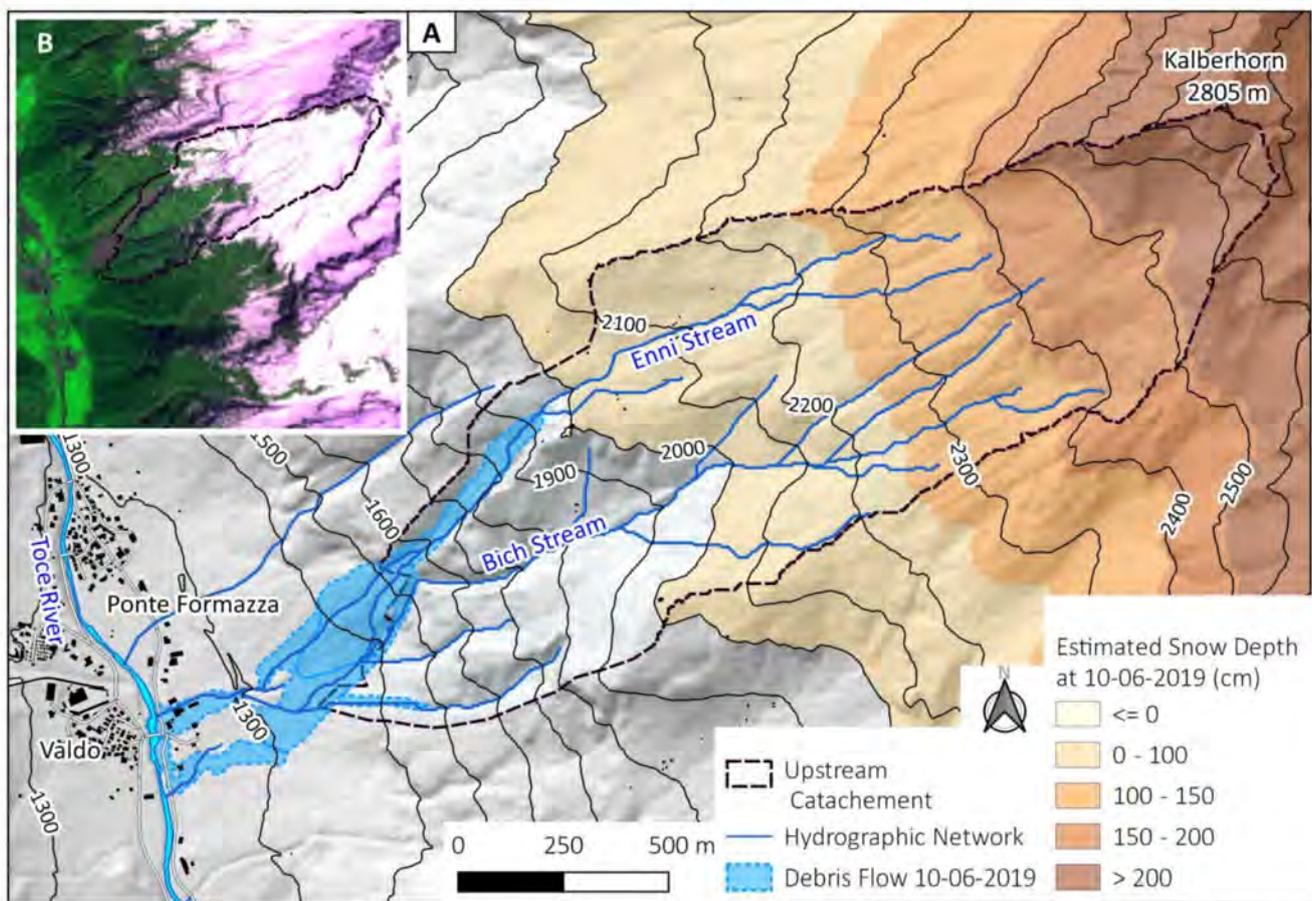
**Figure 6.** (A) The contributing watershed basin upstream from the debris flow area and estimated snow depth and coverage at the moment of the storm (10–11 June 2019) based on snow depth data, Sentinel-2 images and DTM data. (B) Sentinel-2 image acquired on 1 June 2019.

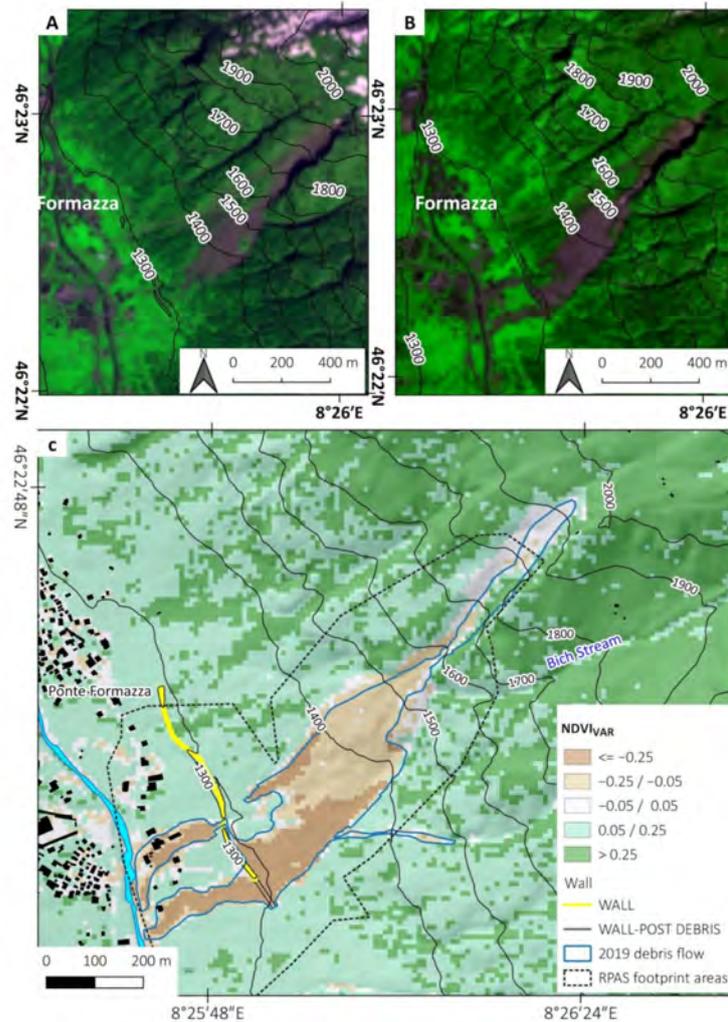
**Figure 7.** Low-Resolution debris flow mapping made with Sentinel-2 data. (A) Pre-event image 1 June 2019; (B) Post-event image 16 June 2019; (C) NDVI<sub>var</sub> map and the boundaries of debris flow further mapped with RPAS

The processing of Sentinel-2 images (Figure 7A,B) allowed us to map the area affected by debris flow in 2019 quickly. Thanks to the first post-event images available a few

Figure 7C shows the NDVI<sub>var</sub> perfectly matching the boundary of the debris flow area further mapped with RPAS, especially in the bottom deposits sector. It is also possible to see that the decrease of NDVI is higher in the lower sector of the slope where vegetation was erased. The areas already occupied by debris and boulder of the 2009 event show a negative NDVI<sub>var</sub> because the debris flow buried pioneer vegetation of the 2009 rockslide deposits.

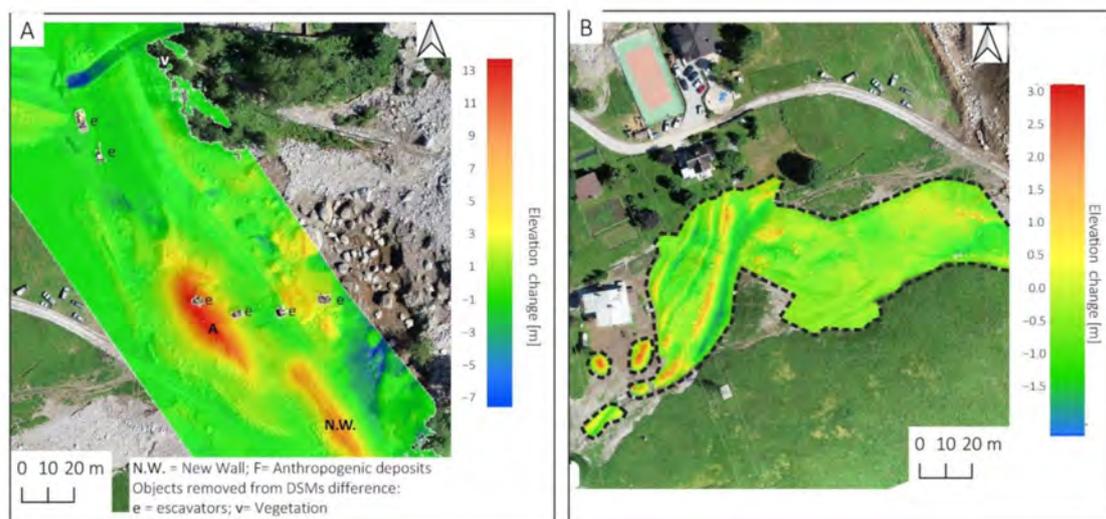
**Figure 8.** (A) DTM of difference (2018–2019) of the wall sector, the volume of accumulated materials is 31,064 m<sup>3</sup> (Case 3c). (B) Low-energy debris flow sector DTM of difference made with clipping and interpolation of 2019 DSM (estimated volume 155 m<sup>3</sup>).

The results Figure 8A show that the volume of accumulated material is respectively 30,909 m<sup>3</sup> (Case 3b) and 31,064 m<sup>3</sup> (Case 3c). The difference between direct photogrammetry with only 3 GCPs and full solution (3c) is about 720 m<sup>3</sup> (2.4%); this is excellent accuracy results for geomorphological analysis. It is possible to appreciate that the excavators were also removed from the volume computation.

Using the methodology described in paragraph 3.4, we calculated the DTM of change and the volume for the low-energy sector of the debris flow (Figure 8B) where there is no available 2018 data (12s in Figure 13). In this case, the estimated cumulated volume is about 155 m<sup>3</sup>, a modest amount compared with the rest of the debris flow volume (described in Section 4.3.4).

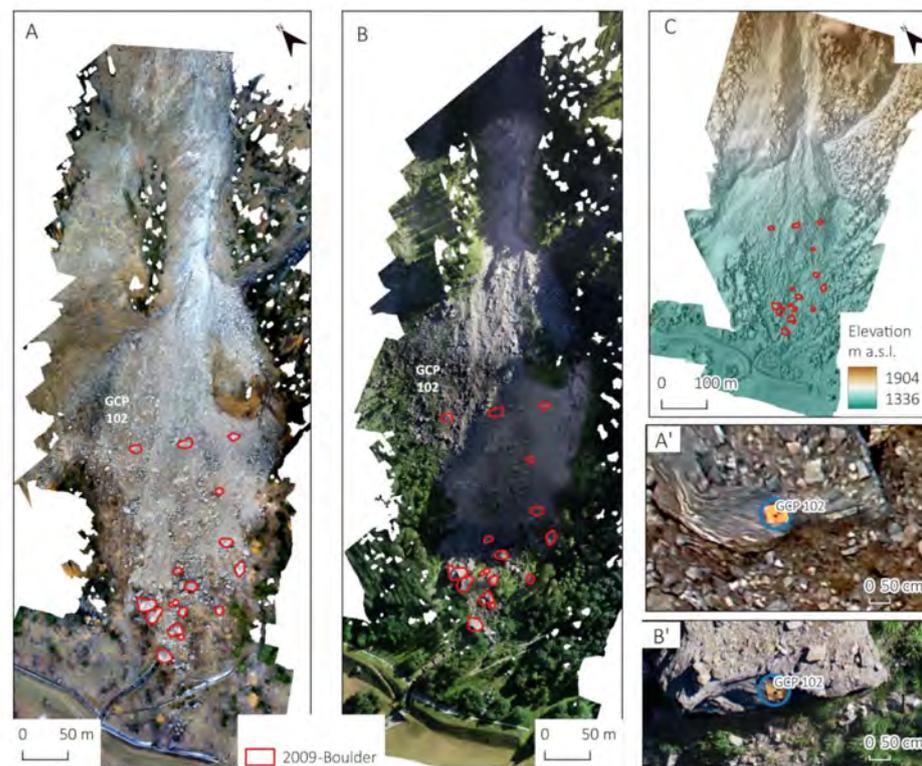
**Figure 9.** High-resolution orthophoto of 2009 rockslide deposits made with RPAS in November 2017 (A) and July 2018 (B), a detailed zoom view on GCP 102 in 2017 (A') and 2018 (B'). In panel (C) the 2017 DSM made with SfM used for the comparison with the 2019 post-event DSM.

The High-resolution RPAS surveys carried out in 2017 and 2018 allowed to obtain an extremely detailed orthophoto (Figure 9A,B) and DSM of the rockslide accumulation (Figure 9C). The 3-D views allowed us to measure and estimated the volumes of large boulders as on the field. It is interesting to note how most of the GCPs installed in 2017 are still well visible in the 2018 orthophoto (e.g., Figure 9A',B').

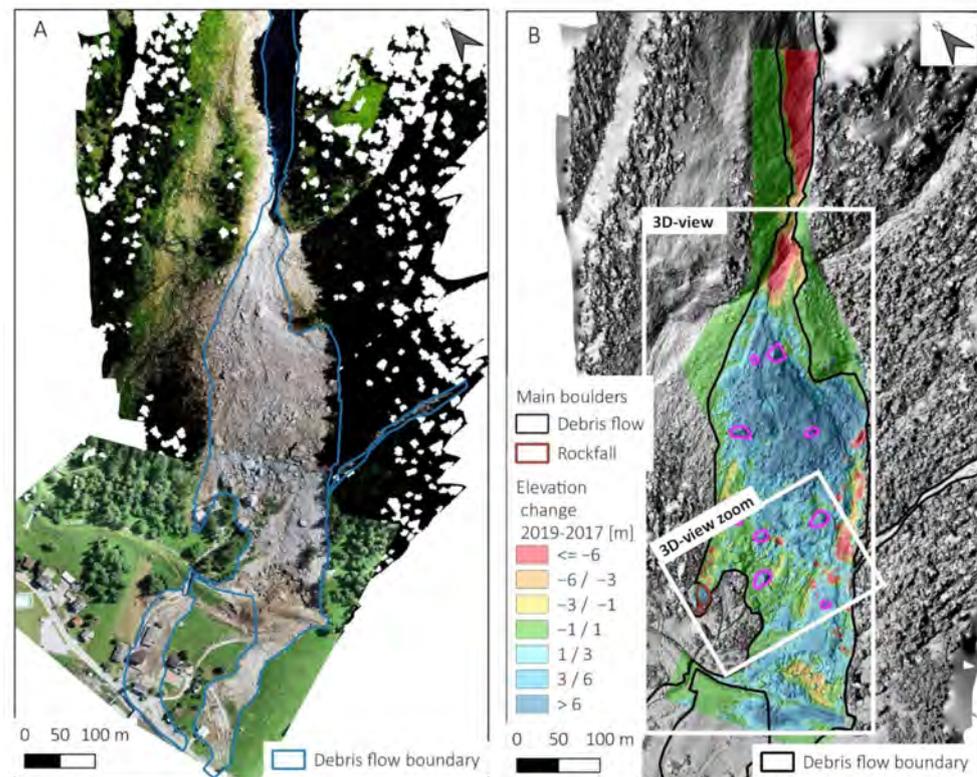
**Figure 10.** 2019 event (A) UAV post-event orthophoto with the boundary of the debris flow; (B) DSM change (2019–2017) draped on the hillshade model and the most massive boulders mobilized during the 2019 event.

The orthophoto allowed a precise mapping of most debris flows (Figure 10A), especially in the lower part, and at the downslope of the wall. Here the relatively low-energy flow created fine-sized debris deposits (from the decimetric block to the sand matrix). Some UAV footage available on the Local Team web video platform [46] shows the debris flow deposit just a few hours after the event. The videos helped to understand some depositional patterns of the restored area at the moment of our RPAS flight 15 days later.

The difference between DSM 2019 and 2017 allowed us to understand the complexity of the processes during the 2019 event (Figure 10B). The main events and their geomorphological evidence can be resumed as follows: (i) The canyon of Enni Stream was utterly washed out of the 30 m thickness of debris and boulders, and now the bedrock is not covered by rockslide deposits; (ii) the giant block a' that was positioned at the top of the fan fall down during the 2019 event following a linear trajectory independent from the rest of debris flow; (iii) most of the debris mass was deposited in the middle sector of the slope, here it is possible to see how the Enni stream migrated from the central part of the fan to the left sector joining the Rich stream; (iv) a sector characterized by the presence of a heterogeneous deposit composed by large blocks in a coarse-grained matrix due to the debris flow transport effect and the rolling component of the movement of unstable rock blocks; (v) the contribution of Rich stream energy and water to the lower sector of the debris flow that accumulated 10 m of materials behind the wall built after the 2009 rockslide; (vi) part of debris flow overpassed the wall, and the rest get around the wall and reached the main Toce river, with two separate branches. These flows hit several buildings, roads, and some sports facilities. The relatively low-energy debris flow avoided more severe damage to buildings, and the few residents were evacuated some minutes before, avoiding life risk.

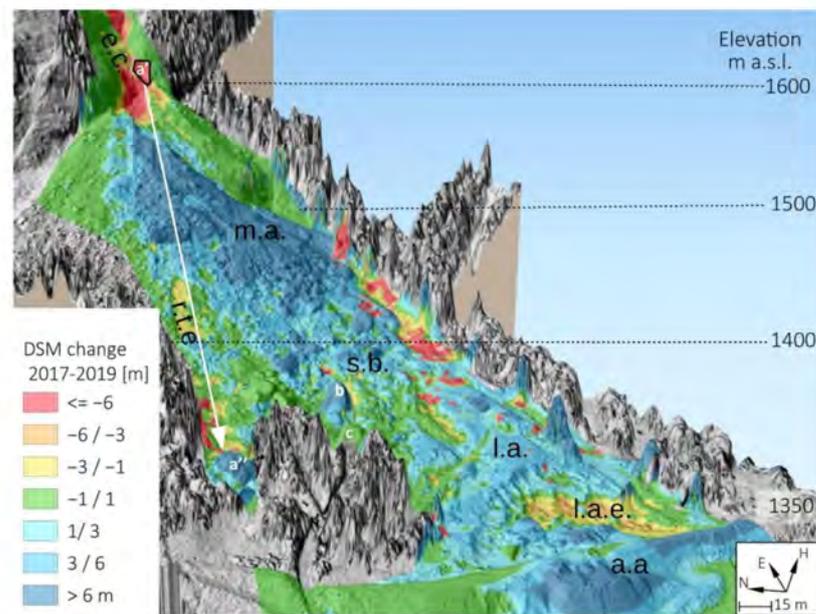
**Figure 11.** 3-D shadow model of the affected area with DSM change 2019-2017 draped on. It is possible to detect: the erosion channel (e.c.); the collapsed block (a'), its rolling/bounce erosion trace (r.t.e.) and its final position (a''); the main accumulation (m.a.); the area with large sparse boulders (s.b.); the lower accumulation (l.a.) partially excavated (l.a.e); the anthropogenic accumulation (a.a.).

In the general 3D view (Figure 11), it is possible to detect the area of erosion in the upper part of the channel, the detachment on the large boulders (a'), and its trajectory until its final position (a''). The main accumulation (m.a.) is located at an altitude of 1500 m. In the lower part of the slope, the debris flow shows the fine-size of the blocks (i.a.), and the restoration work moved part of this debris (l.a.e) to make a new section of the wall (a.a.).

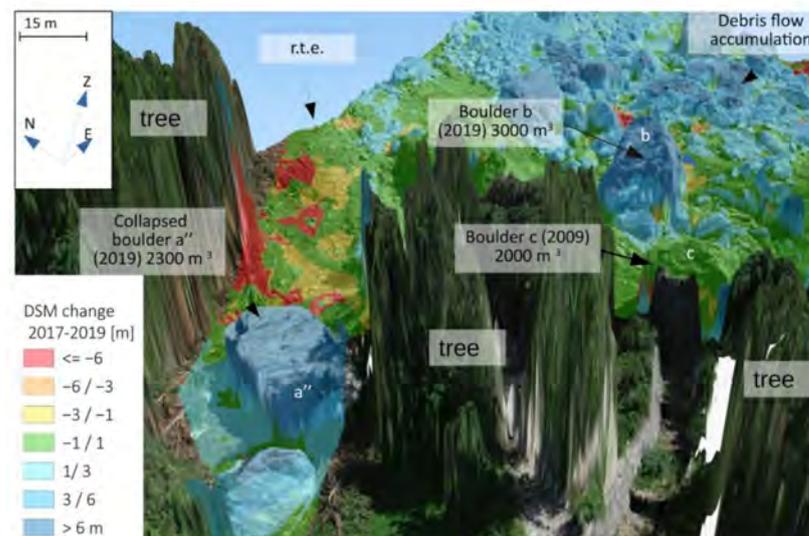
**Figure 12.** A detailed 3d view of the accumulation. It is possible to detect the most massive boulders from 2009 (c with no change in DSM difference) and 2019 events (a” and b). The areas covered by trees are excluded from DSMs differences.

In Figure 12, a 3D view of the areas with the largest boulders is represented with more detail. It is interesting to note how the DSM difference allowed us to distinguish the boulder “c” that is part of the 2009 rockslide, from the block a” derived from the new detachment and the rest of the boulders like “b” that is part of the debris flow.

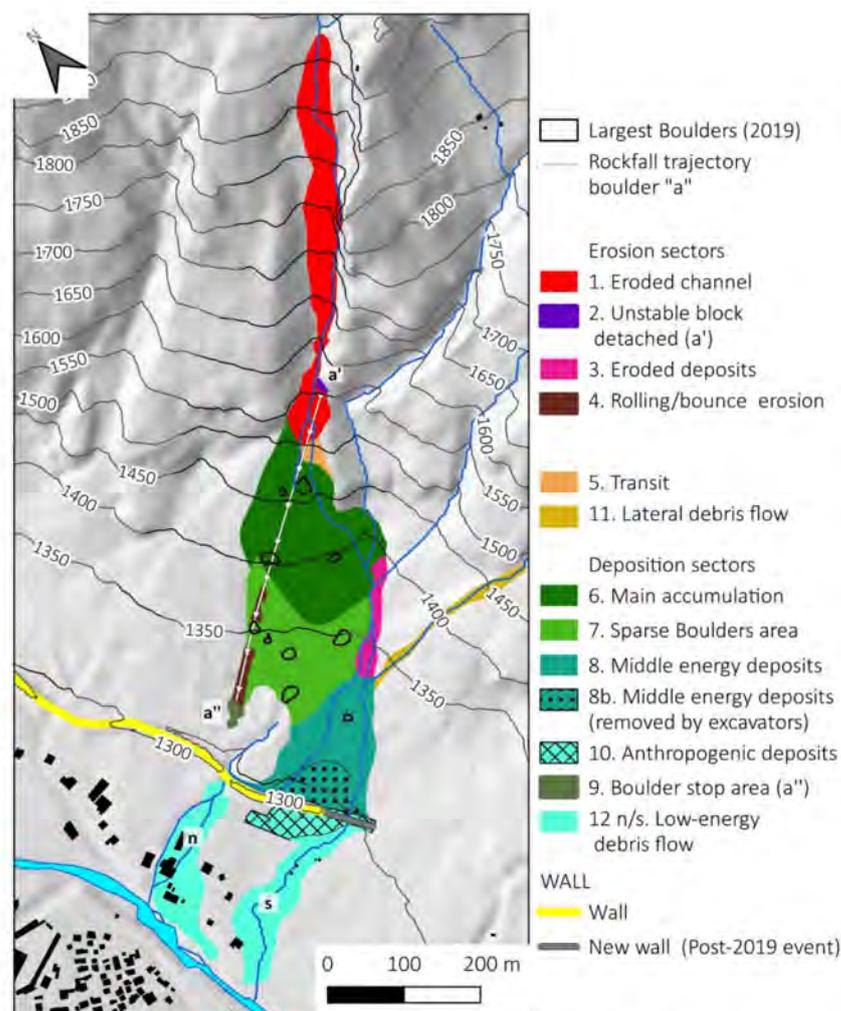
Figure 13. Geomorphological sectors of 2019 debris flow and rockfall.

- Erosion sectors (red/violet colors in Figure 13). Here it is possible to find the eroded channel (1) (source of most of the material mobilized; the area of the detachment of the block a') (2) and the erosion caused by its rolling and bounce (4 a/b); a small area of erosion (3) on the left side of the rockslide deposit related to debris flow action increased by the Bich stream.

- Deposition sectors (green colors in Figure 13). Most of the debris was deposits in the middle sector of the slope just after the channel (6) at 1400 m a.s.l. Just below this deposit, we can find a dispersed accumulation where most of the boulders stopped (about 211,000 m<sup>3</sup>) (7); the lower sector of the slope (under 1350 m) is characterized by middle energy deposits blocked by the wall (8) and partly removed by remedial work in July 2019 (8b). Part of the removed material was used to build a new section of the wall (10). On the right side of the accumulation, we can also find the collapsed boulder a'' (2000 m<sup>3</sup>) that stopped about 30 m from the wall (9).

- Low-energy sectors (cyan colors in Figure 13). A small portion of debris flow over-passed the wall for these deposits (11). We calculated the volume for the 's' portion (155 m<sup>3</sup>) with the method described in Section 3.5 and showed in Figure 8B.
