INTEGRATING MULTIBAND PHOTOGRAMMETRY, SCANNING, AND GPR FOR BUILT HERITAGE SURVEYS: THE FAÇADES OF CASTELLO DEL VALENTINO

KEY WORDS: Photogrammetry, Laser Scanning, Thermography, Ground-Penetrating-Radar, Data Fusion, Built Heritage

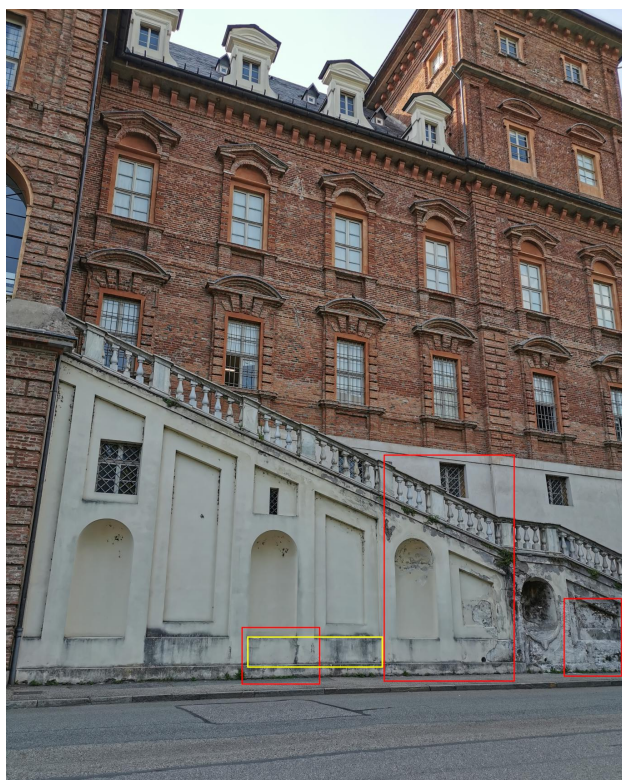
Figure 2. *Castello del Valentino* riverside (east) façade. The preliminary surveys are indicated with red and the detailed surveys with yellow color.

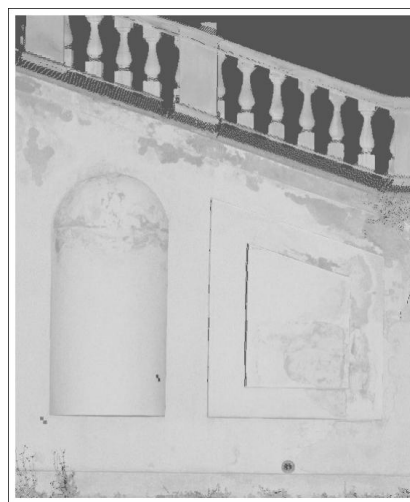
Figure 4: View of point-cloud pseudocolored with architectural surfaces' weathering indices (lower riverside façade)

The first phase of the surveys involved TLS range data acquisitions at the lower areas of the riverside façade and the main part of the east façade. The stations were placed to acquire homogeneously dense point clouds without occlusions, and thus two scans were performed on the east façade and six on the west, with large overlaps, which could facilitate accurate registration. The scans were used to generate general plans and low-resolution models of architectural surfaces after registering, denoising, and subsampling the 3D point clouds. Furthermore, the near-infrared scanning intensities were corrected (Suchocki et al., 2020) and exploited to create rapidly and cost-efficiently a representation of weathering stages (**Figure 4**), since the majority of the observed surface deterioration patterns belonged to a single typology—grey biogenic crusts.

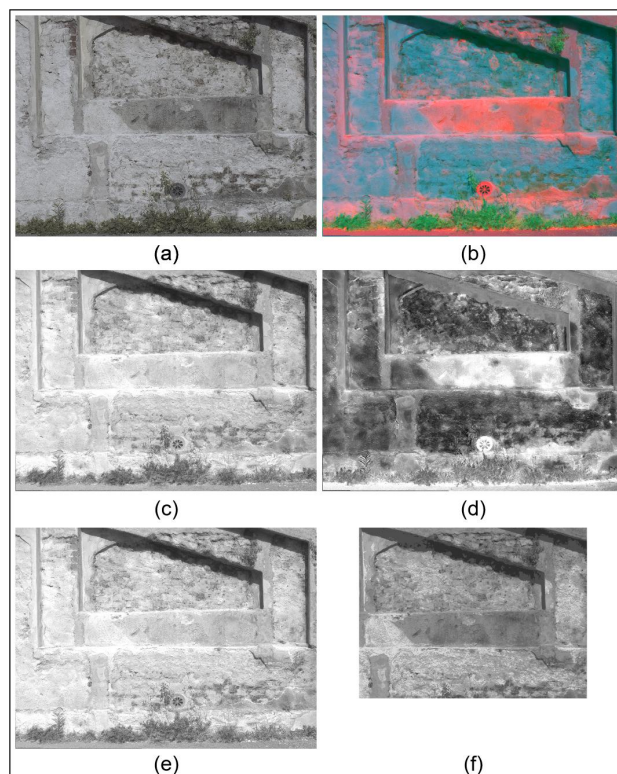
Figure 6. Castello del Valentino riverside façade multiband results: (a) cropped VIS image; (b) TIR-NIR-red false-color composite; (c,d) principal component analysis—first and second component; (e) Fourier transform; (f) quantized image.

All images were subsequently undistorted (utilizing parameters calculated by calibrating the involved sensors), then rectified by picking points that were either measured directly with the total station or indirectly by TLS, and finally merged with the HyperCube software to create multiband images. The multiband imaging data were analyzed by data reduction, decomposition, and compression methods to create 2D image visualizations that could be more easily interpretable. **Figure 5** shows the results of one of the preliminarily surveyed areas on the main façade, where slight plaster detachments and a few surface cracks are visible through the elaboration of the multiband composites. **Figure 6** shows another surveyed area on the riverside façade where extensive detachments, cracking, and biogenic crusts can be observed.

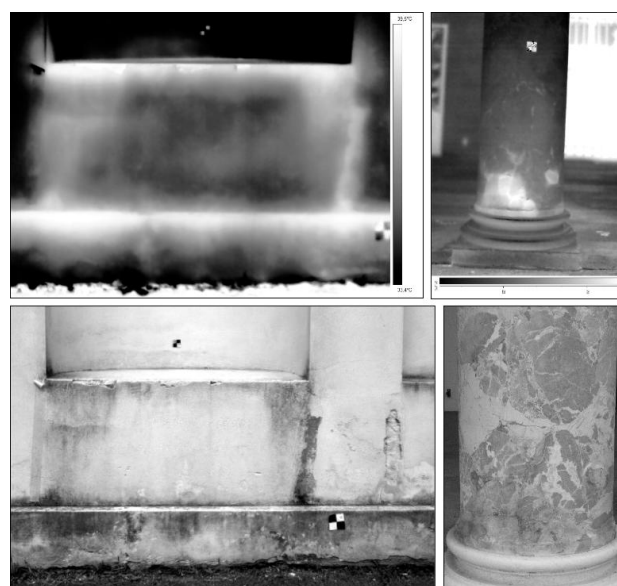
Figure 7. East façade (left), and main façade left column (right) anomalies observed by thermographic imaging and principal component analysis of the multiband data (first components).

Wide-scale representations and 2D preliminary surveys led to identifying areas of interest for in-depth investigations by integrating higher resolution data and the elaborated GPR measurements. These two presented significant radiometric anomalies in the multiband analysis results (**Figure 7**).
