INTEGRATING MULTIBAND PHOTOGRAMMETRY, SCANNING, AND GPR FOR BUILT HERITAGE SURVEYS: THE FAÇADES OF CASTELLO DEL VALENTINO

E. Adamopoulos^{1,*}, C. Colombero², C. Comina³, F. Rinaudo⁴, M. Volinia⁴, M. Giroto⁴, L. Ardissono¹

KEY WORDS: Photogrammetry, Laser Scanning, Thermography, Ground-Penetrating-Radar, Data Fusion, Built Heritage

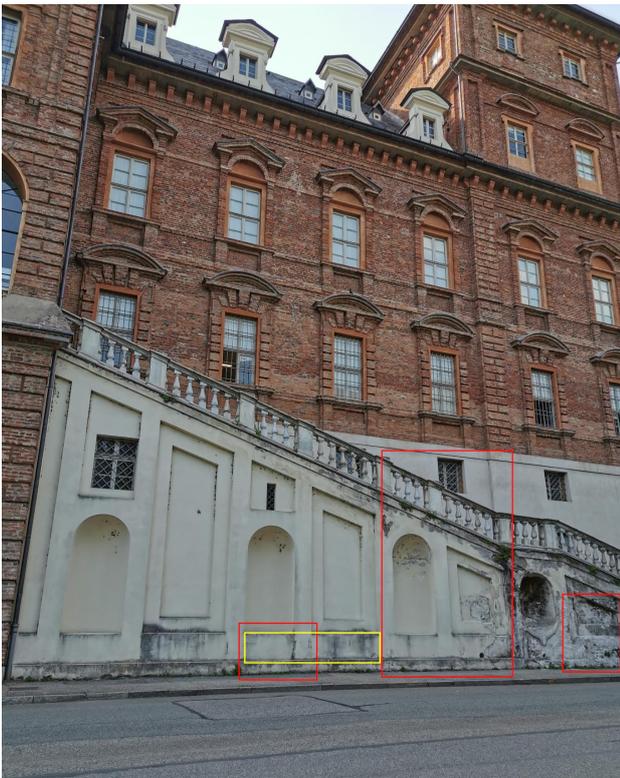
Figure 2. Castello del Valentino riverside (east) façade. The preliminary surveys are indicated with red and the detailed surveys with yellow color.

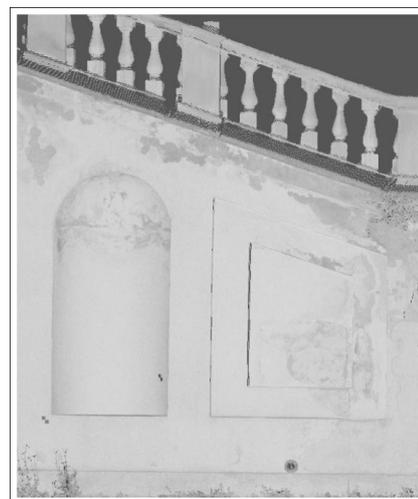
Figure 4: View of point-cloud pseudocolor with architectural surfaces' weathering indices (lower riverside façade)

The first phase of the surveys involved TLS range data acquisitions at the lower areas of the riverside façade and the main part of the east façade. The stations were placed to acquire homogeneously dense point clouds without occlusions, and thus two scans were performed on the east façade and six on the west, with large overlaps, which could facilitate accurate registration. The scans were used to generate general plans and low-resolution models of architectural surfaces after registering, denoising, and subsampling the 3D point clouds. Furthermore, the near-infrared scanning intensities were corrected (Suchocki et al., 2020) and exploited to create rapidly and cost-efficiently a representation of weathering stages (**Figure 4**), since the majority of the observed surface deterioration patterns belonged to a single typology—grey biogenic crusts.
