AE in Masonry

Acoustic Emission Testing

Chapter 15 "AE in Masonry"

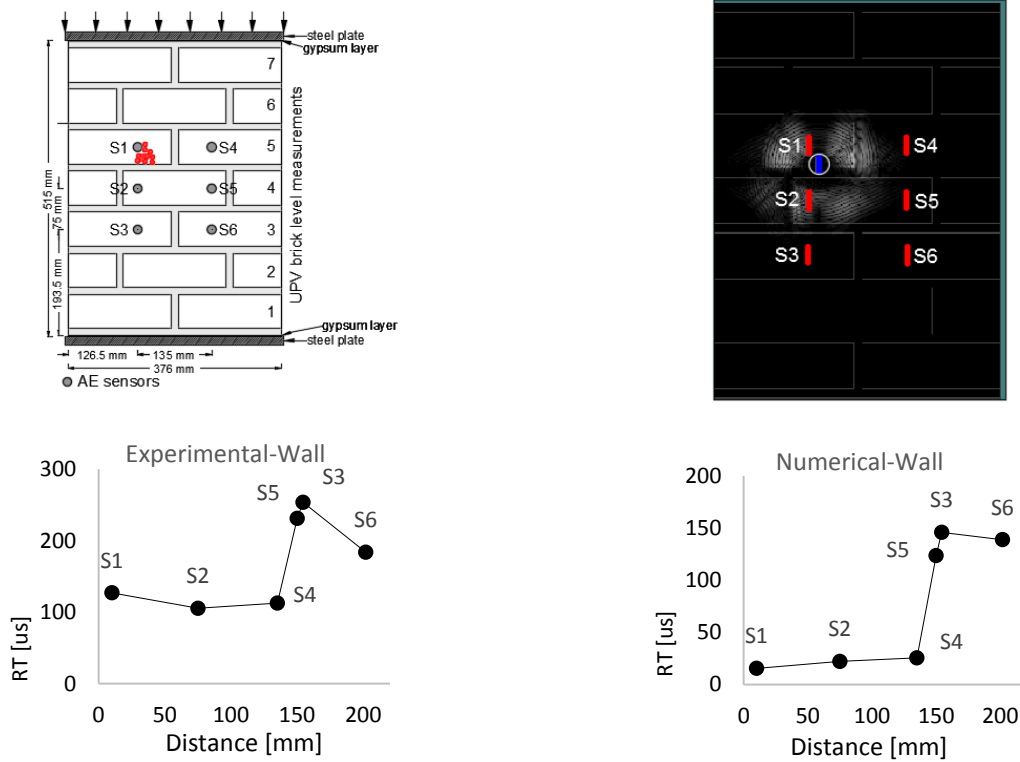
Fig. 15.3 Effect of propagation distance on Rise Time (RT) and Average Frequency (AF), obtained from (a) AE events located near sensor 1 (S1) during a compression test, and (b) AE events simulated near sensor 1 (S1) in a numerical analysis. Figures adopted from (Livitsanos, Shetty et al., 2018b)

parameters such as frequency, amplitude and duration, the effects of distortion of the ultrasonic waves has to be taken into account (Aggelis, Mpalaskas et al., 2012; Carpinteri, Lacidogna, Accornero et al., 2013). In masonry, the distortion of the wave properties increases with increasing source-sensor distance and number of mortar joint crossings. In **Fig. 15.3**, the effect of an increasing wave propagation path on Average Frequency (AF) and Rise Time (RT) in masonry is shown (Livitsanos, Shetty et al., 2018b). Both experimental and numerical results are consistent and show an increase in RT and slight decrease in AF. This is in agreement with similar studies on cementitious mortar samples (Aggelis, Mpalaskas et al., 2012), while the distortion effect increases with the amount of cracks, voids and interfaces. Since both parameters, RT and AF, are often applied in distinguishing tensile and shear mode fracture (see elsewhere in this book), source-sensor distance should be limited and/or distortions should be compensated when crack classification is aimed at in masonry structures.
