AE in Masonry

Acoustic Emission Testing

Chapter 15 "AE in Masonry"

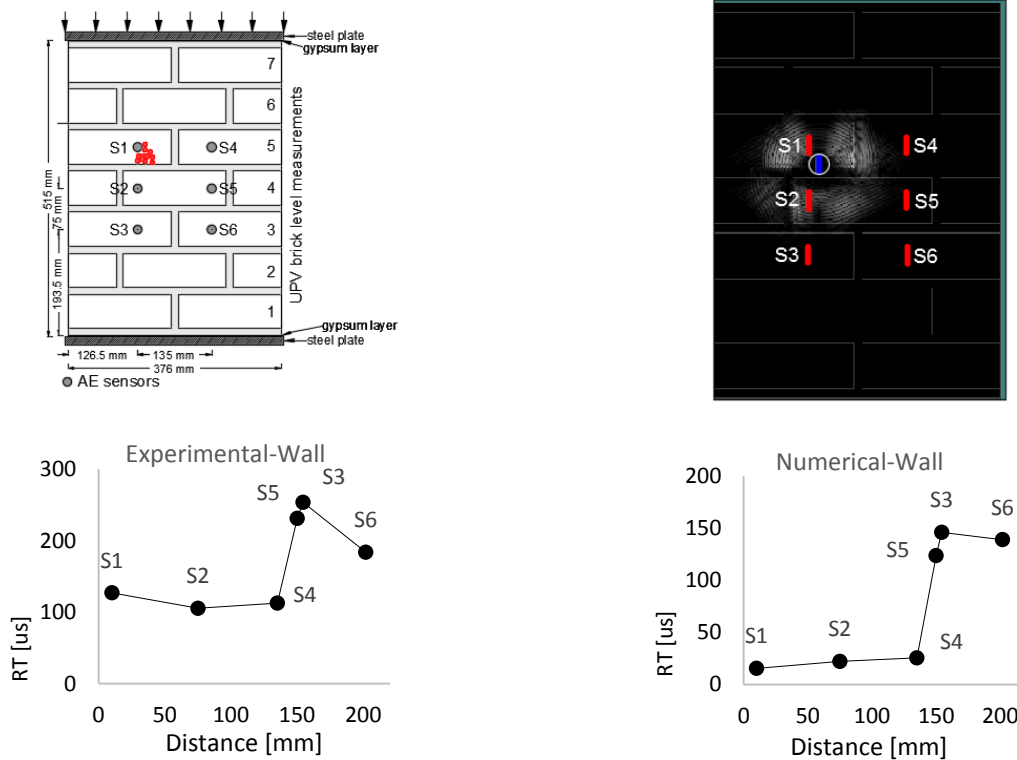
Fig. 15.3 Effect of propagation distance on Rise Time (RT) and Average Frequency (AF), obtained from (a) AE events located near sensor 1 (S1) during a compression test, and (b) AE events simulated near sensor 1 (S1) in a numerical analysis. Figures adopted from (Livitsanos, Shetty et al., 2018b)

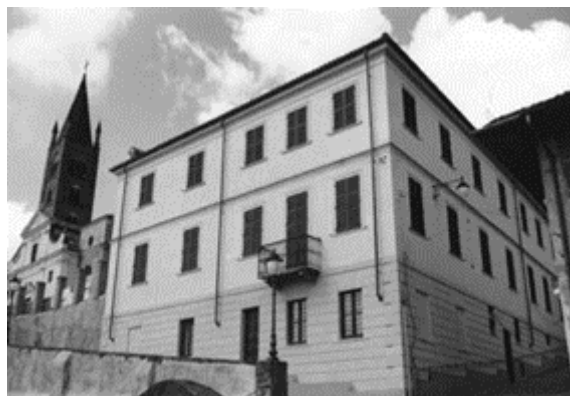
Fig. 15.4 “Casa Capello” in Rivoli (Turin); in the background the bell tower of the Collegiata, in the foreground the breast wall that collapsed during the restoration works.

The historical building known as “Casa Capello” is presently a hospice for elderly people (**Fig. 15.4**). Interventions were carried out for its restoration and functional extension in the years 1996-1999. The building rises in an area situated in the historical center of Rivoli, near Turin (Italy), delimited by Via alla Parrocchia and Via Stella Maris, approximately half way between the Rivoli Castle hill and the valley floor. The building, which looks onto the Medieval Church of the Collegiata, was erected on pre-existing foundations dating back to the 14th Century and was drastically restructured in the 18th Century, when it acquired its present appearance. The main construction is a masonry building which follows the slope of the land and has three storeys facing the streets and two storeys looking onto the inner courtyard. The restoration works performed on this complex took into account its historical and architectural values and respected its sober styling by making changes and additions that blended in with the existing volumes.

During the restoration works of “Casa Capello”, an unexpected accident caused a partial collapse of the breast wall on the downhill side of the building, which altered the equilibrium of the substructures. The damages were immediately repaired by reconstructing the breast wall and strengthening the soil under the wall. Nevertheless, following the accident, a diffused network of cracks began to form in the masonry of the original building structure, with capillary fissures propagating through the masonry front.

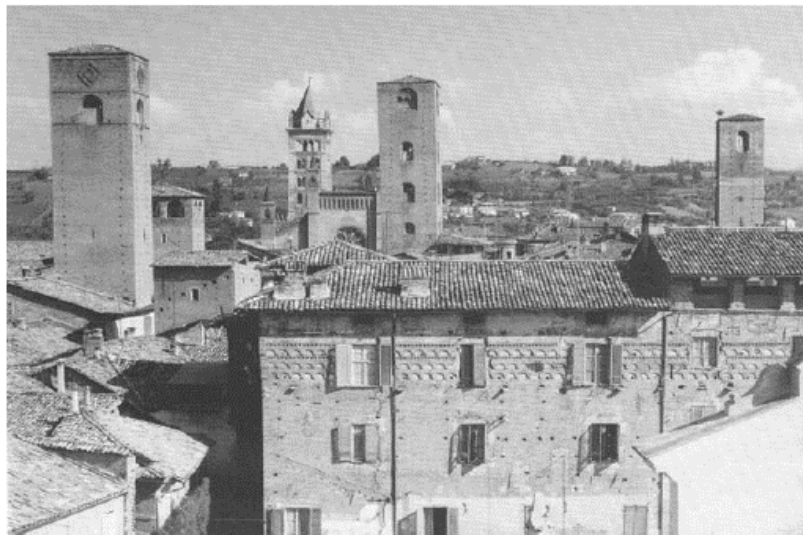
Fig. 15.13 Overall view of the medieval towers of Alba.

The medieval towers of Alba have been monitored by the AE technique. These masonry buildings from the 13th Century are the tallest and mightiest medieval towers preserved in Alba (**Fig. 15.13**). Torre Sineo is square, 39 m high, and leans to a side by about 1% (**Fig. 15.14**). Wall thickness ranges from 2 m at the foundation level to 0.8 m at the top. The bearing walls are constructed “a sacco”, i.e., consist of brick faces enclosing a mixture of rubble and bricks bonded with lime and mortar. Over a height of 15 m, the tower is incorporated in a later building. Torre Astesiano (**Fig.**

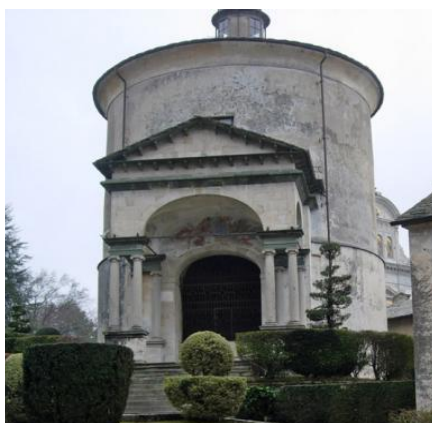
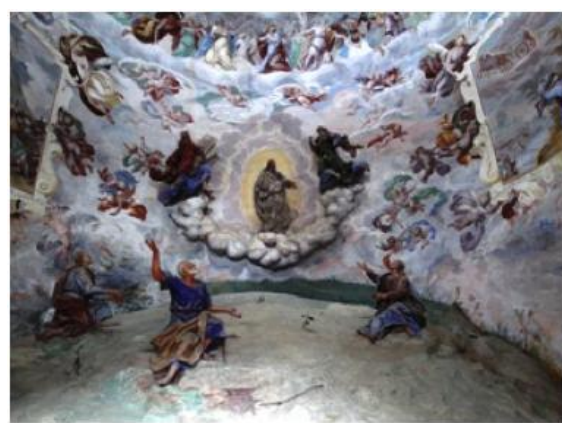
Fig. 15.19 External view of Chapel XVII (a); internal view of the Mount Tabor installation (b)

which are isolated, while others are part of monumental groups. They contain over 800 life-size wooden and multicolored terracotta statues, which represent the Life, the Passion and the Death of Christ (Niccolini, Borla et al., 2014). As the first object of investigation with the AE technique, the Chapel XVII of the Sacred Mountain of Varallo was chosen (**Fig. 15.19**). This Chapel houses the scene of the Transfiguration of Christ on Mount Tabor. The foundations were already begun in 1572, but the chapel was not completed until the 1660s. As described in (Carpinteri, Lacidogna, Invernizzi et al., 2013), also this structure has shown itself sensitive to seismic events occurring within a radius of about 100 km from the City of Varallo, and to moisture infiltrations that have the effect of detaching the mural paintings from their supports.

As a second object of $1/f$ analysis, the results of the monitoring of Chapel XVII of the Sacred Mountain of Varallo are chosen (**Fig. 15.19**). The results obtained by the application of the AE sensors are represented in a log-log plot of power spectrum versus frequency (**Fig. 15.26**), with a fluctuation of f^γ ($\gamma = 0.92$). Also in this case, the source noise revealed by AE signals sounds “pink”, supporting the evidences of the cracking process found during the monitoring campaigns.

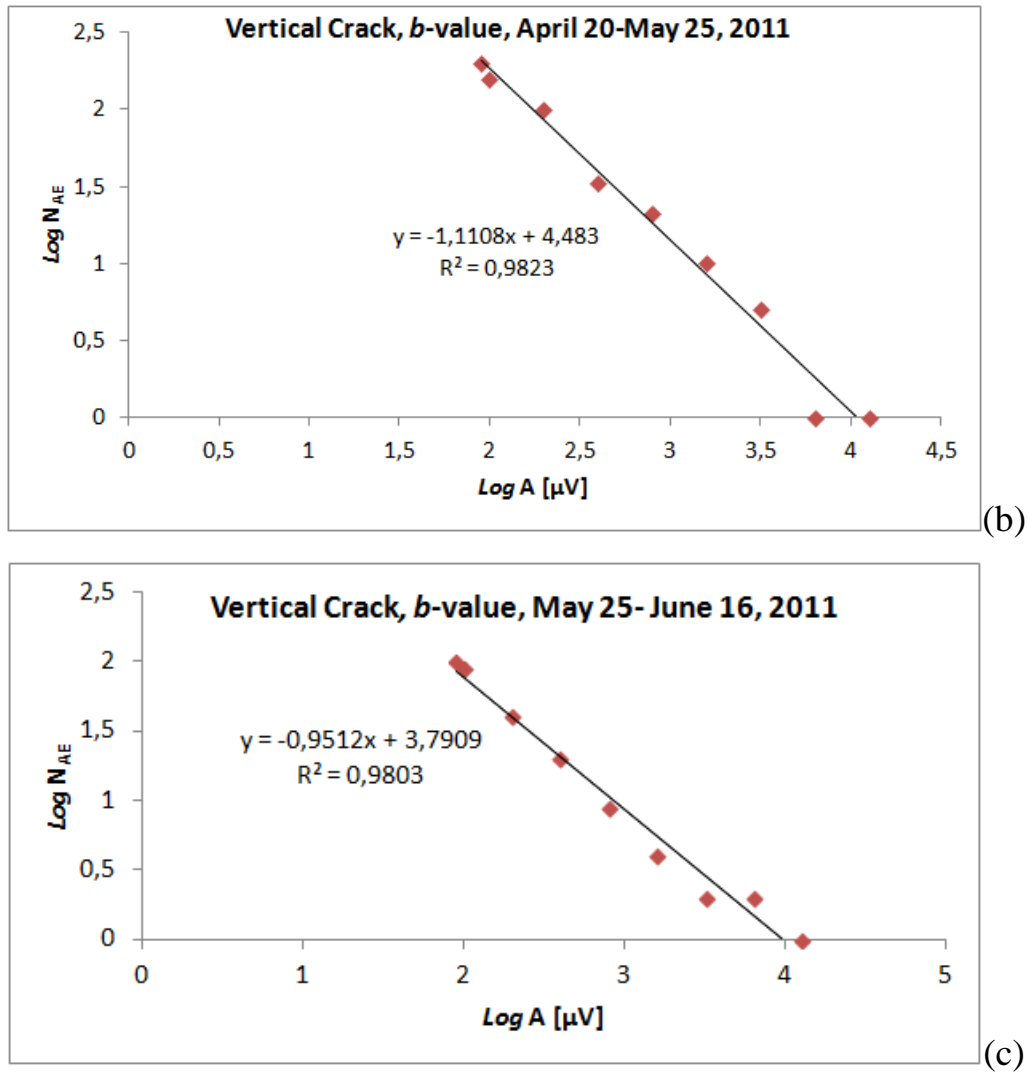
Fig. 15.23 Chapel XVII: b -values computed for the vertical crack with the corresponding coefficients of determination R^2 ; from March 25 to April 20, 2011 (a); from April 20 to May 25, 2011 (b); from May 25 to June 16, 2011 (c).

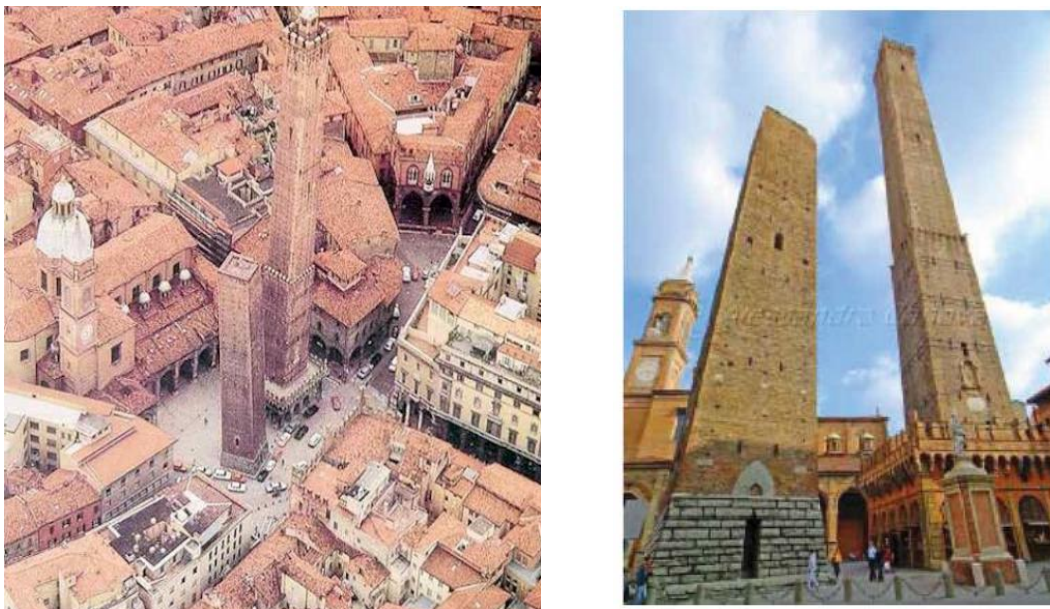
Fig. 15.24 The Garisenda Tower and the Asinelli Tower, in Bologna City center

Concerning the application of $1/f$ noise power spectra analysis, the AE technique has been employed to assess the stability of the tallest structure in the city of Bologna (Italy), the Asinelli Tower, which, together with the nearby Garisenda tower, is the renowned symbol of the city (**Fig. 15.24**) (Carpinteri, Lacidogna et al., 2016). The Asinelli Tower dates back to the early XII Century, and it is the tallest leaning tower

The AE activity in the masonry was detected in a significant region for monitoring purposes and easy to reach. Six piezoelectric sensors (working in the range of 50–800 kHz) were attached on the north-east corner of the tower, immediately above the terrace atop the arcade, at an average level of ~9.00 m above ground. In this area, the double-wall masonry has a thickness of ~2.45 m. AE monitoring began on 23 September 2010 at 5:40 p.m., and ended on 28 January 2011 at 1:00 p.m., covering, therefore, a 4-month period. The AE monitoring was carried on exploiting the USAM system. To filter out the environmental background noise a detection threshold of 100 mV was set. From the monitoring process carried out on a relevant part of this tower, it was possible to evaluate the incidence of seismic activity, vehicle traffic, and wind action on fracture evolution and damaging phenomena within the structure.

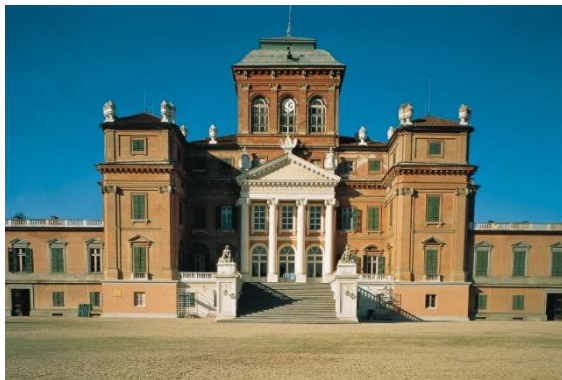
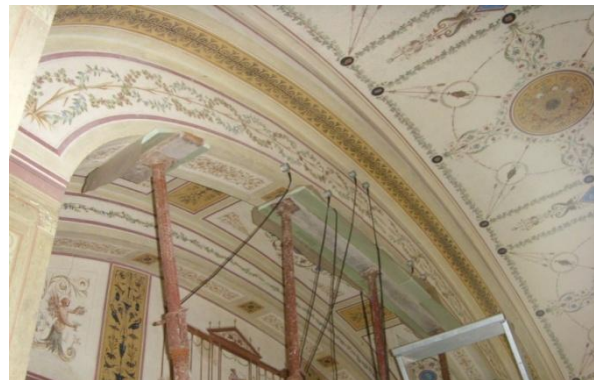
Fig. 15.27 External view of the Racconigi Castle (Italy) (a) and the monitored masonry arch inside the Castle (b).

Finally, the log-log plot of the AE power spectrum versus frequency for a monitored masonry arch, belonging to the Racconigi Castle (**Fig. 15.27**) in Piedmont (Italy) is presented. This last example is proposed in order to demonstrate that a “white”

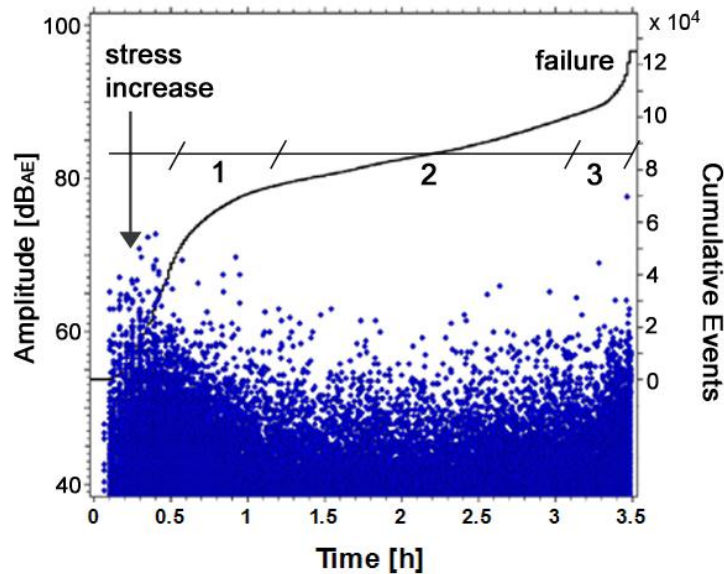
Fig. 15.31 Typical result from 1-step creep test: AE amplitude and cumulative AE event count vs. time with indicated creep phases (1, 2, 3). (A. K. Tomor & Verstryngne, 2013)

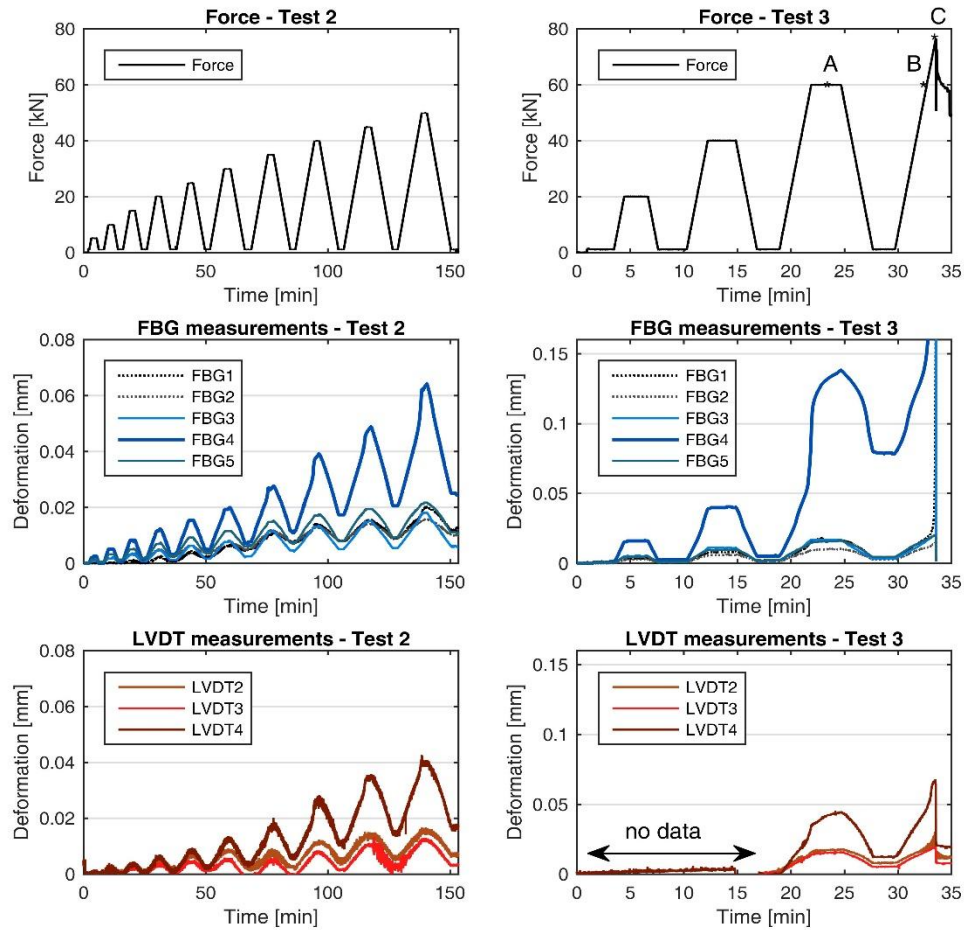
Fig. 15.35 Applied force (top), deformations measured with FBGs (middle) and with LVDTs (bottom) during cyclic three-point bending test 2 (left) and test 3 (right).
