Very High Cycle Corrosion Fatigue Study of the Collapsed Polcevera Bridge, Italy

# Very High Cycle Corrosion Fatigue Study of the Collapsed Polcevera Bridge, Italy

Stefano Invernizzi<sup>1</sup>; Francesco Montagnoli<sup>2</sup>; and Alberto Carpinteri, F.ASCE<sup>3</sup>

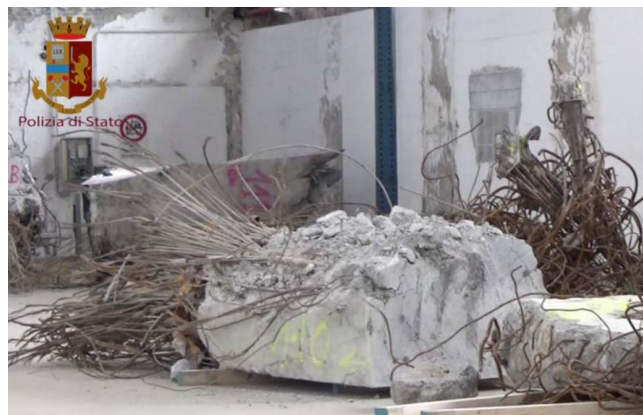
**Fig. 2.** (a) Triggering of the bridge collapse, which started from the failure of the SE cable-stay cross-section close to the antenna (image courtesy of Guardia di Finanza di Genova 2019); and (b) picture of the corroded strands subjected to forensic analysis (image courtesy of Polizia di Stato, republished from Bonchi (2020) with permission from Genova24).

As shown in the following, the cross-section of the cable-stay close to the antenna is the most critical. This hypothesis is consistent with the image shown in Fig. 2(a), which was taken from a recently declassified video, where it is possible to appreciate the very first instants of the collapse. First, the cross-section close to the antenna of the South-East (SE) cable-stay suddenly broke apart (A). Then the bridge-deck and the adjacent Gerber beam (on the right) collapsed (B). At the same time, due to dynamic rebound and missing balance, the top of the antenna broke and rotated anticlockwise (C). The rebound was such that the cable-stay on the left side buckled in compression (D), propagating the failure to the left side of the bridge deck and Gerber beam (E). A key role in the collapse was certainly played by corrosion. Fig. 2(b) shows part of the corroded tendons that were considered in the forensic analysis.

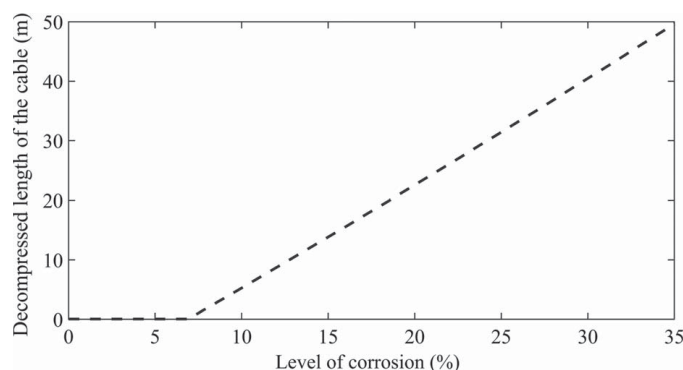
**Fig. 19.** Decompressed length of the cable versus corrosion level.
