MIG and TIG Joining of AA1070 Aluminium Sheets with Different Surface Preparations

MIG and TIG Joining of AA1070 Aluminium Sheets with Different Surface Preparations / Fracchia, Elisa; Bidulská, Jana; Bidulský, Róbert; ACTIS GRANDE, Marco. - In: MATERIALS. - ISSN 1996-1944. - ELETTRONICO. - 15:412(2022). [10.3390/ma15020412]

**Abstract:** In this work, AA1070 aluminium alloy sheets are joined using TIG and MIG welding after three different edge preparations. Shearing, water jet and plasma-cut processes were used to cut sheets, subsequently welded using ER5356 and ER4043 filler metals for TIG and MIG, respectively. Mechanical properties of the obtained sheets were assessed through tensile tests obtaining a relation between sheet preparation and welding tightness. Micro-hardness measures were performed to evaluate the effects of both welding and cutting processes on the micro-hardness of the alloy, highlighting that TIG welding gives rise to inhomogeneous micro-hardness behaviour. After tensile tests, surface fractures were observed employing scanning electron microscopy to highlight the relation between tensile properties and edge preparations. Fractures show severe oxidation in t

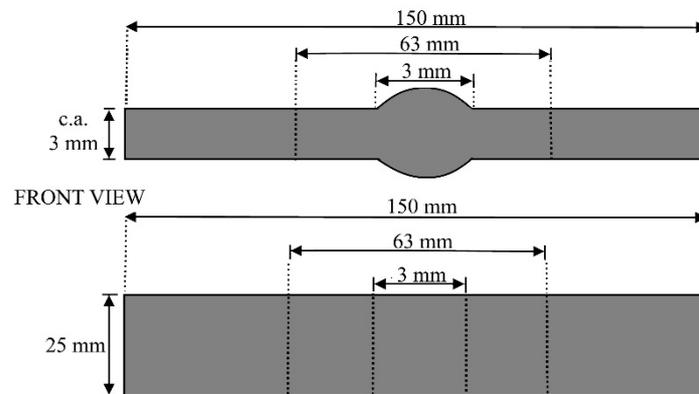
Specimens for tensile tests were milled following the UNI EN ISO 4136:2012 standard (Figure 1): gauge length 120 mm, length 150 mm, width 25 mm, thickness 3 mm. Test parameters used were preload 50 N, test speed  $8 \text{ N/mm}^2\text{s}^{-1}$  before yielding point  $R_{p0.2}$  and  $0.008 \text{ N/mm}^2\text{s}^{-1}$  after yielding point  $R_{p0.2}$ . Each welded sheet contained eleven specimens: five specimens had a protruding weld, while in the other six samples the weld was milled, as drawn in Figure 2. In fact, a protruded weld could be detrimental to the mechanical resistance, and it is commonly considered a weld-shape defect. Tensile tests were performed by a Zwick-Roell machine (Zwick-Roell BT1-FR100, Zwick Roell S.r.l., Genova, Italy).

**Figure 1.** Drawing of specimens for tensile tests. Welding length: 3 mm; gauge length: 60 + weld length; thickness: ca. 3 mm; width: 25 mm; total length 150 mm.

Tensile tests were performed on samples shown in Figures 1 and 3.

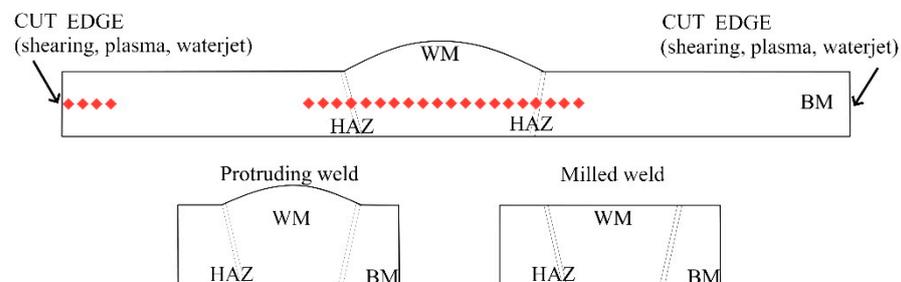
**Figure 2.** Drawing of micro-hardness measures path (red-diamond) along with BM, HAZ and WM and near the edges. Representation of the weld in the protruded and in the milled state.

Cross-sectional micro-hardness measurements were performed on the welded samples using a Vickers micro-hardness tester, LEICA VMHT (Leica Microsystems, Heerbrugg, Switzerland), as shown in Figure 2. The parameters applied were 200 gf and 15 s. The number of specimens and tests are reported in Table 3, while samples' production in a single welded sheet is shown in Figure 3.

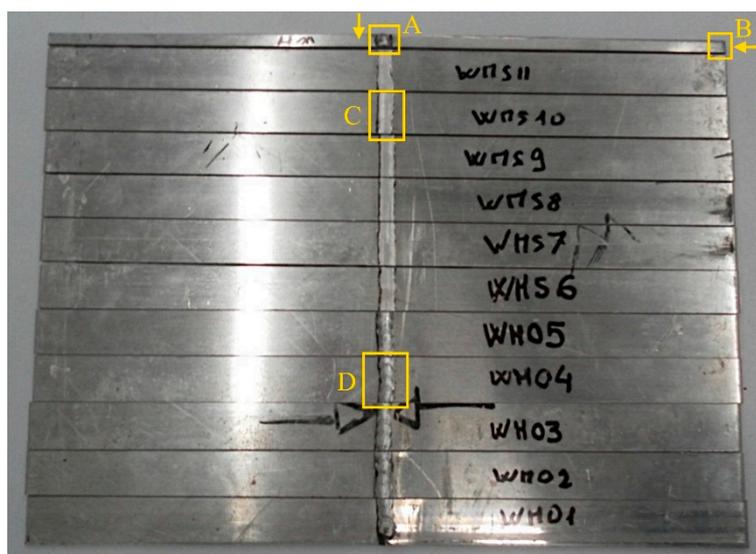
**Figure 3.** Sheets after waterjet cutting and MIG welding. The welded sheets were cut to obtain tensile test specimens and samples for microstructural observation and micro-hardness measures. A: Sample for weld observation and micro-hardness; the arrow indicates the side of observation. B: Sample for edge observation and micro-hardness; the arrow indicates the side of observation. C: Milled weld. D: Protruding weld.

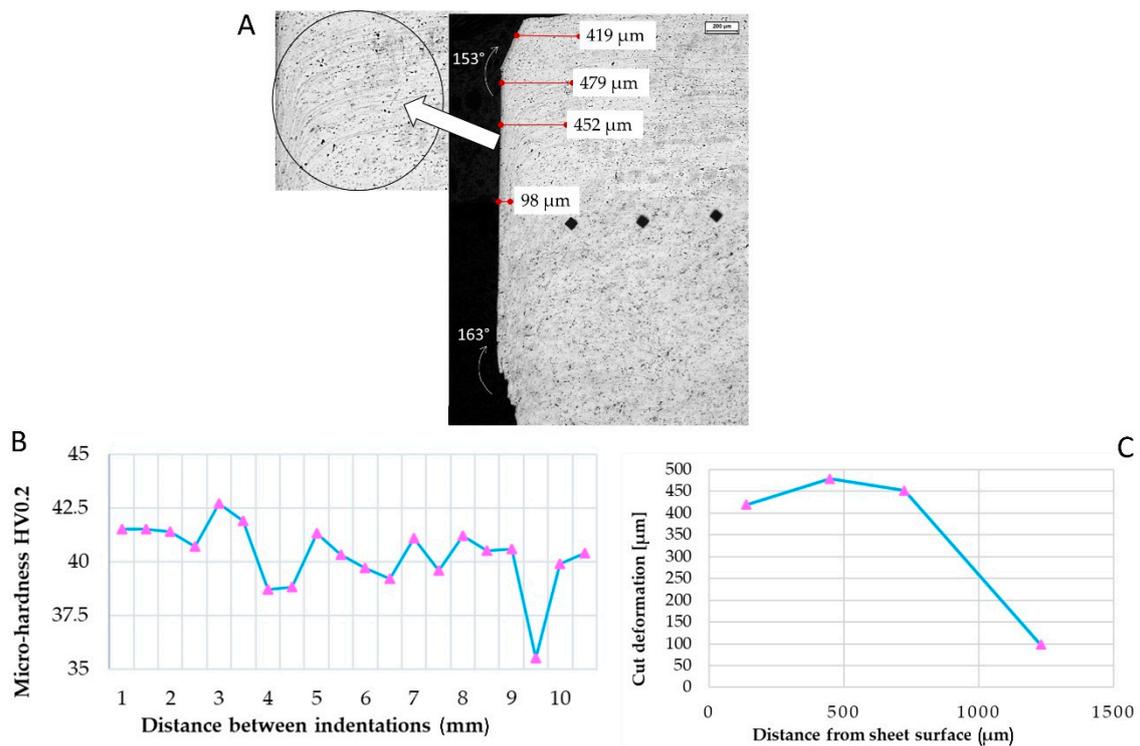
The aluminium sheets after the shearing process appear to have almost linear edges, as clearly noticeable from Figures 4A and 5. The sheet microstructure is oriented along the rolling direction (horizontal direction); after the chemical etching, the distortion of the microstructure at the edges appears evident.

**Figure 4.** (A) Microscope image of the shearing cutting trace on AA1070 sheet. (B) Distortions in the first 1200  $\mu\text{m}$  were documented. (C) Micro-hardness measured along the first 10 mm starting from the cut edge. Marker: 200  $\mu\text{m}$ .

Some microstructural measures were performed through image analysis software (LEICA QWin, version 3.5, Leica Microsystems, Heerbrugg, Switzerland) to evaluate the microstructural distortions. Shearing caused damage to the sheet's edges and material removal. Deformation angles were  $27^\circ$  (top sheet) and  $17^\circ$  (bottom sheet), while distortions decreased from 419 on the top to 98  $\mu\text{m}$  in the middle of the sheet (Figure 4B).

Micro-hardness measured along the edge after shearing did not show an increase caused by plastic deformation near the edge; the micro-hardness resulted almost constant along with the sheet (Figure 4B).

In terms of weldability, this configuration may affect the filler metal penetration, causing inadequate welding penetration during the welding process. On the other hand, despite the sheet edge shown in Figure 4 not being wholly planar, there was a proper welding penetration in both the welding processes (TIG and MIG). After TIG, specimens prepared by shearing resulted in the best mechanical values (along with water jet). On the other hand, mechanical tests showed similar behaviour for shearing-cut specimens and plasma-cut specimens after MIG processing.

Krinninger et al. [27] underlined that aluminium alloys' adhesive tendency (galling) is possible. Hence, the cutting surface in Figures 4 and 5 do not display the galling, while the cutting surfaces result in being relatively planar.

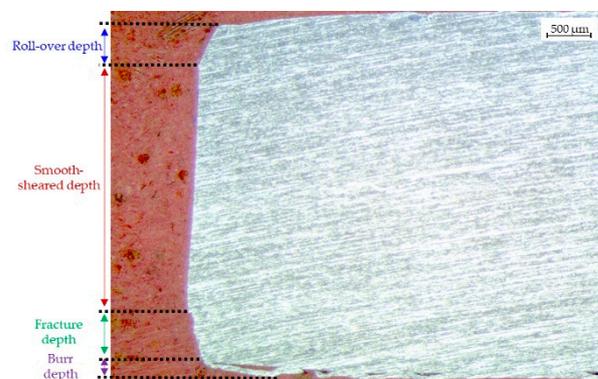
**Figure 5.** Different zones of the edges after shearing.

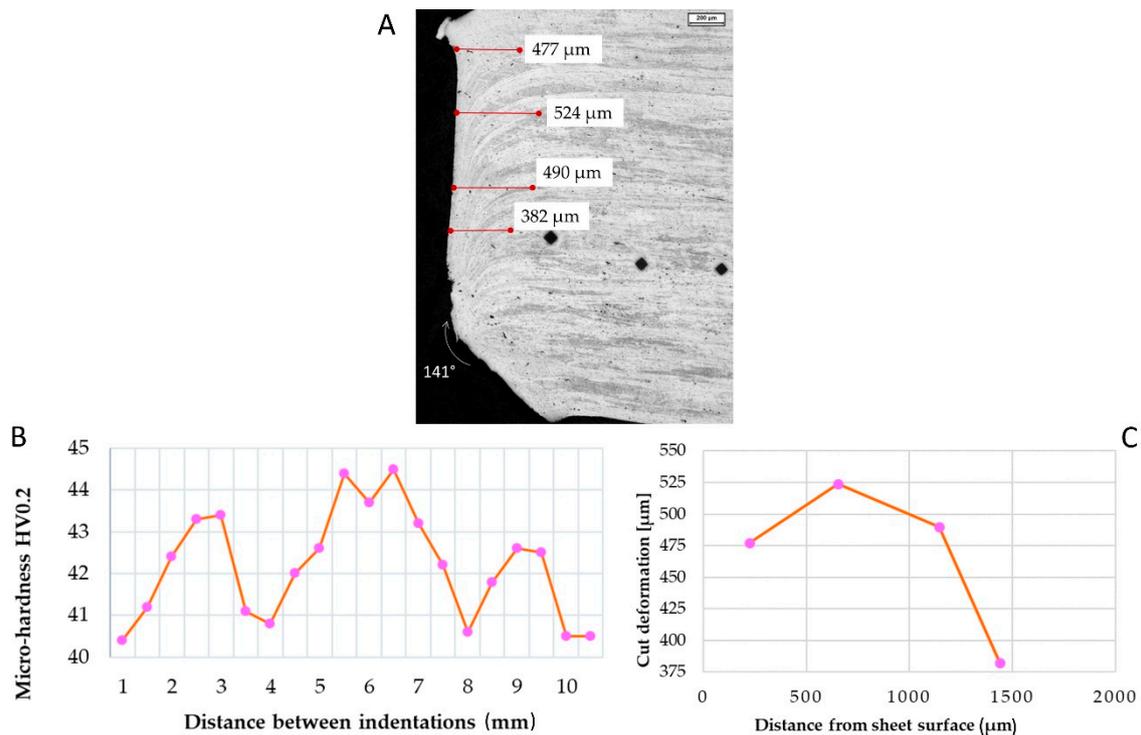
As for the water jet (Figure 6A), the initial distortion remained almost constant, with a measured value of 382  $\mu\text{m}$  in the middle of the sheet (Figure 6C). The bottom part of the sheet showed an intense deformation and material removal; an angle of  $141^\circ$  was measured. Only short variations in micro-hardness were documented (Figure 6B).

**Figure 6.** (A) Microscope image of the water jet cutting trace on AA1070 sheet. (B) Distortions in the first 1500  $\mu\text{m}$  were documented. (C) Micro-hardness measured along the first 10 mm starting from the cut edge. Marker: 200  $\mu\text{m}$ .

In [32], Wang et al. studied the kerf taper in aluminium alloy 6061, arguing that reducing the cutting speed causes the reduction of the kerf taper. Slow cutting speeds can produce a reverse taper, as seen in Figure 6, where the cut's kerf width is wider at the bottom than at the top. The jet stream removed more material at the bottom of the sheet than at the top. The reverse taper can also occur when cutting very soft materials [33]. On the other hand, literature highlights that multipass cutting [34] may increase surface finishing by obtaining flat surfaces.

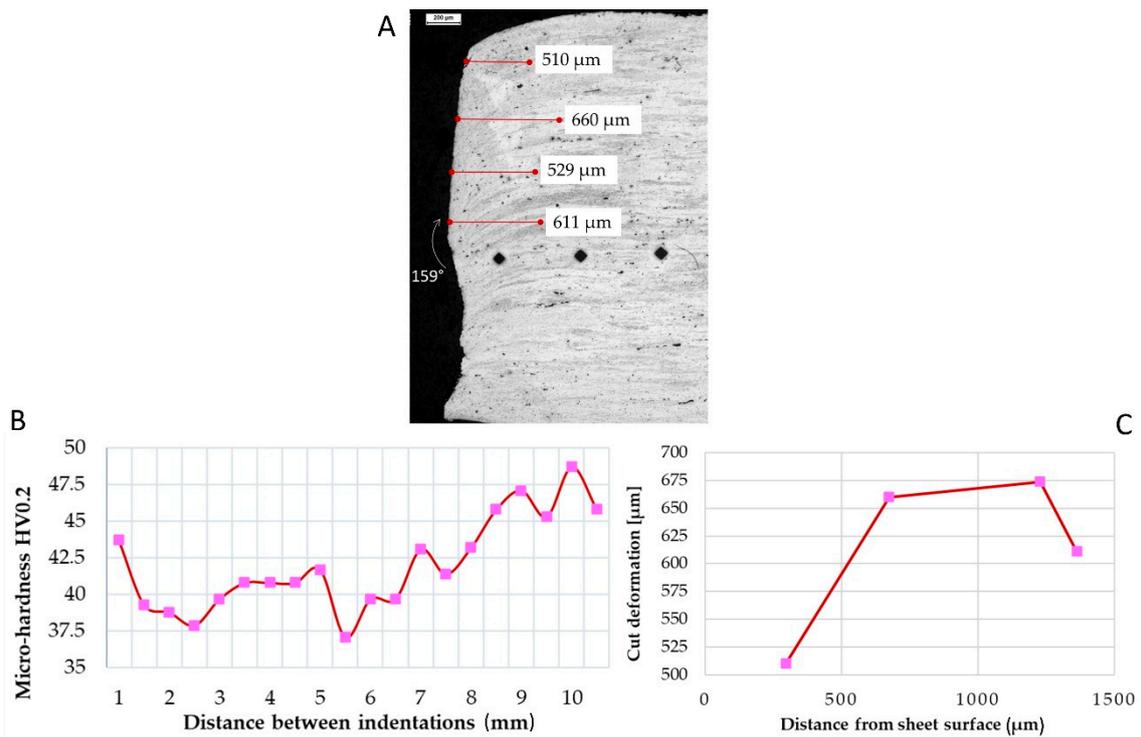
Plasma cutting (Figure 7A) caused higher specimen edge and microstructure orientation distortions. The distortion near the surface was 510  $\mu\text{m}$  and at the mid-thickness 611  $\mu\text{m}$  (Figure 7B).

A slight increase in micro-hardness was detected near the sheet's edge (Figure 7B).

Furthermore, significant damage was caused during the cutting process, with material removal in the lower half of the sheet, with a measured angle of  $159^\circ$ , while  $180^\circ$  was expected for a plain surface. Almost 100  $\mu\text{m}$  of material was removed during the cut, causing a potential lack in penetration of the welding seam.

**Figure 7.** (A) Microscope image of the plasma cutting trace on AA1070 sheet. (B) Distortions in the first 1400  $\mu\text{m}$  were documented. (C) Micro-hardness measured along the first 10 mm starting from the cut edge. Marker: 200  $\mu\text{m}$ .

From the literature, plasma cutting is considered the worst in terms of microstructural modification; moreover, heat-affected zones may develop if plasma power is too high [12]. Figure 7 shows the sheet microstructure after the plasma process. High microstructural distortions were noticed in the first half-width of the sheet. A consistent material removal was observed in the lowest part of the sheet, with a measured angle of 159° (21° of deformation in respect to the planar surface). With regards to micro-hardness, the first indentation (near the sheet edge) resulted in ca. 44 HV0.2, probably caused by strain hardening, then the micro-hardness decreased. In the first 7 mm, a slight heat-affected zone was noticed, micro-hardness decreased to 37 HV0.2; away from the edge, the micro-hardness increased up to 45–47 HV0.2.

Near the edges, different cutting processes caused different effects on both microstructures and micro-hardness measured. Plasma cutting affects the micro-hardness near the edges: the first micro-hardness value was slightly higher (ca. 40 HV0.2), while in the next 7 mm, the plasma effect occurs, resulting in a HAZ (see Figure 7).

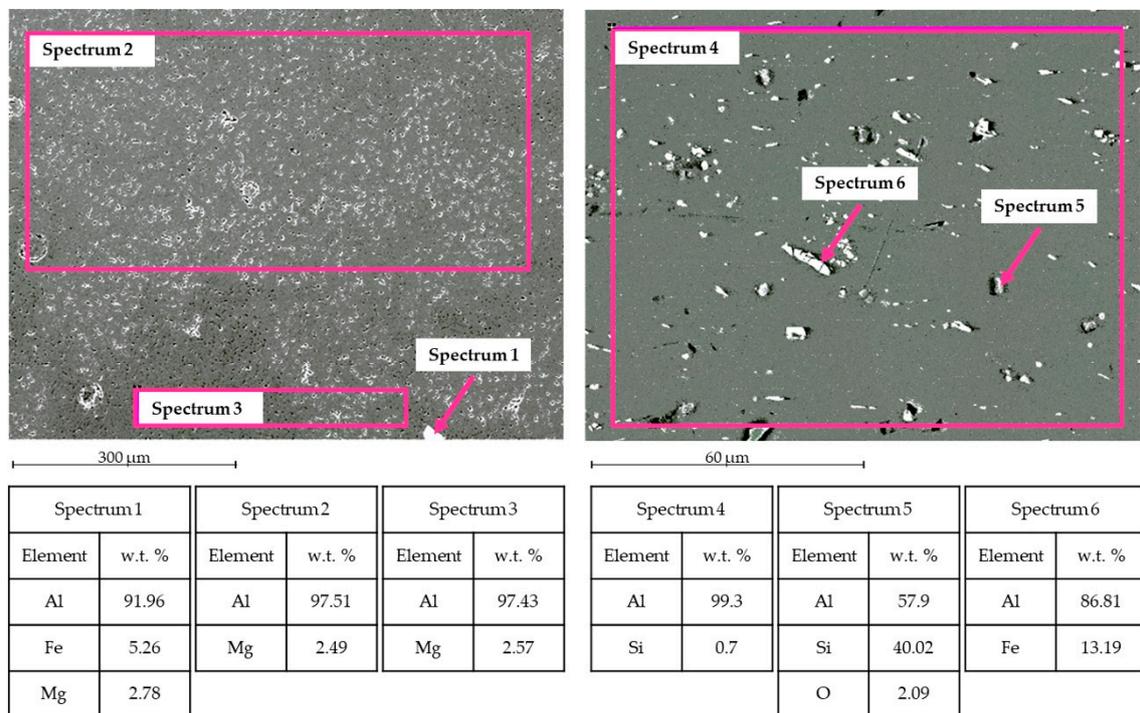
Figure 8 shows SEM-EDS analysis for TIG welding. In the WM, Al and Mg were observed, as expected, in the filler metal ER5356. Some intermetallic phases were observed, for instance, the phase Al-Fe-Mg [15] in Spectrum 1. In the HAZ zone, Al-Si and Al-Fe intermetallic phases were noticed [16].

**Figure 8.** TIG welding analysis. Left side: SEM image and EDS in WZ. Right side: SEM image and EDS in HAZ.

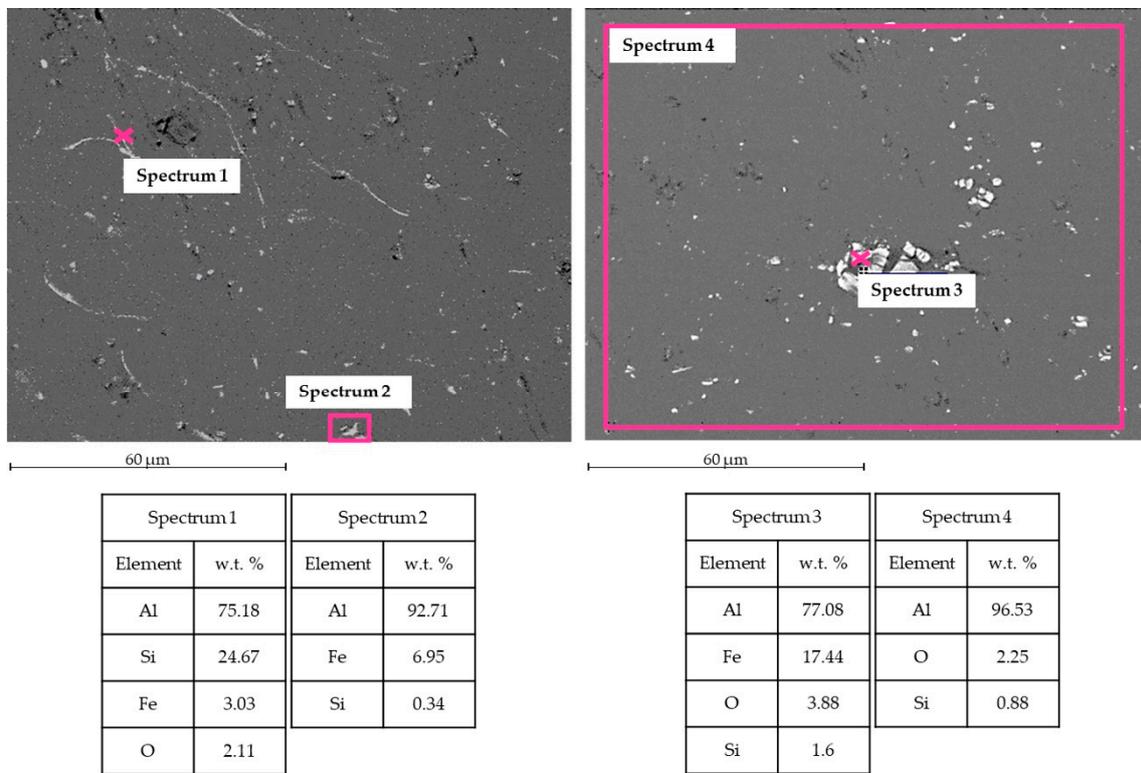
Figure 9 shows SEM-EDS analysis for MIG welding. Into the WM, it was possible to observe the presence of Al and Si, typical elements for the filler metal ER4043. Some intermetallic phases are found; for instance, in Spectrum 1 and Spectrum 3, the phase

Al-Fe-Si is in the form of acicular phase  $\beta$  and polygonal phase  $\alpha$  [17]. Even Al-Si and Al-Fe phases occur in the HAZ zone.

Figure 9. MIG welding analysis. Left side: SEM image and EDS in WZ. Right side: SEM image and EDS in HAZ.

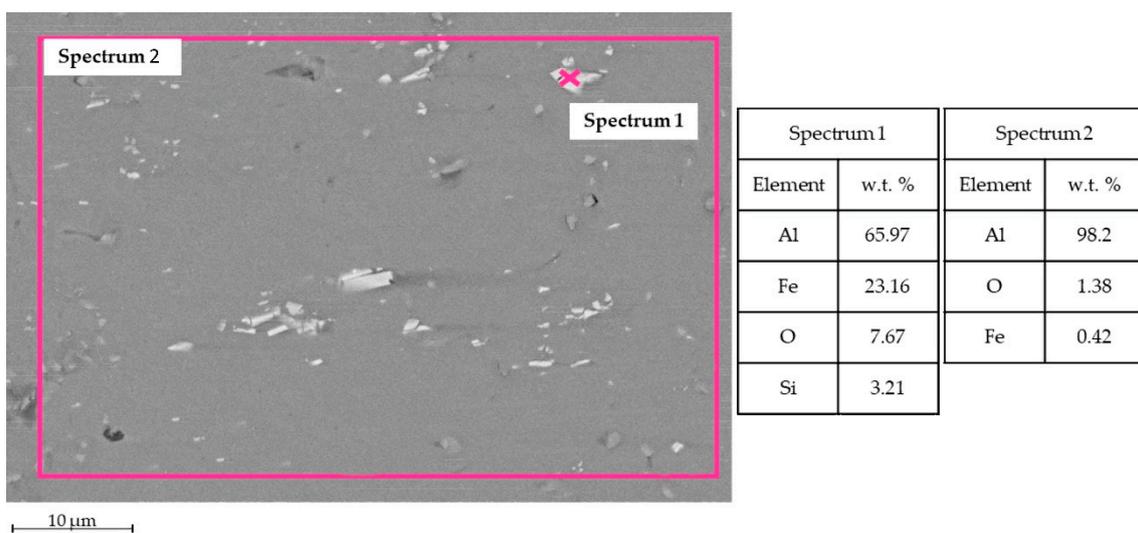
The base metal contains a certain amount of Si and Fe, as shown in Figure 10. It is well known that, if Fe exceeds the solid solubility limit of 0.05 wt %, it forms intermetallic phases Al-Fe [18]. Due to the H16 starting structure, these phases show an elongated shape.

Figure 10. Base metal (BM) AA1070 H16.

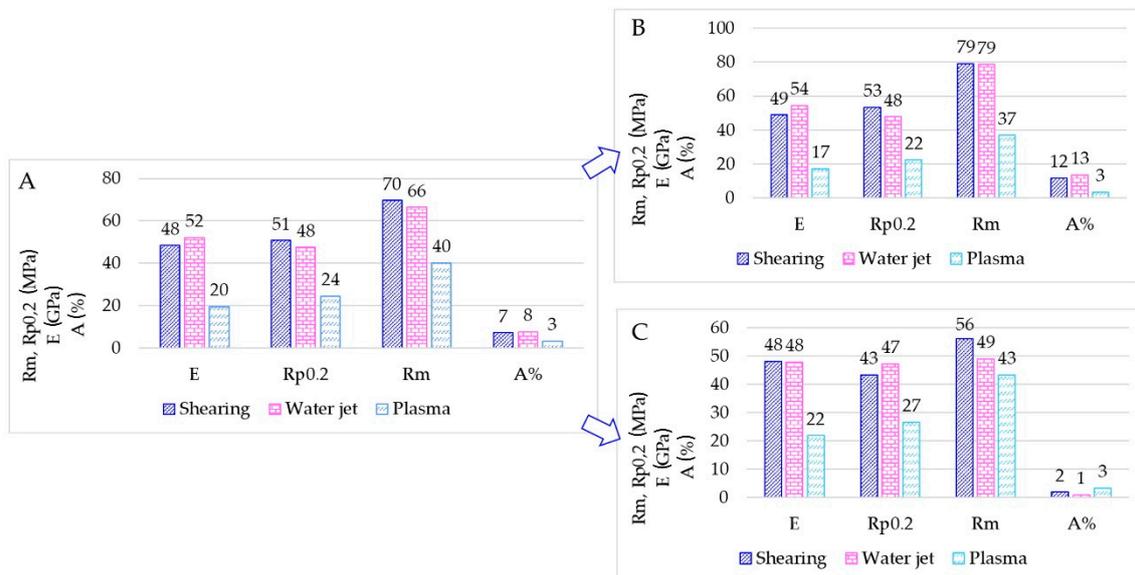
Results for TIG welding are summarized in Figure 11 through bar charts. The bar charts represent the average tensile properties measured (Figure 11A), the average tensile properties for the specimens as-welded (Figure 11B) and finally, the average tensile properties for the specimens having the milled weld (Figure 11C).

**Figure 11.** (A) Overall bar chart for TIG-welded sheets. (B) Bar charts for as-welded samples. (C) Bar charts for milled samples.

The average elongation at rupture A% in TIG-welded specimens is affected by the very low A% in the milled specimens. Mechanical properties observed (Rm, tensile strength;  $R_{p0.2}$ , yield strength) for sheared and water jet cutting appear similar.

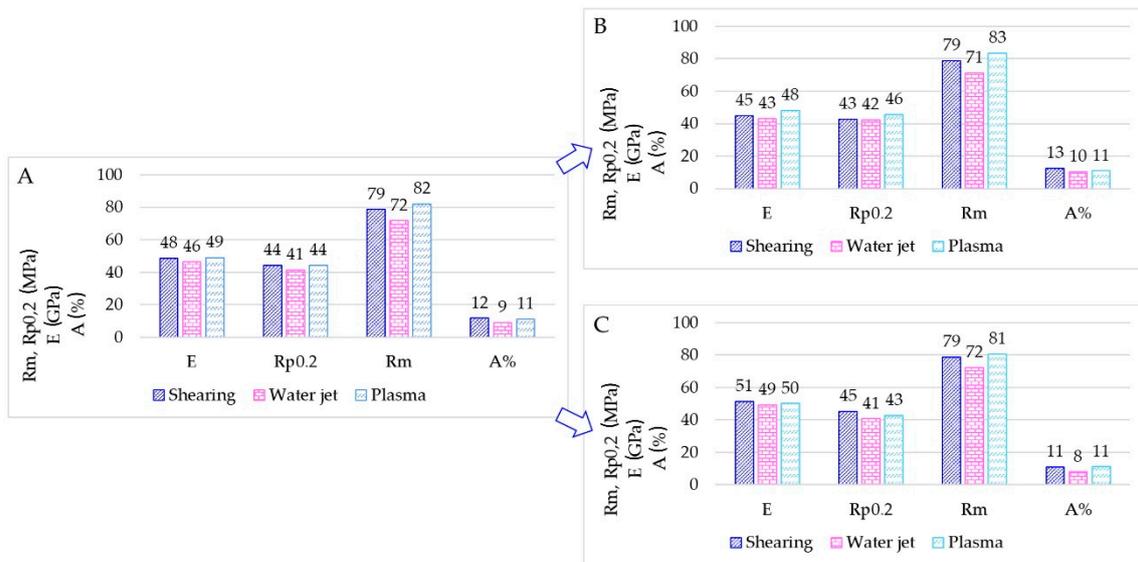
The average mechanical values of MIG-welded specimens are shown in Figure 12. Mechanical properties observed appear similar for each kind of sheet edge preparation, and the A% appear similar with or without the weld milling.

**Figure 12.** (A) Overall bar chart for MIG-welded sheets. (B) Bar charts for as-welded samples. (C) Bar charts for milled samples.

Moreover, porosities inside the weld cause a decrease in hardness near the BM values. On the contrary, in MIG welded specimens, specimens after water jet cutting (orange-bullet marker in Figure 14B) show low micro-hardness in WM. This behaviour is in line with the mechanical results shown in Figure 12 (the worst in MIG welding specimens).

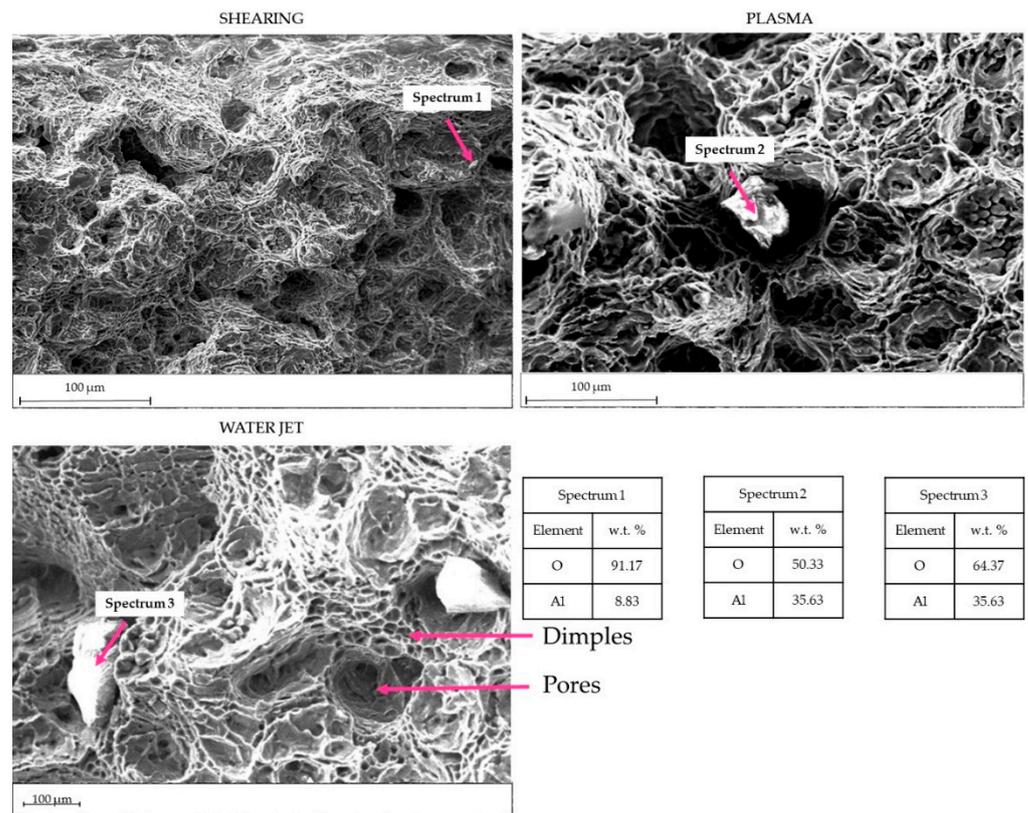
To assess these hypotheses, SEM observations were performed. The fracture surfaces were observed using SEM (Figure 13). Ductile fractures were noticed in all the specimens; all fractures were located in the welded part. Some welding appears non-penetrating along the entire thickness of the sheet. Furthermore, the weld seams appear rich in gas porosities [19] and in dendrites that negatively affect the mechanical strength. A high amount of oxide scale was observed, particularly in the water jet and plasma specimens (Figure 13—Spectrum 2 and Spectrum 3).

**Figure 13.** Surface fractures in three TIG-welded tensile specimens. Oxides were detected of variable sizes.

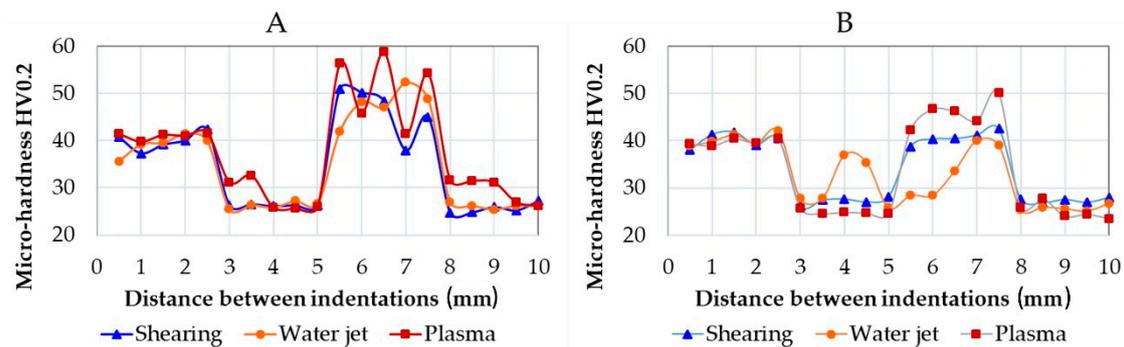
The WM has a dilution ratio that depends on the welding process. WM comprises AA1070 base metal and ER5356 filler metal for TIG welding and AA1070 and ER4043 for MIG welding. The micro-hardness in the welded samples was measured as drawn in Figure 2, and results are shown in Figure 14. The different dilution ratios may affect the average micro-hardness. Furthermore, in the WM, the micro-hardness is subjected to a certain variation caused by defects or hardening phases. In TIG welding, specimens' plasma-cuts show some inadequate penetration and porosities. This behaviour causes a variation in the micro-hardness measured (red-square marker in Figure 14A).

**Figure 14.** Graphical representation of the micro-hardness measured in TIG (A) and MIG (B) specimens.

Overall, higher micro-hardness was noticed in TIG welding with an average value of 48 HV0.2, while in MIG welding, the average value was 40 HV0.2. This result is, in turn, affected by the filler metal. In TIG welds, the micro-hardness in WM is higher than the micro-hardness in the BM; on the contrary, in MIG welds, the micro-hardness resulted similar in the BM and the WM. Micro-hardness values are average values depending on the intermetallic phases. Considering that the number of intermetallic phases is low in alloy AA1070, hardness in BM is almost the hardness of the  $\alpha$ -Al phase: ca. 40 HV0.2. Furthermore, the micro-hardness in the  $\alpha$ -Al depends on the alloying elements dissolved in the solid solution [20]. Intermetallic phases detected may affect the average values:  $\alpha$ -AlFeSi and  $\beta$ -AlFeSi are respectively ca. 883 HV and 765 ([21]), Al-Mg ca. 48 HV [22], Al-Si ca. 80 HV [20].

The variation in micro-hardness inside the WM was caused by the high amount of gas porosities found in the weld pool, as observed in the surface fracture analysis in Figure 14. The reduction in the micro-hardness from the BM to the HAZ is attributable to the intermetallic Al-Fe coalescence and the grain coarsening.
